BAT PRESENCE/ABSENCE SURVEY OF:

BARN 10
CARN FRIAR FARM
CARN FRIAR
ST MARY'S
ISLES OF SCILLY
TR21 0NZ

Our reference: BS36-2021PAS

Report date: 25th May 2021

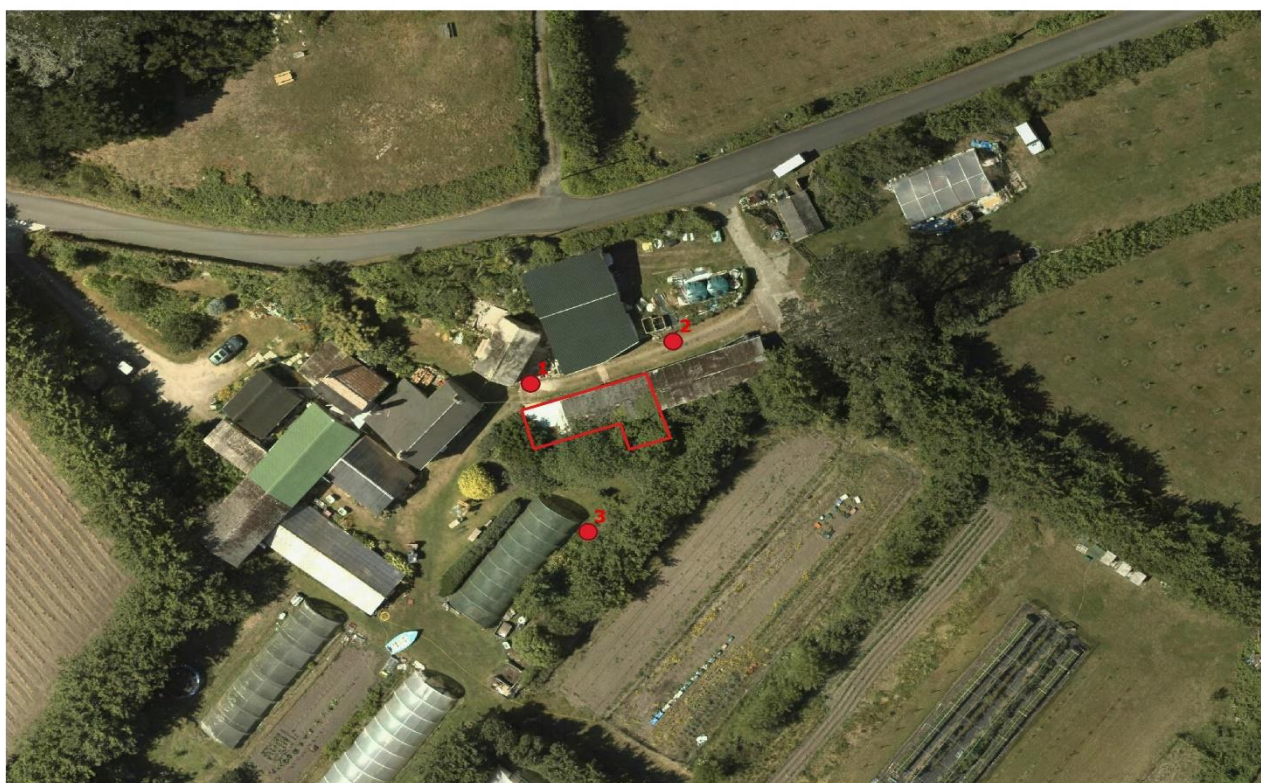
Photo 1. Surveyor location for the dusk emergence survey 19-5-21

- Starting the survey 15 minutes before sunset and continuing for approximately 1.5-2 hours after¹
- Identification of bat species primarily using ultrasound characteristics. To aid identification flight and habitat characteristics were also noted (where possible) to determine the species.
- Identifying exit locations of bats by standing at different vantage points around the building that offered visual contact with any potential exit point previously recorded. Surveyors stood no more than 50m apart, or away from the building (see Fig 1 for location of surveyors).
