PERMISSION FOR DEVELOPMENT

Application No: P/21/018/FUL

Site address: Block House Cottages Old Grimsby Tresco Isles of Scilly TR24 0PZ

Proposal: Demolition of existing row of cottages, construction of new replacement two storey 5/6 bedroom dwelling, single storey annexe, single storey studio outbuilding extension, and associated landscaping works.

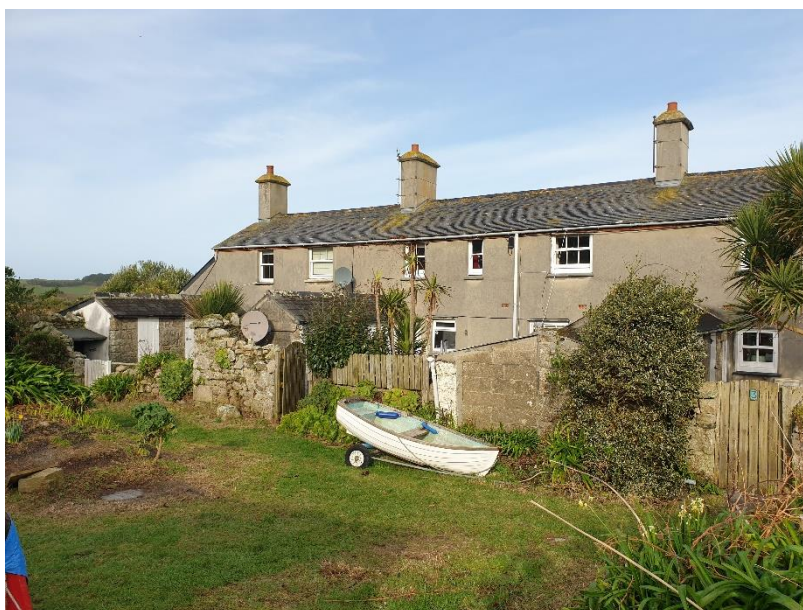
Figure 2: Southern elevation of 1 and 2 Blockhouse cottages

The buildings surveyed comprise a terrace of four two-storey cottages of stone and concrete block construction (Figs. 2-5), with four attached single-storey outbuildings of similar construction on the southern elevation (Figs. 6 & 7). On the northern elevation of the cottages are four single-storey concrete block lean-to's, one per cottage (Figs. 4 & 5). There is an adjacent detached single-storey outbuilding (outbuilding 1) to the south of the property (Figs. 12 & 13), also of stone and concrete block construction, and a detached timber shed to the north of Cottage 3 (Fig. 14). The cottages are currently in use as staff accommodation and the outbuildings are used for storage.

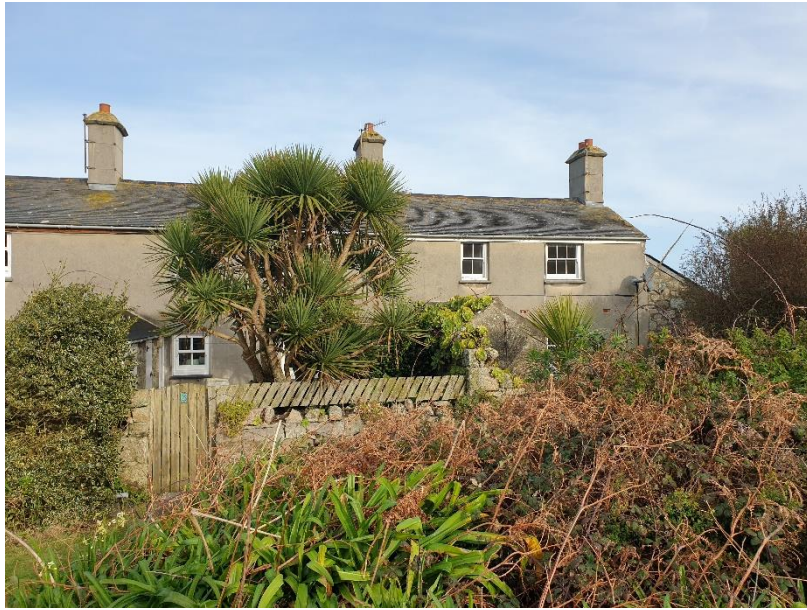
Figure 3: Southern elevation of 3 and 4 Blockhouse cottages

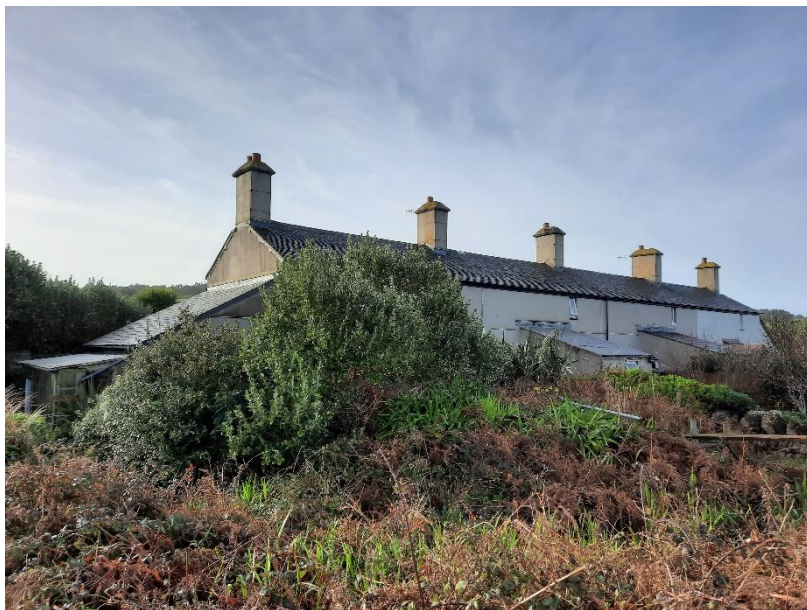
Figure 4: Northern and eastern elevations of Blockhouse cottages

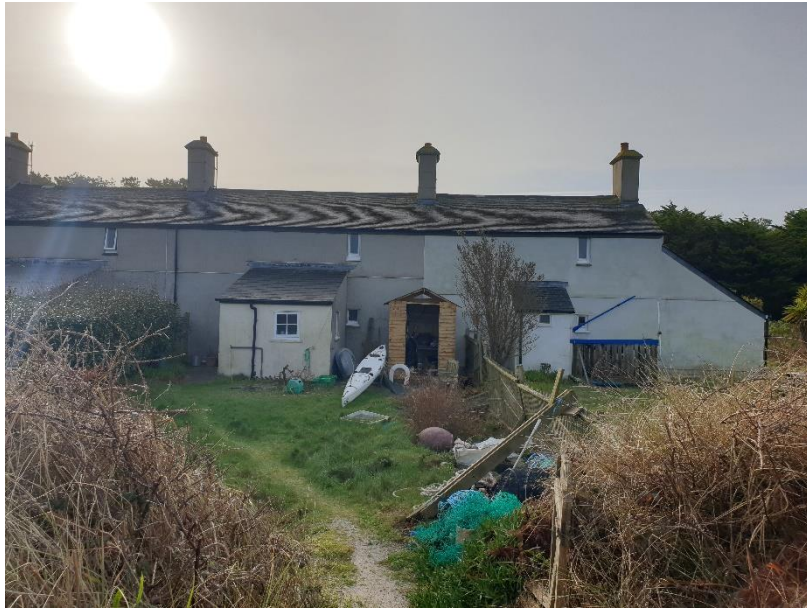
Figure 5: Northern elevation of 1 and 2 Blockhouse cottages

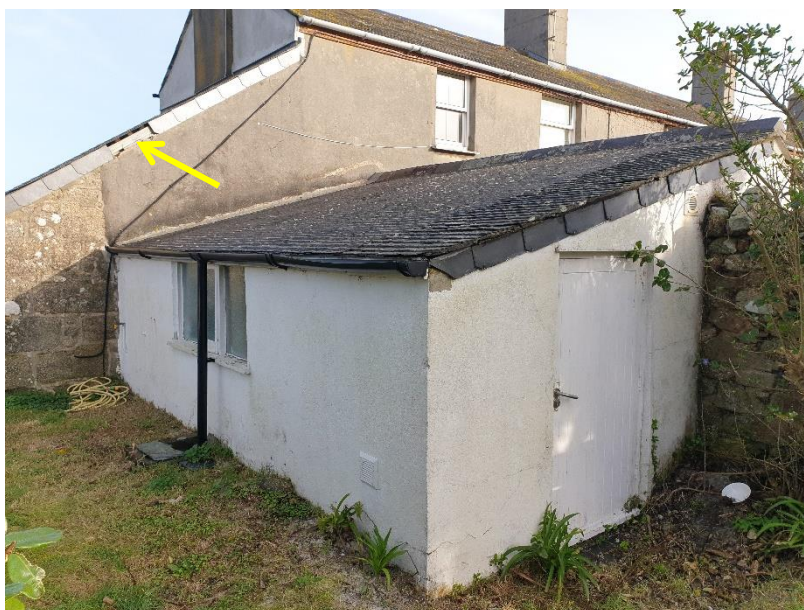
Figure 7: Southern and western elevation of outbuilding 1, also showing hole in roof from missing hanging slate on cottage 1 lean-to (yellow arrow)

On the southern elevation there are four single-storey, stone/concrete block attached outbuildings with either mono-pitched or pitched roofs covered with either composite/traditional slate or corrugated cement fibre with composite ridge tiles (Figs. 6 & 7). The outbuildings feature lead flashing, occasional small, glazed windows and wooden doors. The external walls are part cement rendered and part exposed/painted stonework. Gaps were observed within all of the outbuildings, notably beneath lifted roof slates, above doors, under lead flashing, under the eaves, within the stonework and behind hanging slates. All of these features could provide potential roost sites for crevice-dwelling bats or bat access to the underside of the roofs and/or interior rooms (Fig 7).

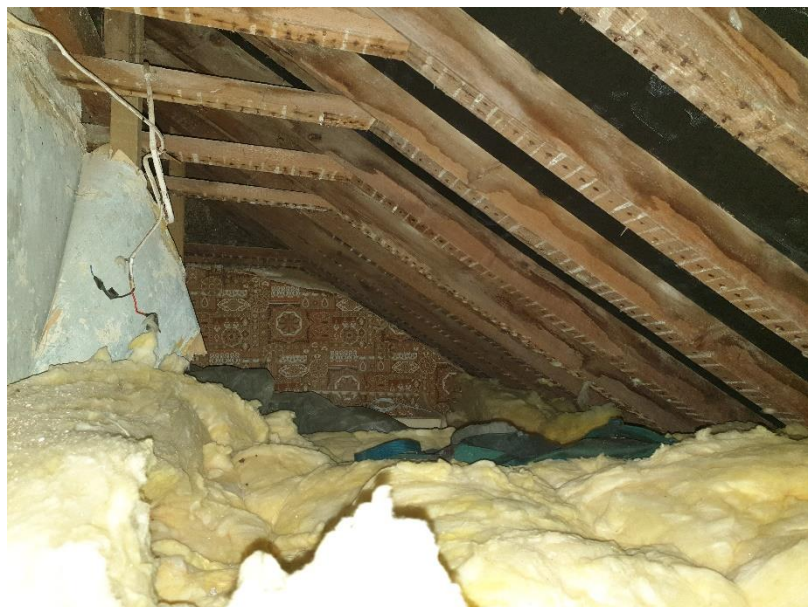
Figure 8: Interior of void 1, cottage 1 (viewed towards the south)

Void 1 is dark and features thick mineral loft insulation on the floor, with a synthetic roof membrane lining the roof. The walls are either plastered or wallpapered and the wall tops are open to the interior of the void. No evidence of roosting bats was found within this void, although it was not possible to fully inspect this area due to the thick layers of insulation covering the ceiling joists.

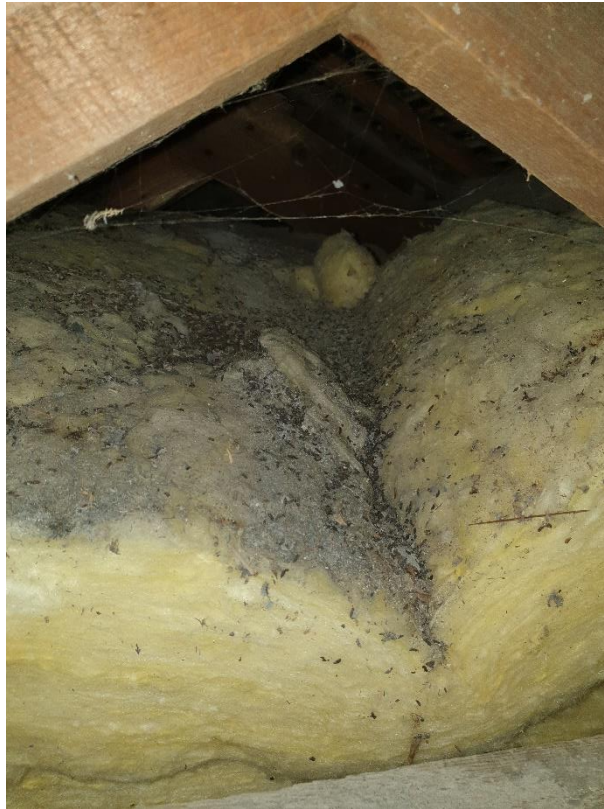
Figure 9: Accumulation of bat droppings within void 3, cottage 2 (viewed towards the east).

Void 3 is in the centre of the property, over cottage 2, and is of the same composition as void 1. Within this void on top of the insulation a light scattering of bat droppings was noted throughout, with a large accumulation of several hundred mixed-age bat droppings noted underneath the ridge in the centre of the void (Fig. 9). The droppings were characteristic of a long-eared bat spp., likely to be brown long-eared bat (*Plecotus auritus*) as the site is outside the known range of grey long-eared bat (*Plecotus austriacus*). NB: species present must be confirmed with DNA analysis of bat droppings.

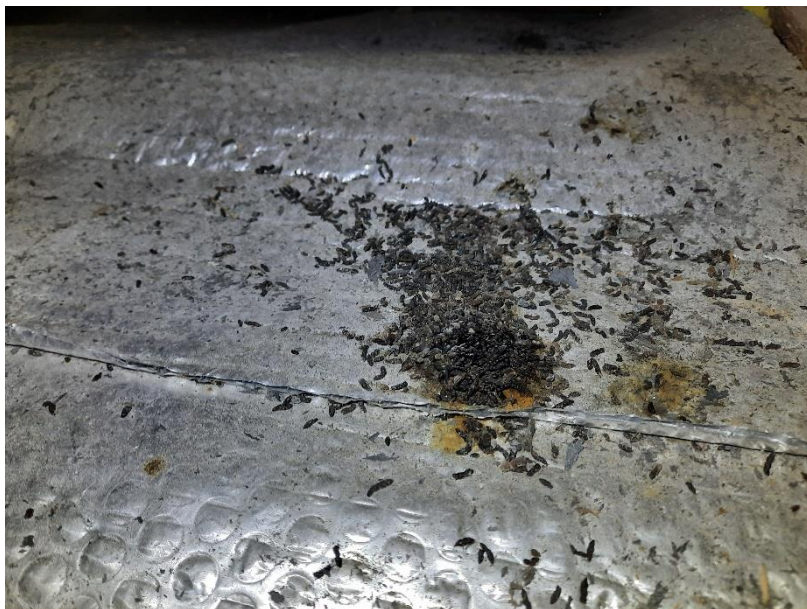
Figure 10: View of one of the piles of bat droppings found within void 4, cottage 3.

Void 4 spans the length of cottage 3, the composition is largely the same as the other cottages, but the roof tiles are unlined. There was rolled insulation and a metallic insulation sheet covering the joists. Scattered bat droppings were observed throughout the void with concentrations observed under the apex (c. 500, Fig 10), likely from the same bat species as those found within void 3. Gaps were seen at the wall tops (Fig 11) and gaps were seen within the chimney stonework, which provide potential bat access into the void.

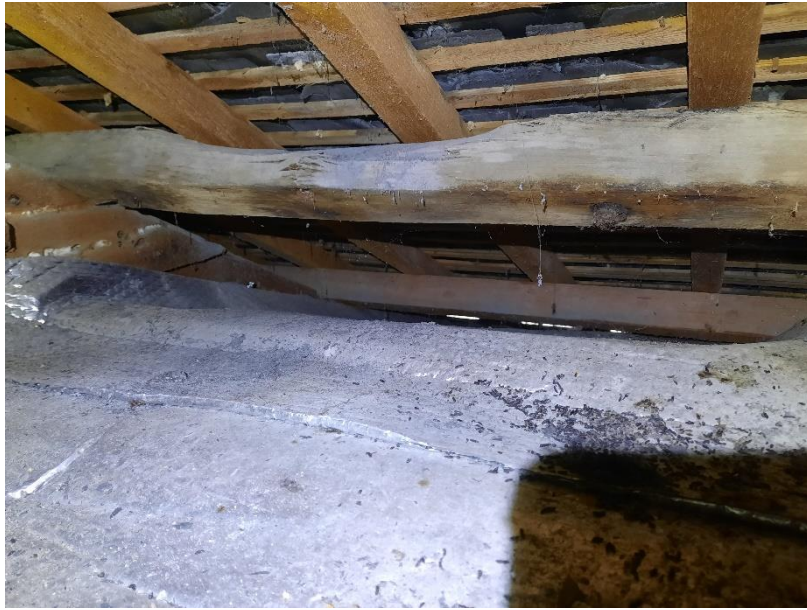
Figure 11: View of gaps at the wall tops of void 4 within cottage 3

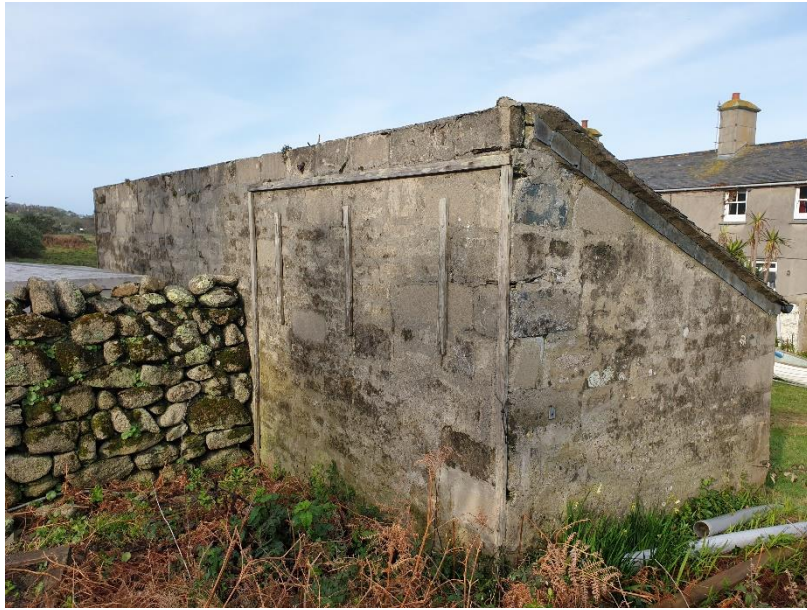
Figure 12: Southern and eastern elevations of detached outbuilding, showing attached stone wall

Internally, the outbuilding consists of two rooms, separated by an internal stone wall. The underside of the roof is mostly unlined, with some polystyrene insulation in places, and it is covered with thick cobwebs. The internal walls are whitewashed stone/concrete block and the floor is concrete. The rooms are both light and open and there are no significant crevices or enclosed spaces present with potential to be used by roosting bats.

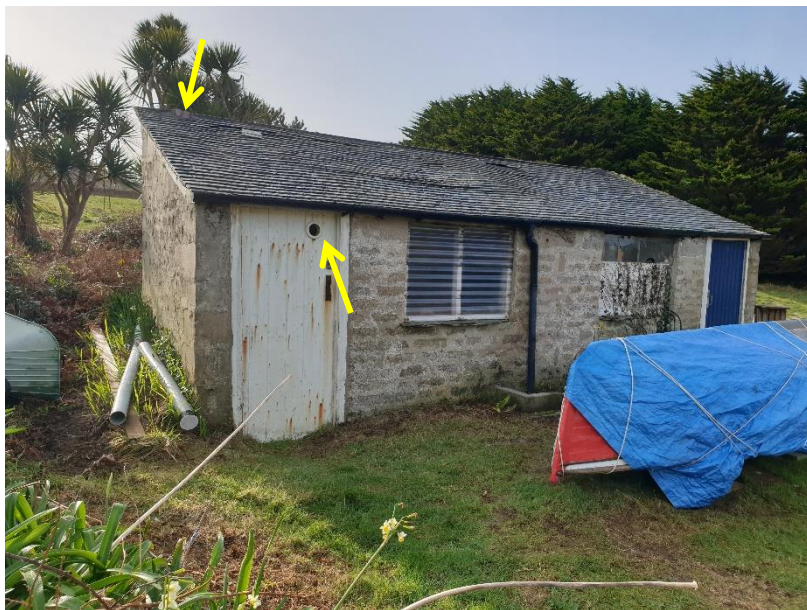
Figure 13: Northern elevation of detached outbuilding, showing holes in door and roof (yellow arrows)

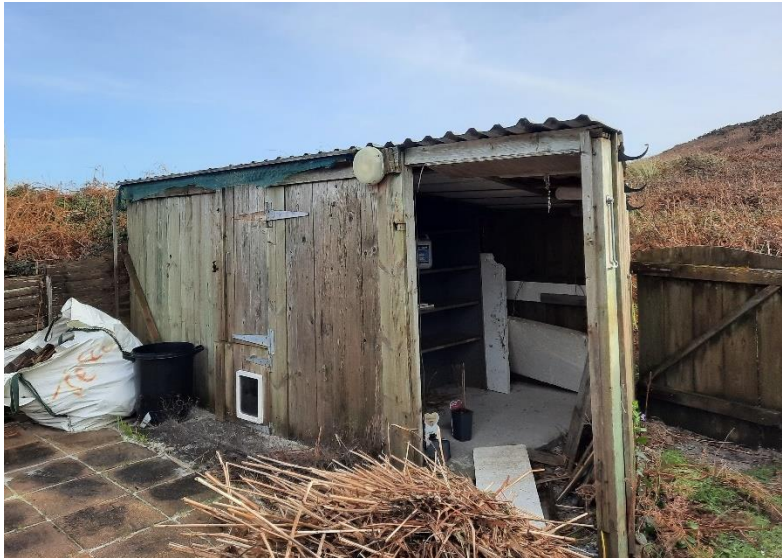
Figure 14: Western elevation of timber shed

A timber shed was also present to the rear of Cottage 3, this was of timber construction with a corrugated sheet flat roof (Fig 14). This was open and draughty internally, consisting of a single room with no significant crevices or enclosed spaces with potential for roosting bats noted.

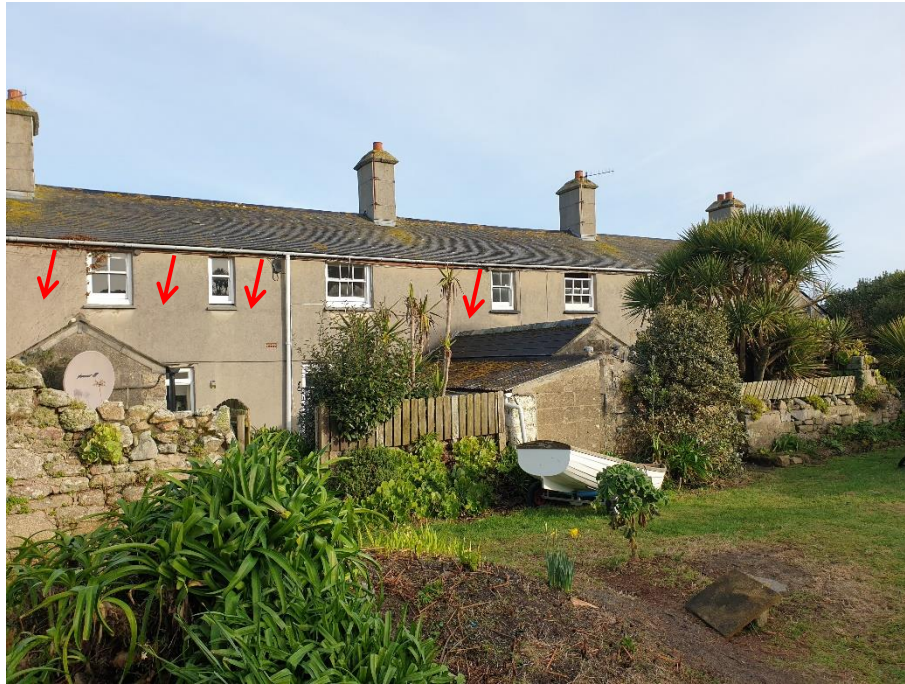
Figure 15: Locations six common pipistrelles were seen to emerge during the first emergence survey (red arrows), from under the fascia board on the southern elevation of Blockhouse.

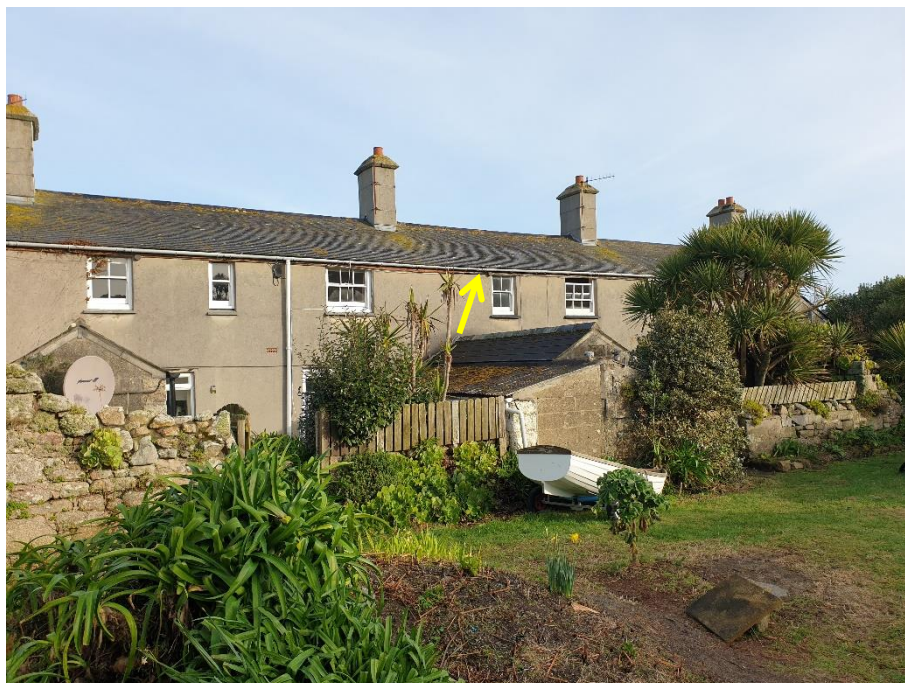
Figure 16: Location three common pipistrelles were seen to re-enter the building during the second re-entry survey (yellow arrow) under the fascia board on the southern elevation of Blockhouse.

enter a gap behind the fascia board on the southern elevation of the cottage between 04:57 and 05:20 (Fig. 16).

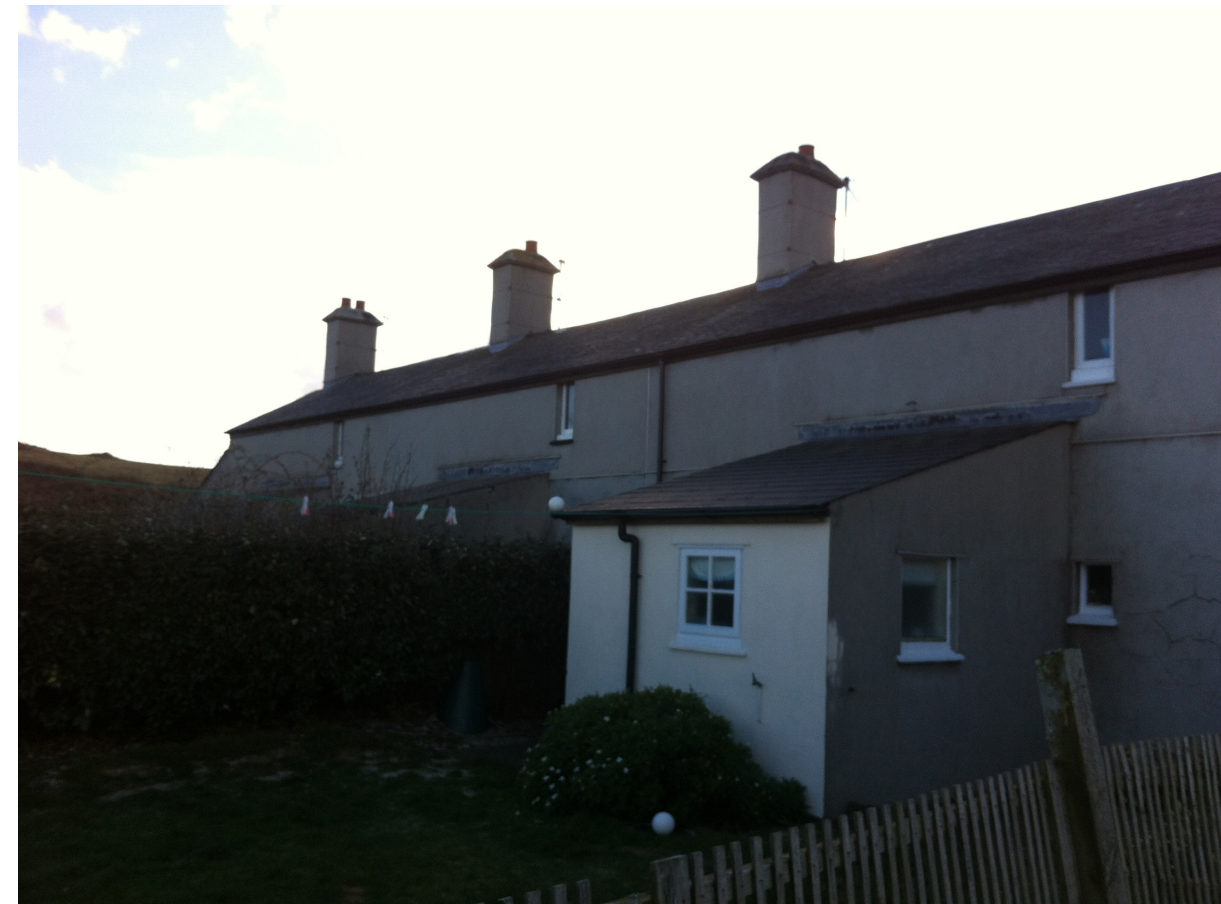
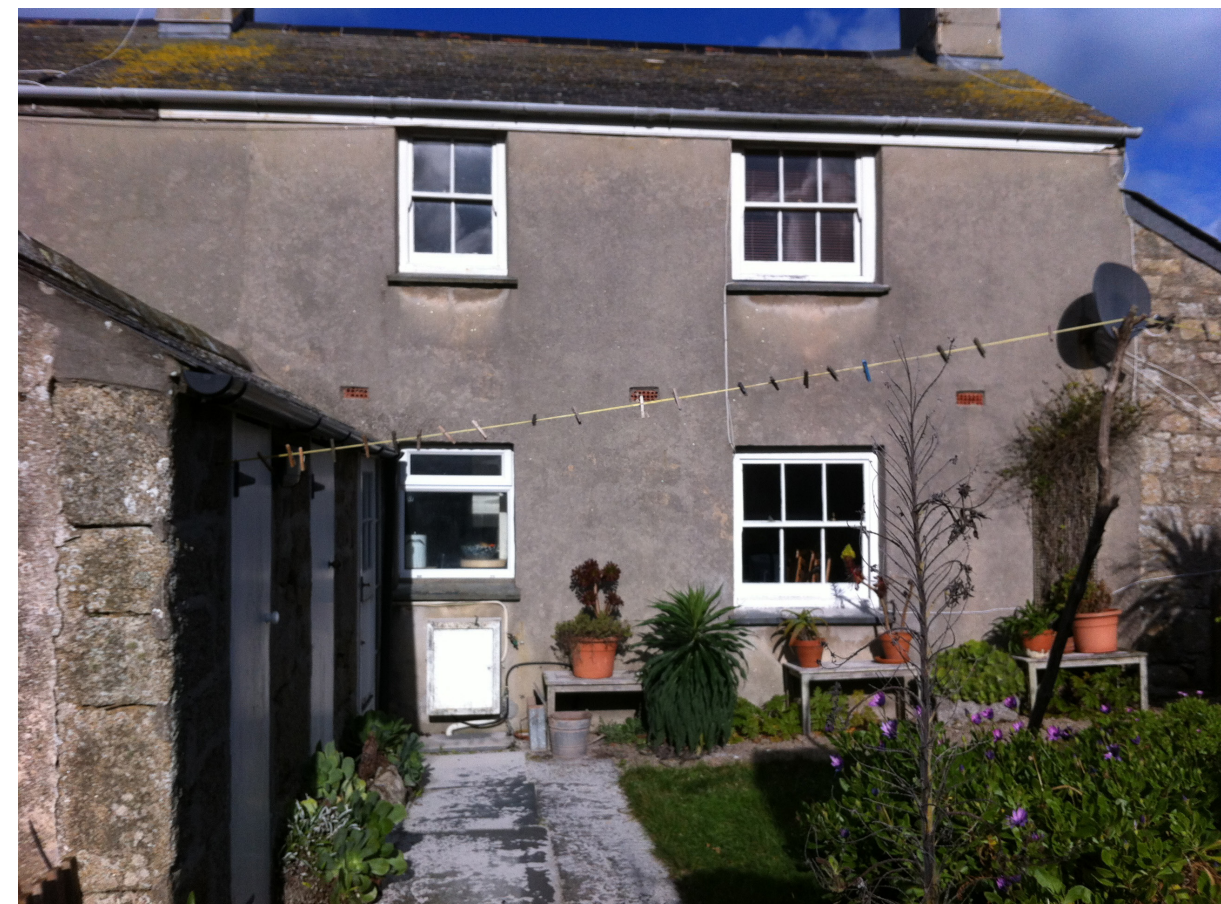
The existing under sized timber joists have a high deflection, offer no acoustic separation, and would have a poor performance in a fire. The buildings are not efficient to heat, with limited opportunities to retrofit insulation into the existing walls. The rooms rely heavily on artificial lighting because of the lack of natural light entering the building through the small windows, which also limit views from the buildings.

Existing Blockhouse Cottages

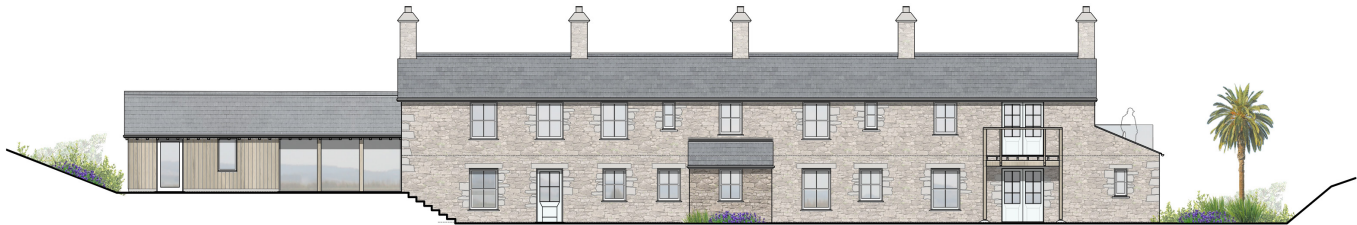
NORTH ELEVATION

Proposed Elevations as labelled

The proposed building would continue this pattern of development, with Tresco Estate making significant investment into high quality materials. Local granite masonry salvaged from the demolition of the existing cottages would be re-used to face the majority of the replacement building (a significant improvement over the current pebble dash).

Other proposed materials would reflect the surroundings and existing buildings; they include a palette of granite, cornish hedging, natural slate roofing, untreated timber boarding and painted timber windows to provide continuity of character.

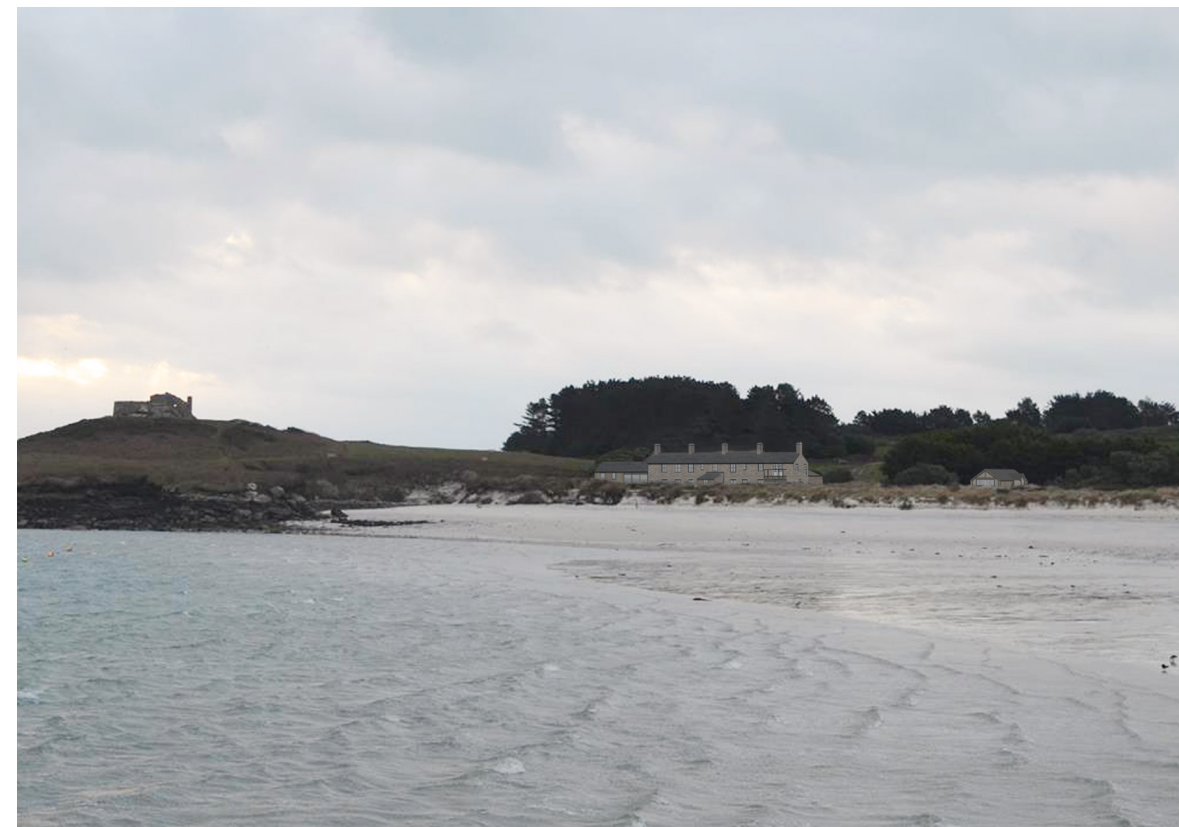
Proposed view towards the Old Blockhouse
