## **BAT, BARN OWL AND NESTING BIRD SURVEY**

## **A GLASS HOUSE AT HILLDROP HOUSE, LOWERTOWN, ST MARTINS, ISLES OF SCILLY**

**August 2021**

### **Wheal Grey Ecology Ltd**

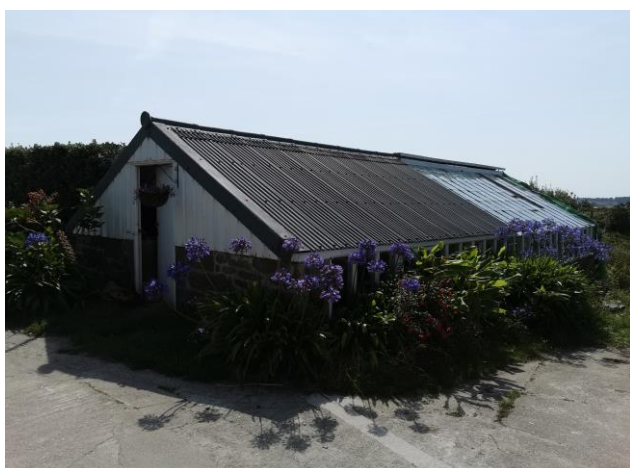
The building subject to this survey is a single storey rectangular glass house built on a north south alignment. It has gable ends, with the lower parts of the walls being stone and the upper parts of the walls being vertical timber clad or timber framed supporting glass. The northern gable end and eastern wall are solid with the upper parts of the western and southern walls being glazed or being open, the southern gable end is timber framed but unglazed being covered with a tarpaulin. The northern half of the roof is covered with corrugated cement fibre sheeting with the southern end being glazed, see photos 1 and 2.

Photo 1. Showing the glasshouse  
from the north west

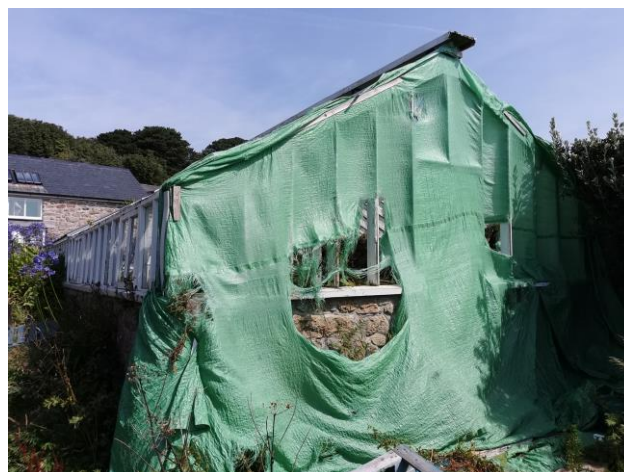
Photo 2. Showing the glasshouse  
from the south west

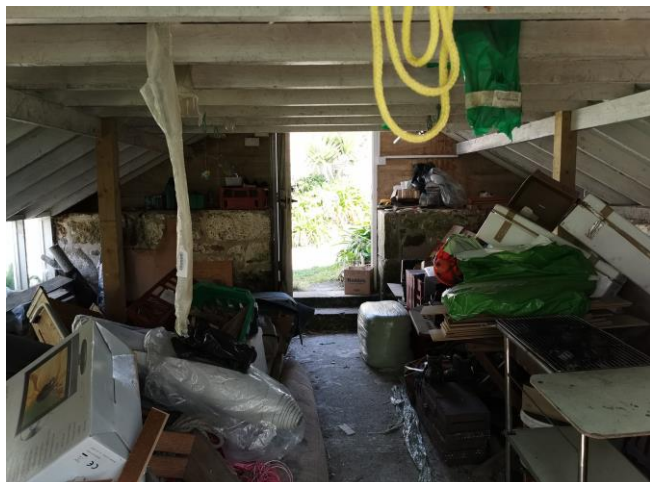
Internally the building is divided into two rooms by a timber partition wall with an open doorway in the centre. The northern room is roofed with corrugated cement fibre sheeting and the southern room is roofed with glass. Both rooms are open from the floor to the underside of the roofs and the interiors are used for storage and to grow plants. The interior is open to outside via missing windows and a vent over the glass roofed section of the building. The building supports very few features with any potential to support roosting bats and the interior is very light and will get very warm making its use by roosting bats unlikely, see photos 3 and 4.

Photo 3. Showing the interior of  
the northern room

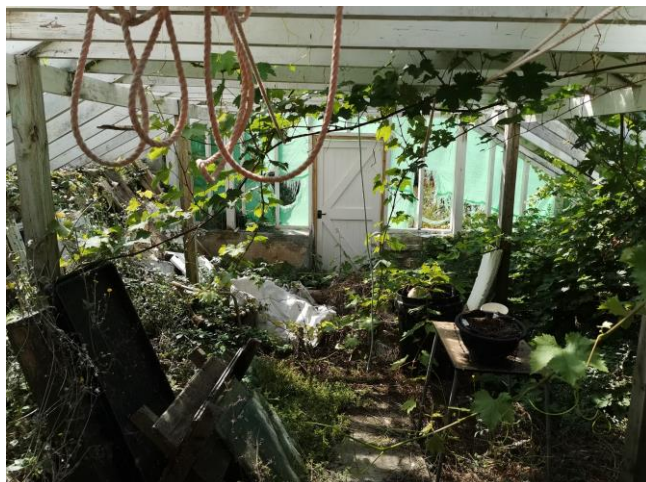
Photo 4. Showing the interior of  
the southern room
