PERMISSION FOR DEVELOPMENT

Application No:	P/21/077/COU	Date Application Registered:	26th October 2021
Applicant:	Mr & Mrs Green Sea Glass 4 Porthcressa Road St Mary's Isles Of Scilly TR21 0JL	Agent:	Mr N Bush St Marys House Point Mills Bissoe Truro TR4 8QZ
Site address:	Freesia 3 The Parade Hugh Town St Mary's Isles Of Scilly		
Proposal:	Change of use of guest house to self-contained holiday let with owners' accommodation and associated works. (Listed Building) (AMENDED PLANS)

**Freesia Guesthouse
Hugh Town
St Mary's, Isles of Scilly
NHLE 1219064
Heritage Statement**

CHIMNEY REMOVAL AT FREESIA GUESTHOUSE HUGH TOWN, ST MARY'S, ISLES OF SCILLY

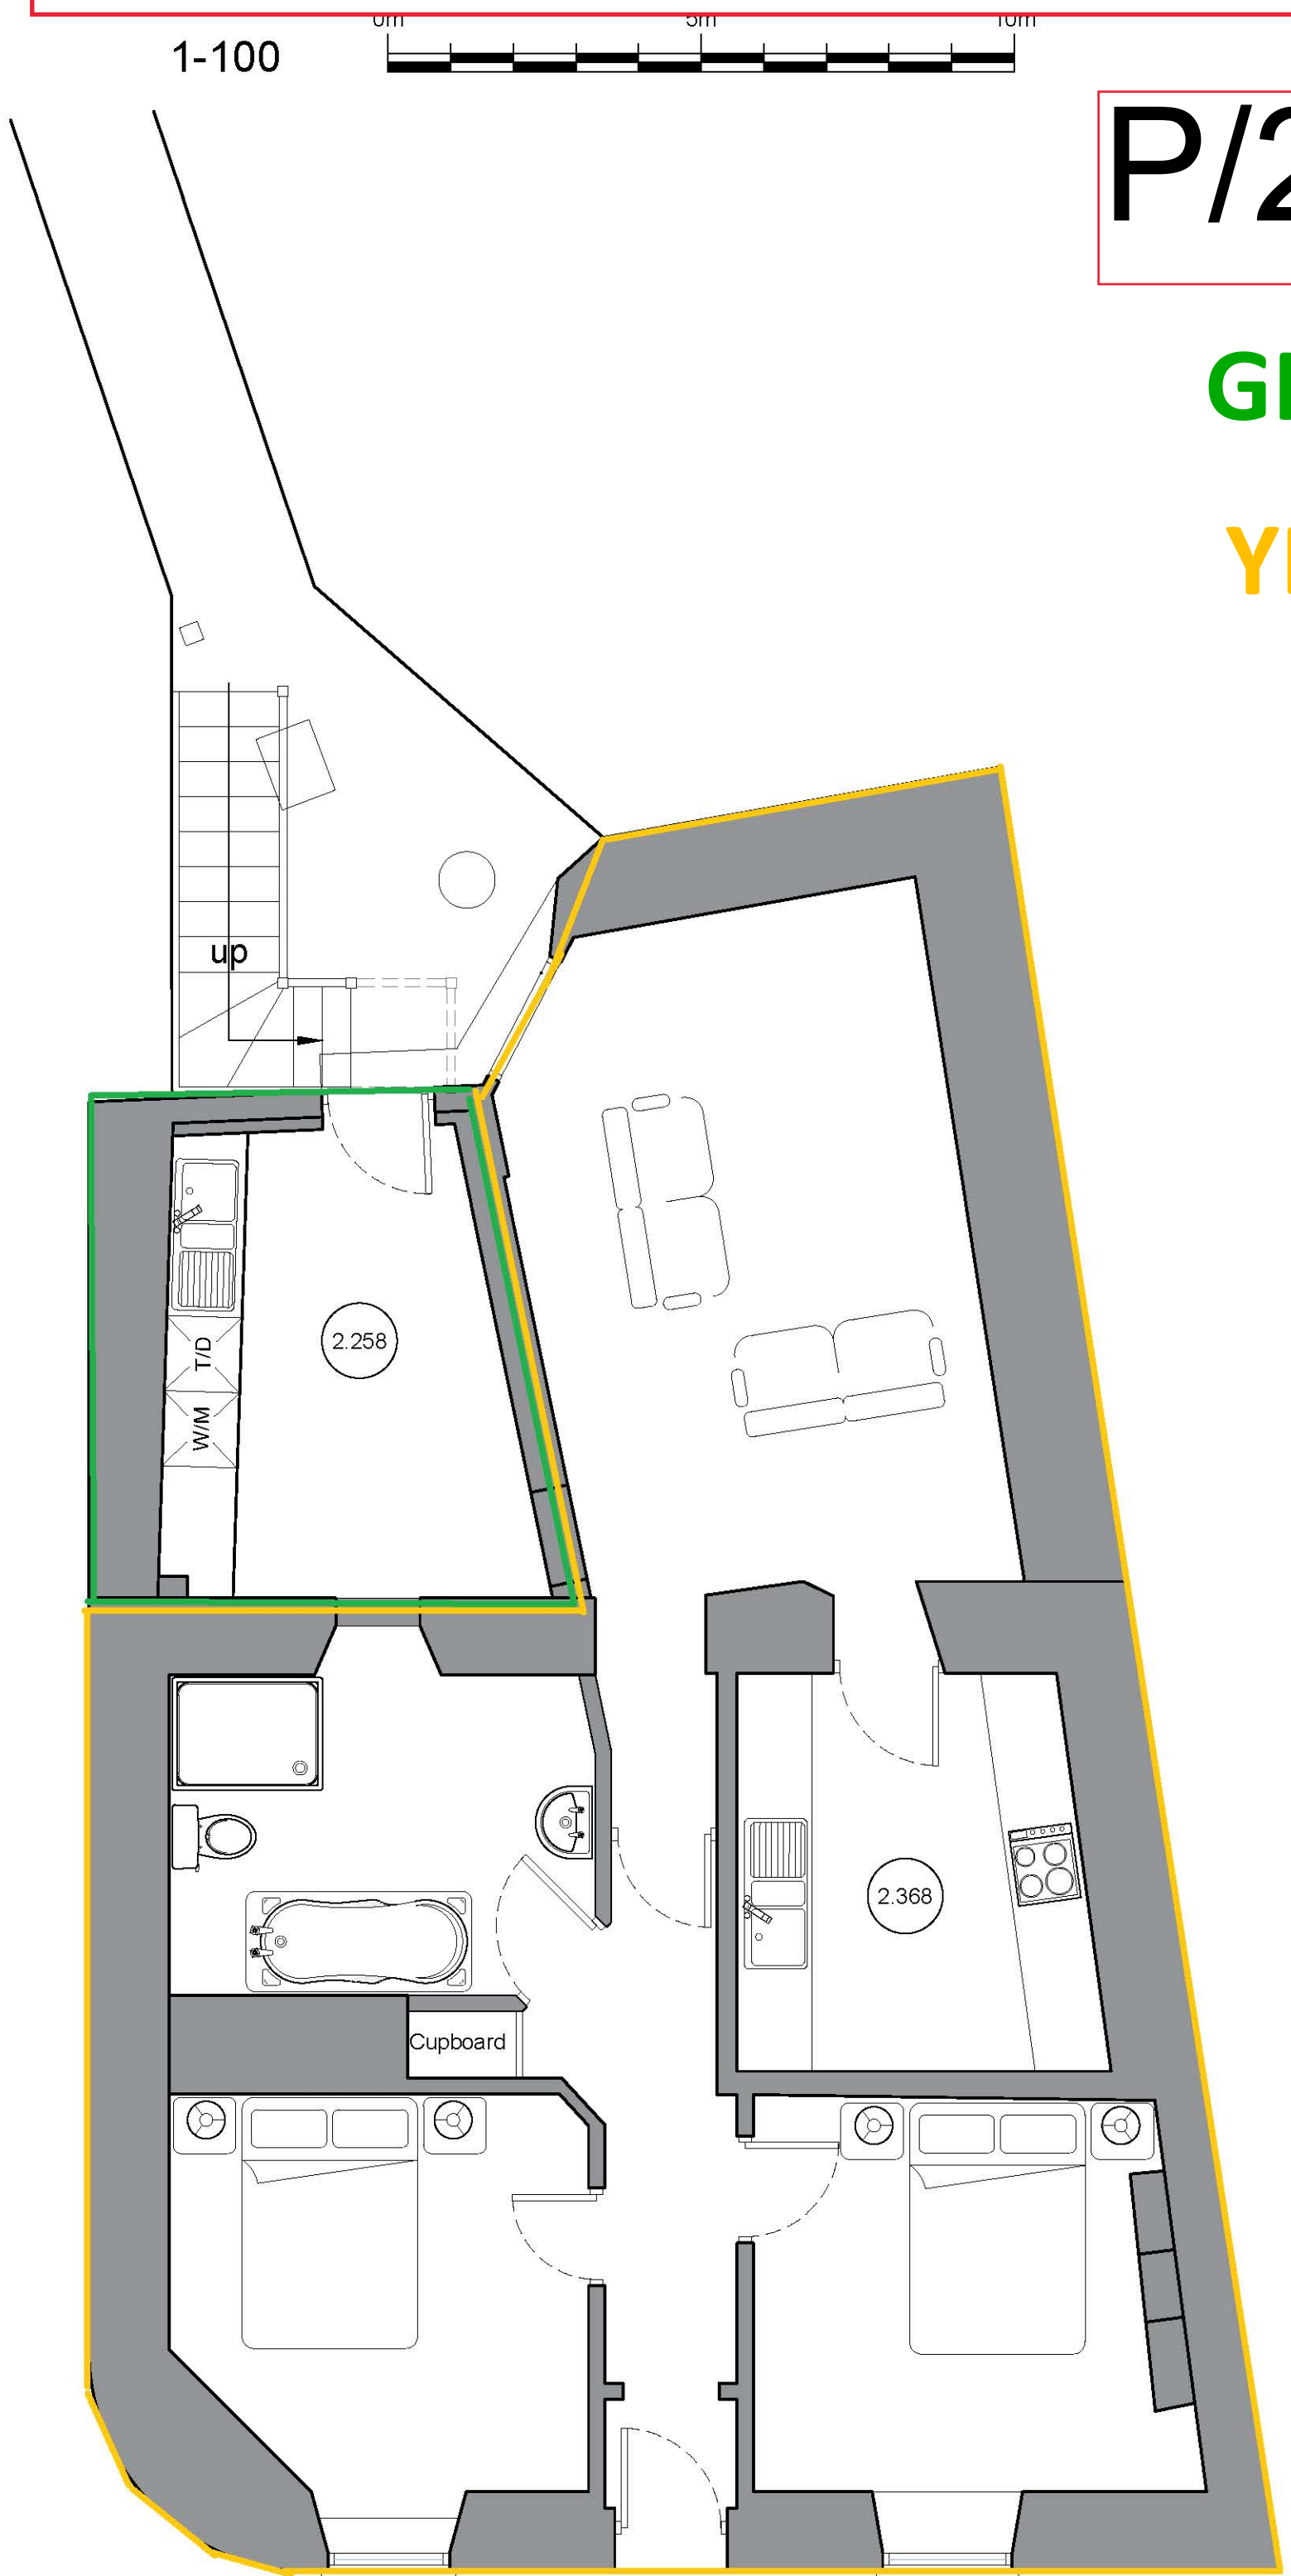
PROPOSED GROUND FLOOR PLAN 1:50

YELLOW - Holiday Letting Accommodation

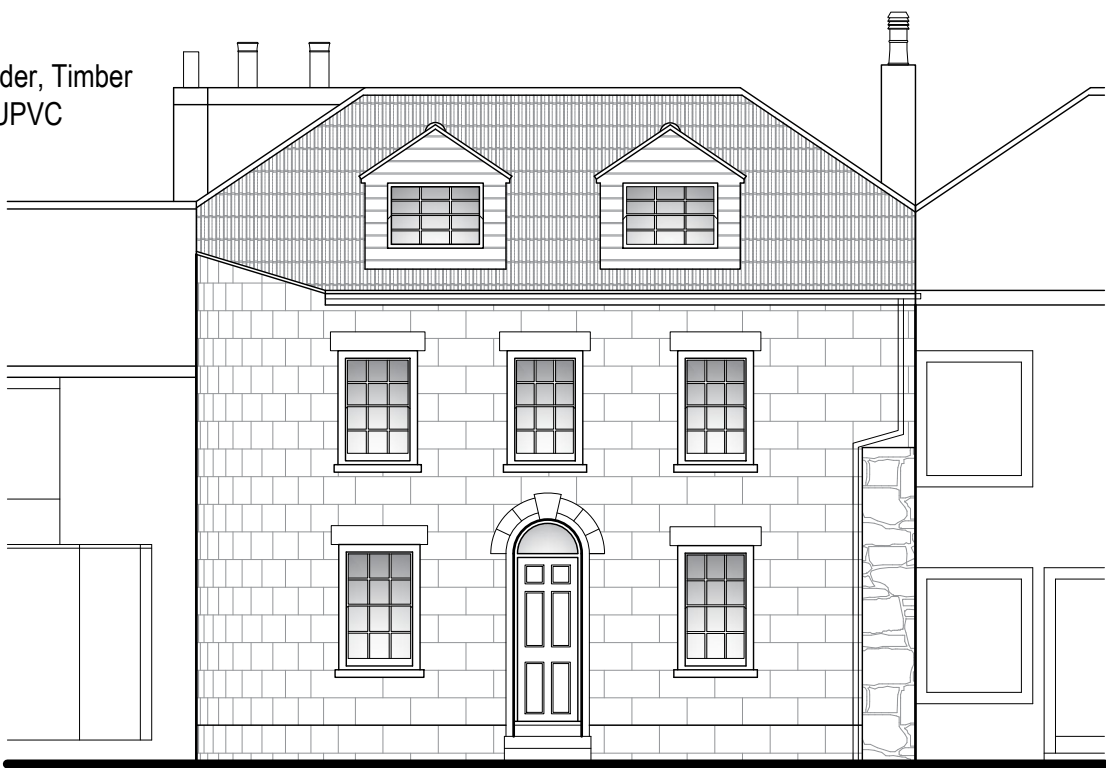
EXISTING SOUTH ELEVATION 1:100

EXISTING FINISHES:
Roof - Concrete Tiles
Walls - Stone, Painted Render, Timber
Windows/ doors - Timber, UPVC

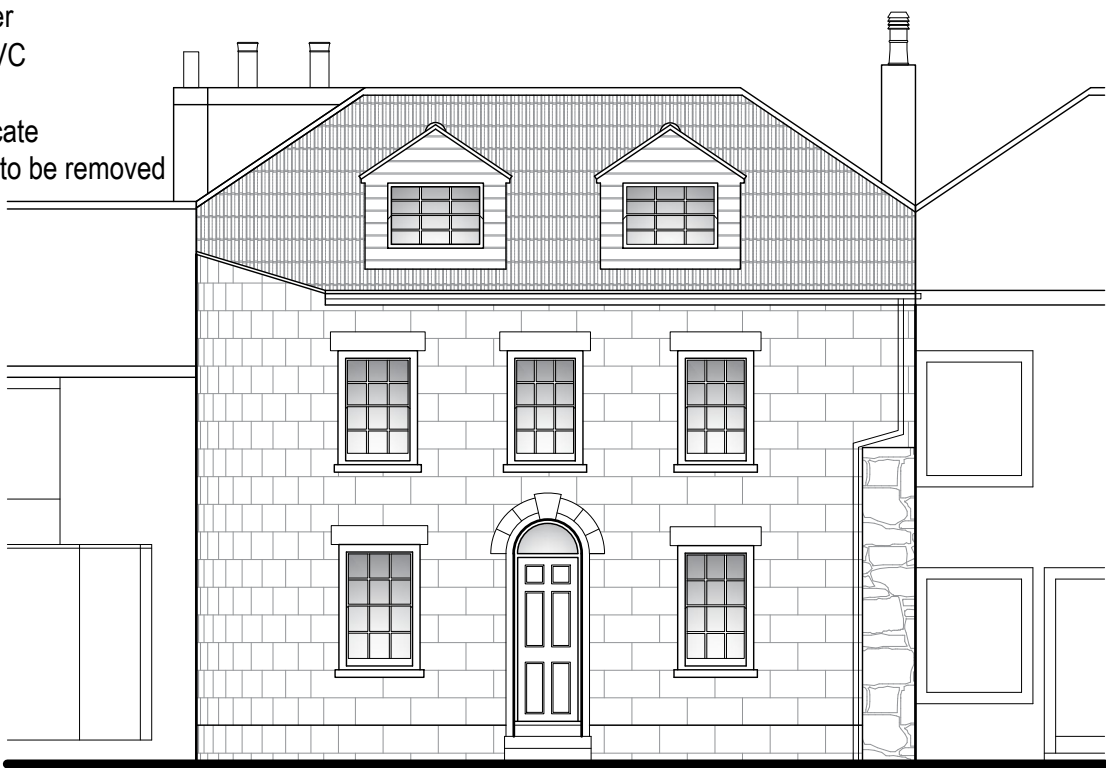
PROPOSED SOUTH ELEVATION 1:100

PROPOSED FINISHES:
Roof - Concrete Tiles
Walls - Painted Render, Timber
Windows/ doors - Timber, UPVC

False chimney formed to replicate
existing chimney which is due to be removed

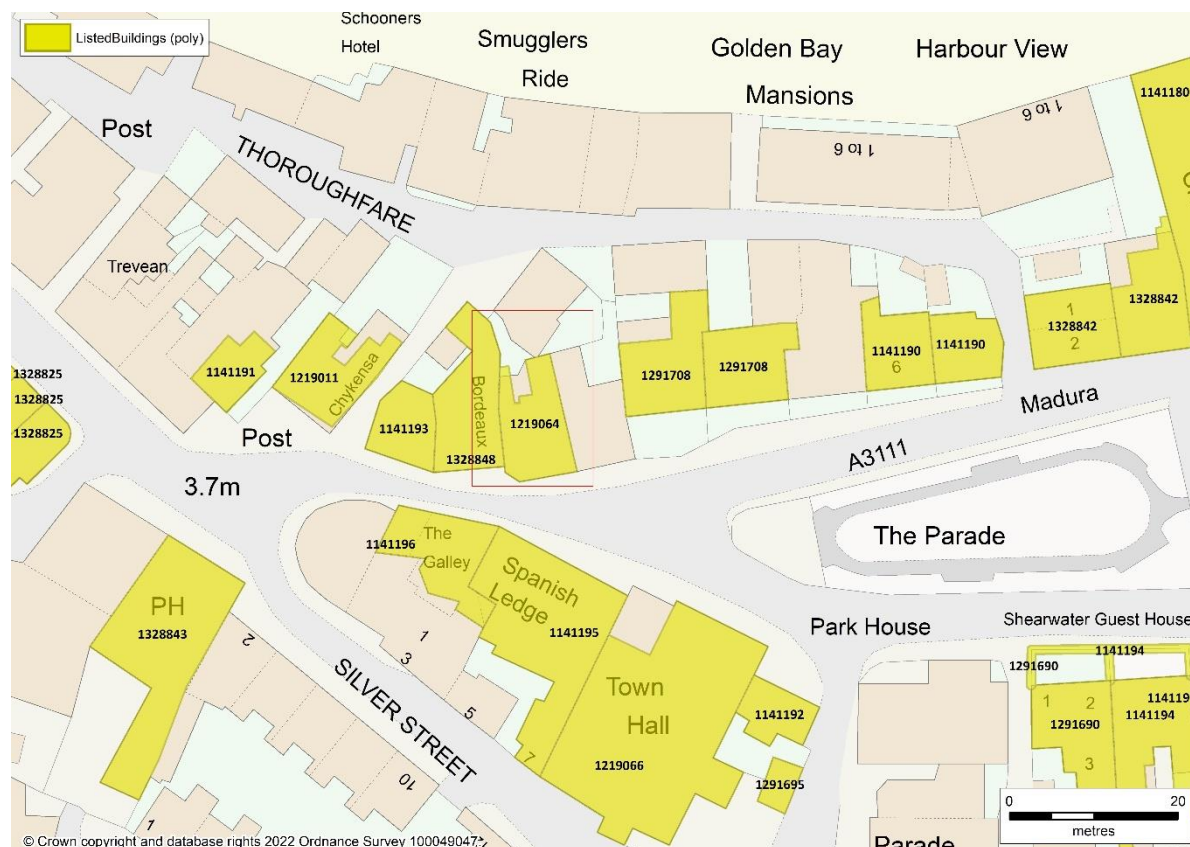
Fig 3 Map showing listed buildings within the study area of 0.1km around Freesia.

This assessment is focussed on heritage assets identified within the proposal area itself (hereafter referred to as the 'site'). The assessment also identifies relevant heritage assets within a wider 0.1km radius buffer around the site (Figs 3 and 4) and considers potential impacts upon designated heritage assets over a wider area (hereafter referred to as the 'study area').

In addition to Freesia, there are 25 Grade II listed buildings within the study area (Fig 3). Immediately to the west, 'Bordeaux' (NHLE 1328848) shares a party wall with Freesia, next to Bordeaux is 'Parade House' (NHLE 1141193); both these houses are of similar date to Freesia.

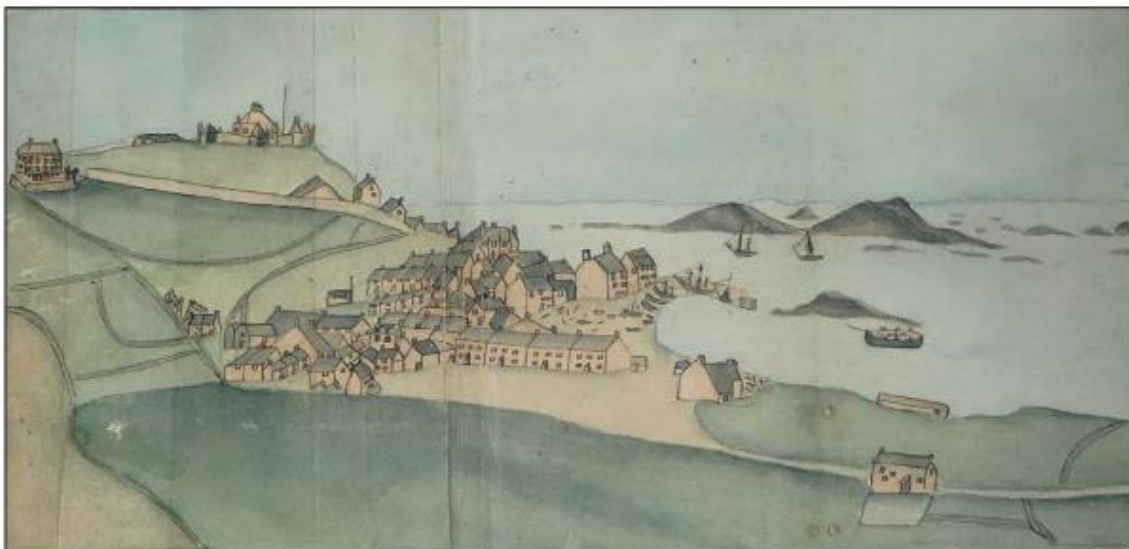
Fig 6 An original water colour in naïve style annotated 'A view of St Mary's Island (Scilly)'. The view was discovered bound into a copy of Troutbeck's 'Survey of the ancient and present state of the Scilly Isles (published c1794) held at Kresen Kernow, Redruth. Neither the artist or the date of the illustration are known but it is likely to be bear contemporary with the Troutbeck volume.

The extent of Hugh Town in the 1790s is depicted on a water colour painting (Fig 5). The town remained small — the population in 1800 was only 350 — until the 19th century when, under the proprietorship of Augustus Smith, a new phase of building expanded the settlement considerably. The economy diversified to include shipbuilding and maritime trade and, towards the end of the century, tourism and the export of flowers and bulbs (Kirkham 2003, 1).

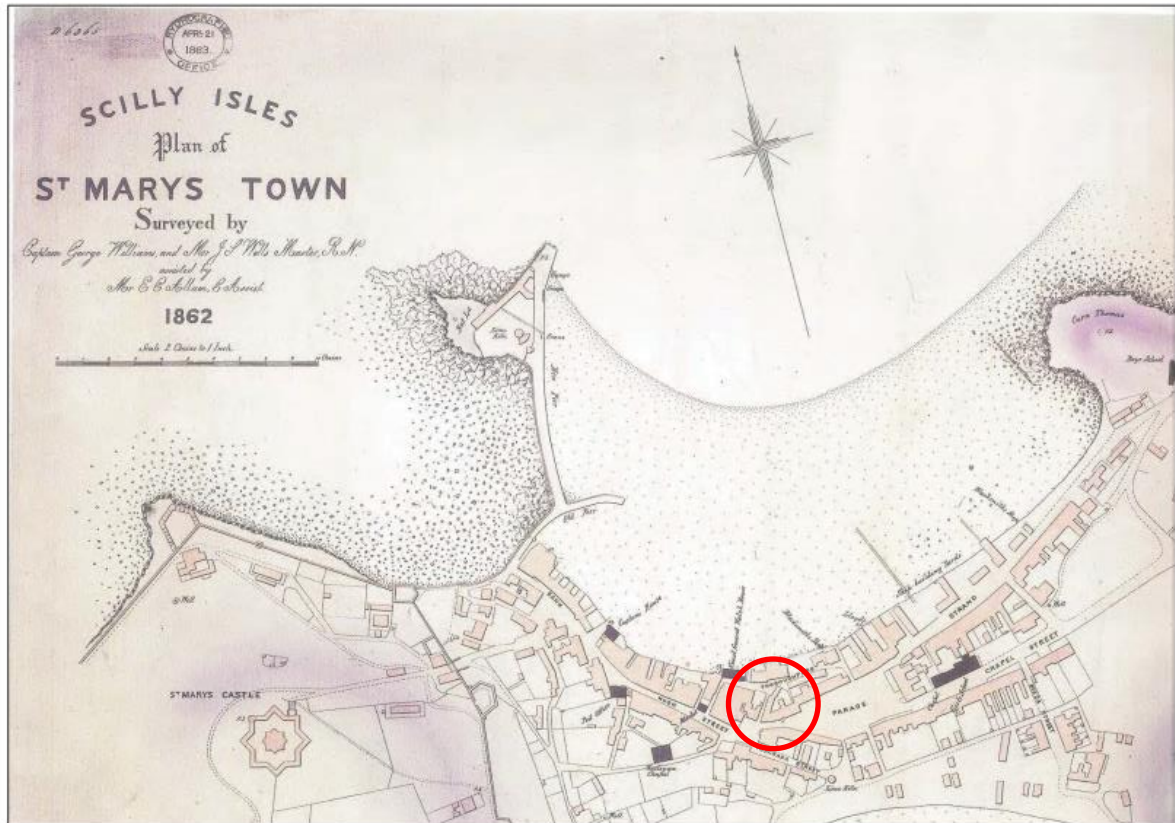
Fig 7 Plan of Hugh Town by Captain George Williams and Mr S J Wells, 1862 (Sourced from the UK Hydrographic Office, Taunton, www.ukho.gov.uk).

Unlike the Cornish tithe maps, the c1840 Tithe Map for St Mary's does not show anything on the island in detail because of the monopolistic landownership of Scilly's two main islands. The Parade is, perhaps, first mapped on an 1862 Admiralty plan of Hugh Town (Fig 5).

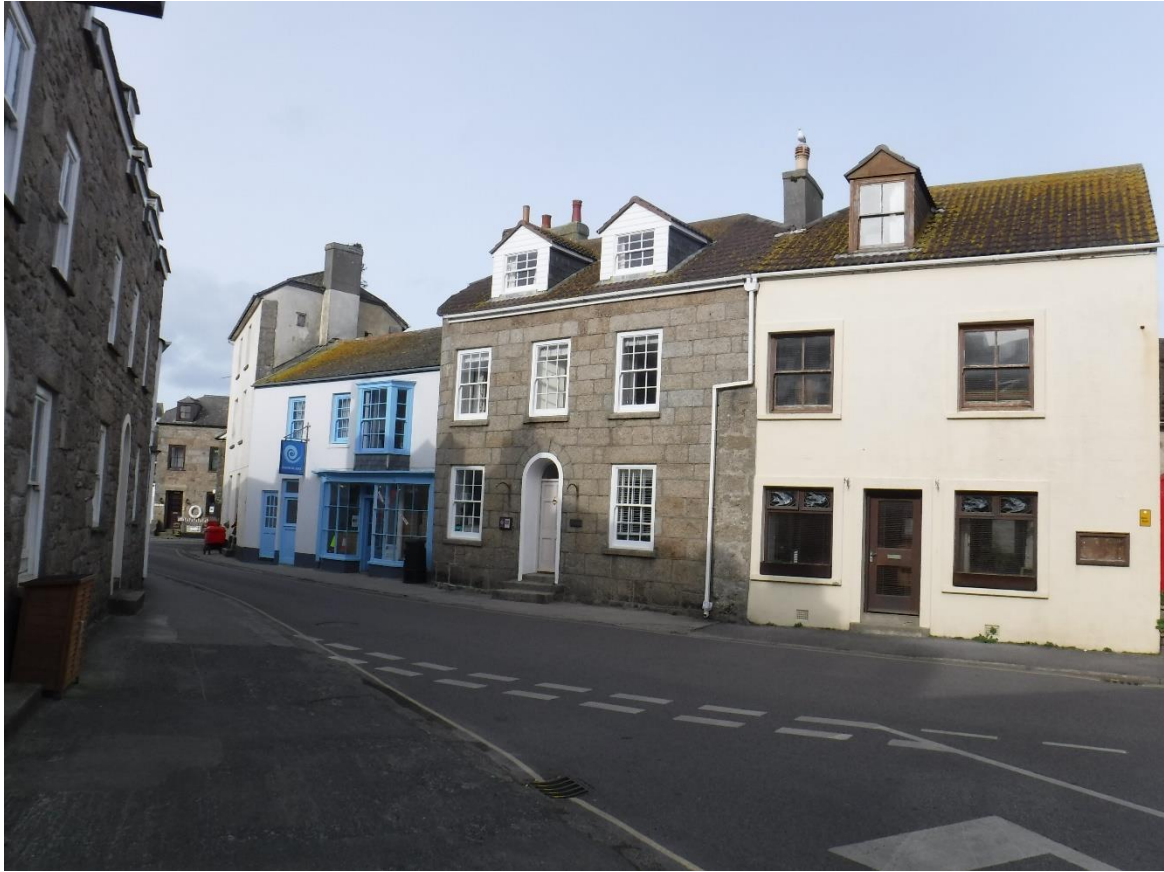
Fig 11 Frontage of Freesia with Bordeaux to the left and Nornour to the right.

At the front are 6/6-pane horned sash windows and on the first floor 2/2-pane horned sash windows; the dormer windows are smaller 6/6-pane horned sash windows. All in good condition and dating to the 2002-3 refurbishment (Fig 11).

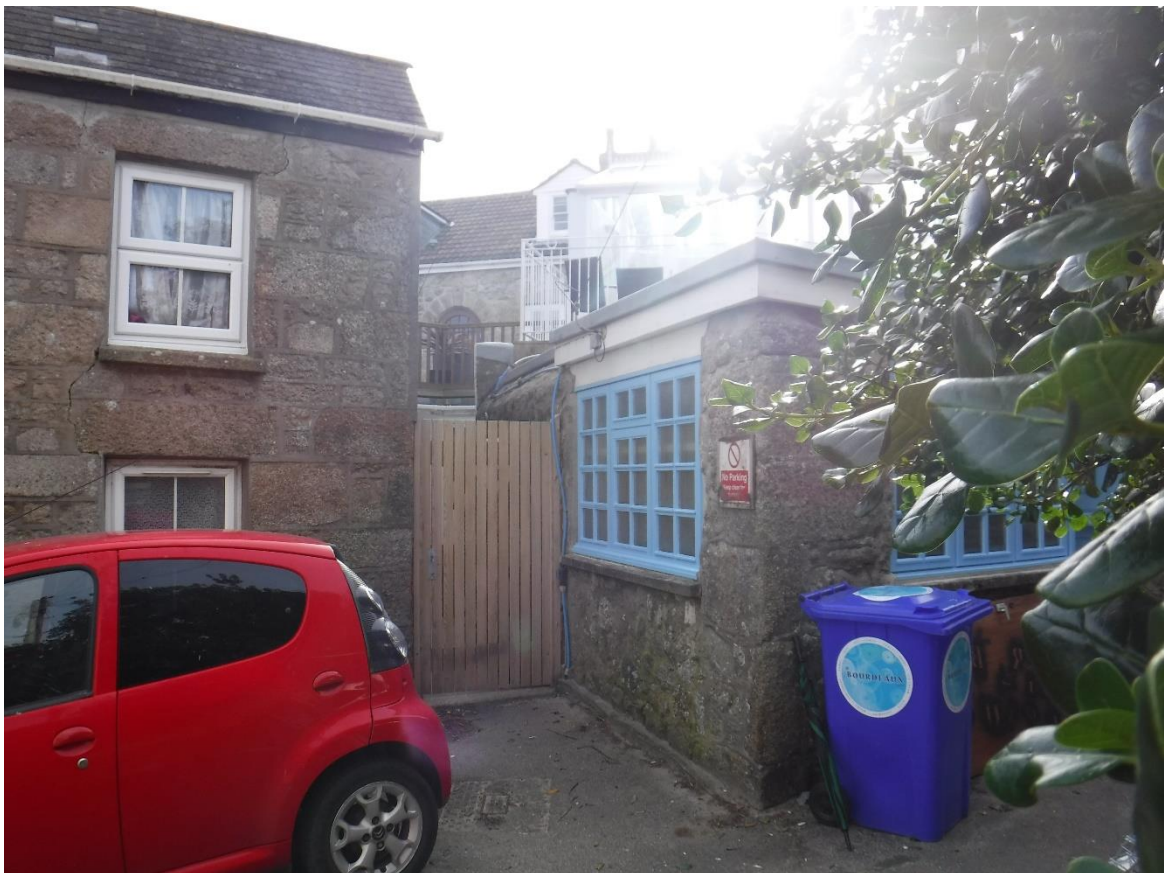
Fig 12 The view of the rear elevation of Freesia from Thoroughfare.

The works to the rear of the property only concern the modern ground floor extension. The rear of the property is effectively screened from Thoroughfare by a gate and restricted alleyway access (Fig 11). The heritage impact on the setting of identified heritage assets and the Conservation Area is assessed as **Neutral**.

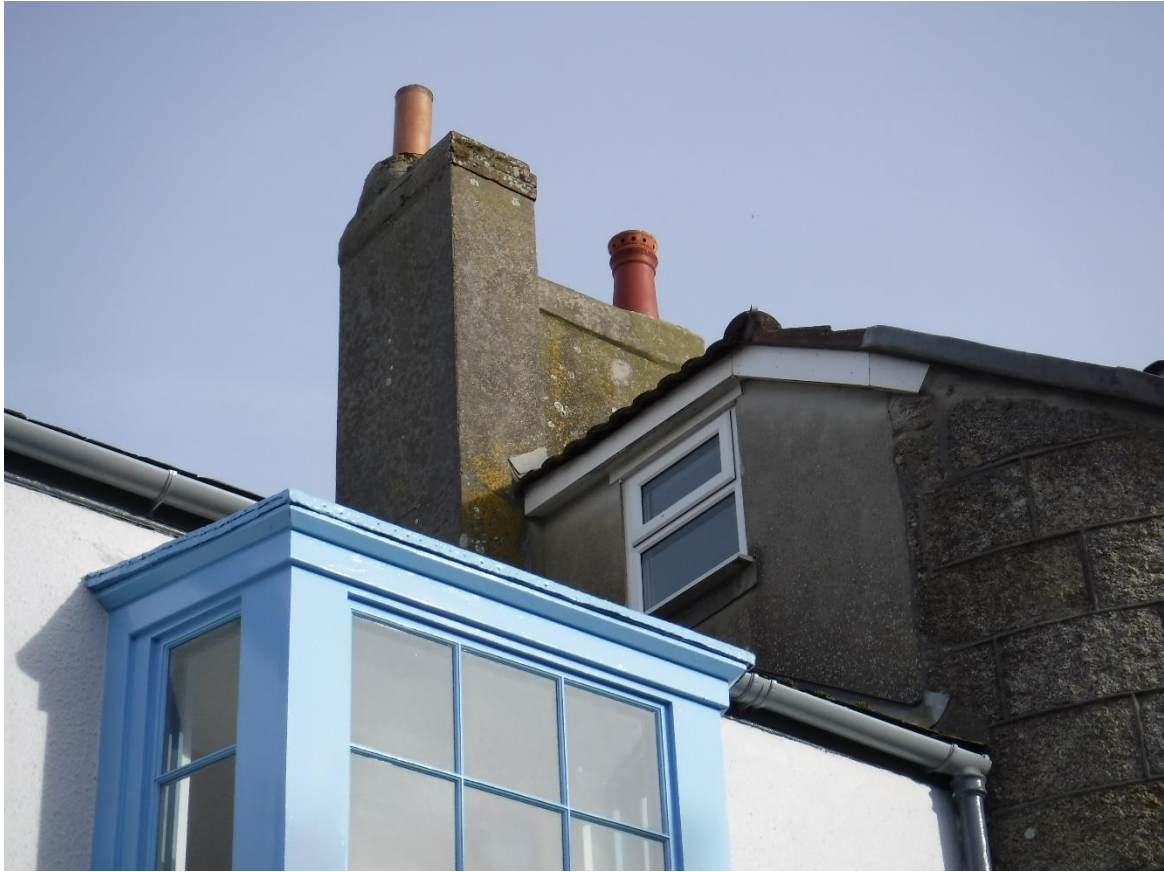
Fig 13 The chimneys at western end of Freesia.

The original chimney is built into the roof at the western gable and it appears that an additional chimney might have been added at right angles to this, along ridgeline of the roof. The original chimney passes through the roof of the adjoining property (Bordeaux) which is one-storey lower in pitch. The chimney itself is of brick-built construction with concrete render – this render covers all external aspects and is in good condition. There are three chimney pots – two of which are capped whilst the western-most (on the original chimney) appeared to be uncapped.

It is necessary to remove the chimney because cracks have appeared in the chimney stack which year by year are worsening, it is inevitable that eventually the chimney will collapse or debris will fall onto the roof of Bordeaux and roll off this roof and directly onto the pavement. It is a very busy street and there are concerns for the health and safety of passers-by.

The proposed works will entail the removal of the chimneys at the western end of the building (Fig 13). This will impact upon the visual appearance of the front (south) and rear (north) elevations and the gable end of the building and consequently upon the roofscape of the Conservation Area. The heritage impact is assessed to be irreversible **Negative/Minor (Less than Substantial) Harm** but could be mitigated by construction of a replacement chimney in which case the impact would be **Positive/Substantial Benefit** (see below Section 6.1).

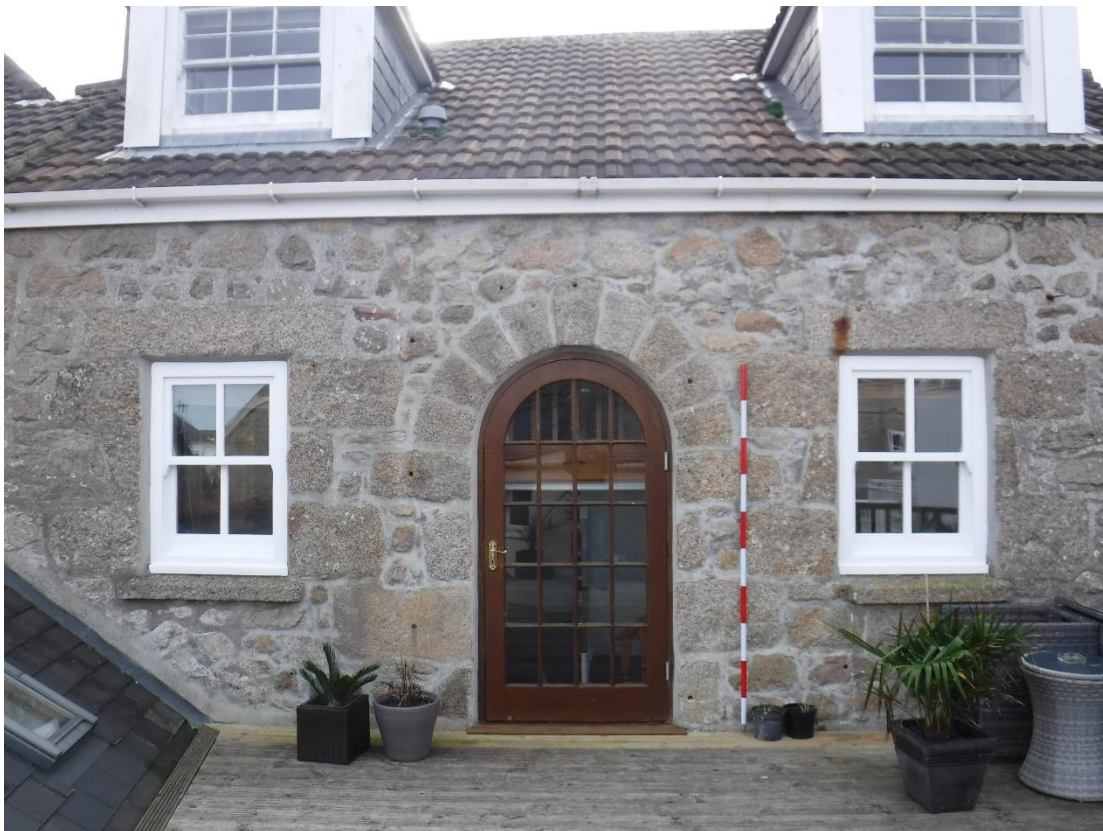
Fig 14 The central window of the first floor rear elevation has been converted into a doorway leading on to a decking surface on the roof of the ground floor extension.

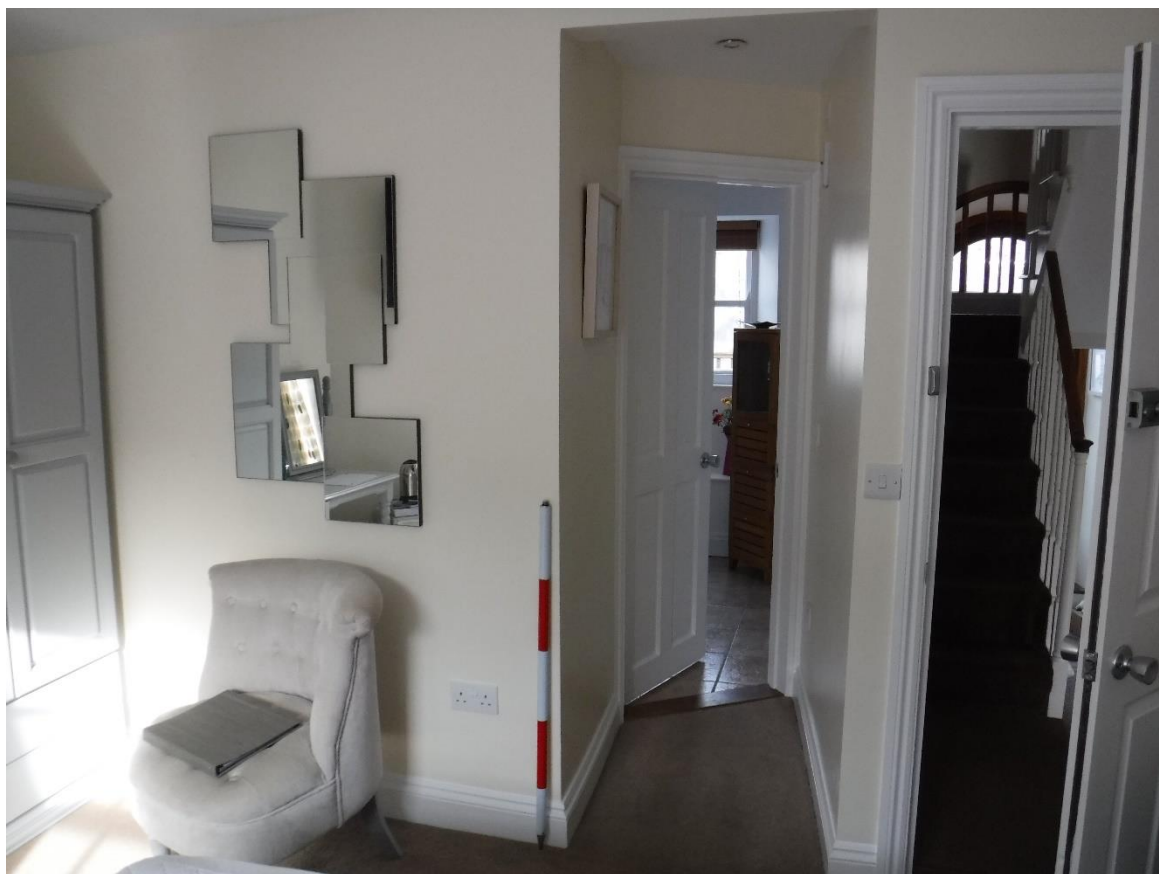
Fig 15 Stud wall concealing chimney breast on first floor.

The chimney breasts are concealed by stud walls and their condition is unknown (Figs 15 and 16). They may be secondary features and conceal original fireplaces built into the thickness of the wall (which could be preserved). This heritage impact of their removal is

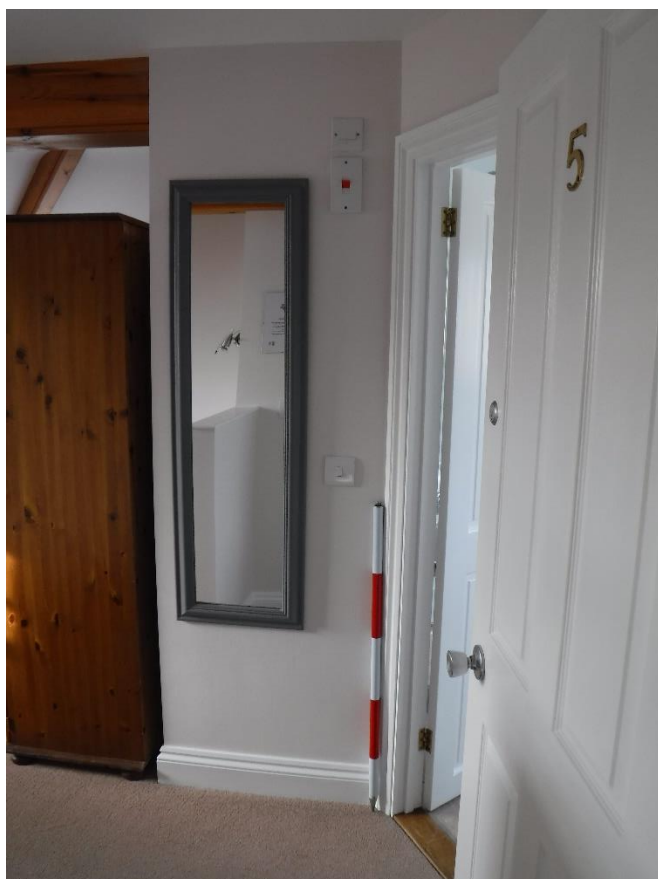
Fig 16 Stud wall concealing chimney breast on second floor.

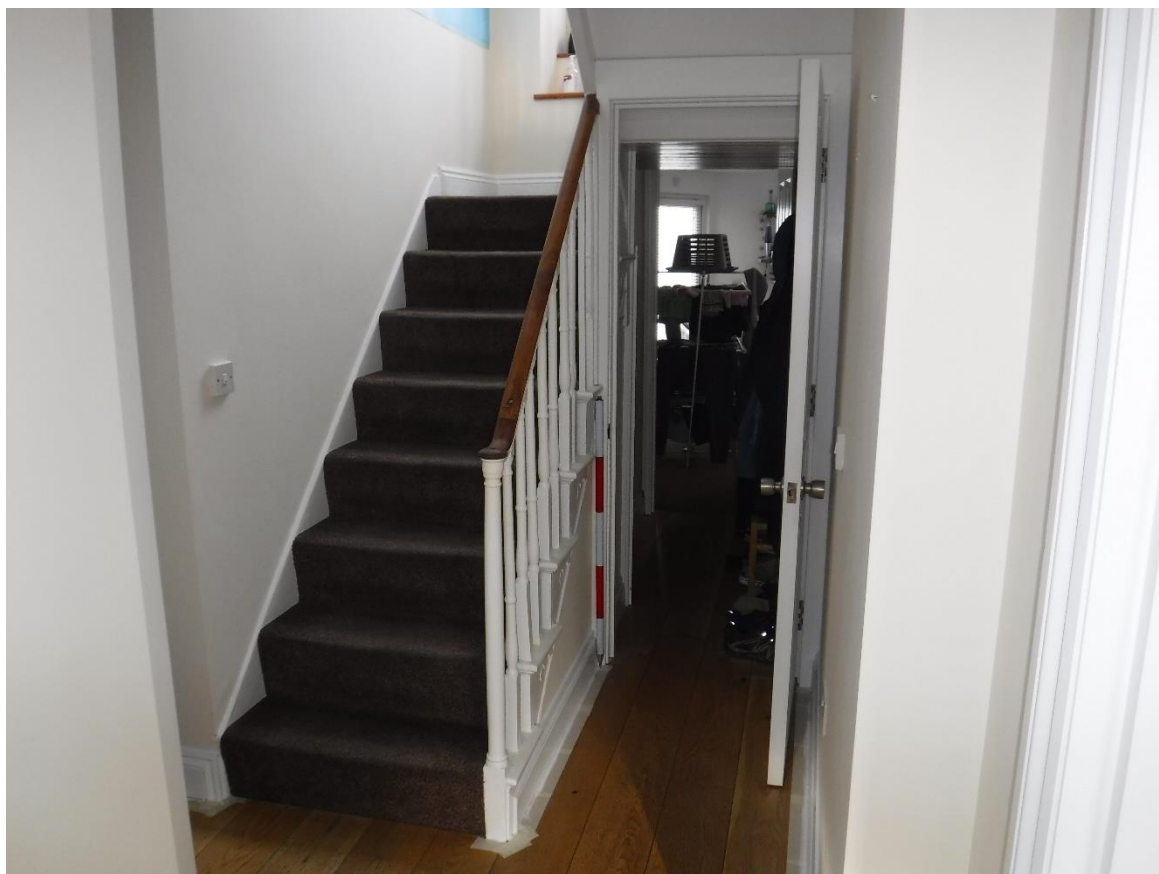
Fig 17 Ground floor staircase.

Ordinarily the presumption would be in favour of retaining the period staircase (Figs 17–20) and incorporating it in the new design. However, this is not possible because it does not comply with current building regulations and there are some very awkward areas with restricted headroom. The landing is not square and has a skewed step. The junction of the stairs and the first floor door (originally a window) is particularly awkward and dangerous, when the door is opened and one is immediately faced with three steps.

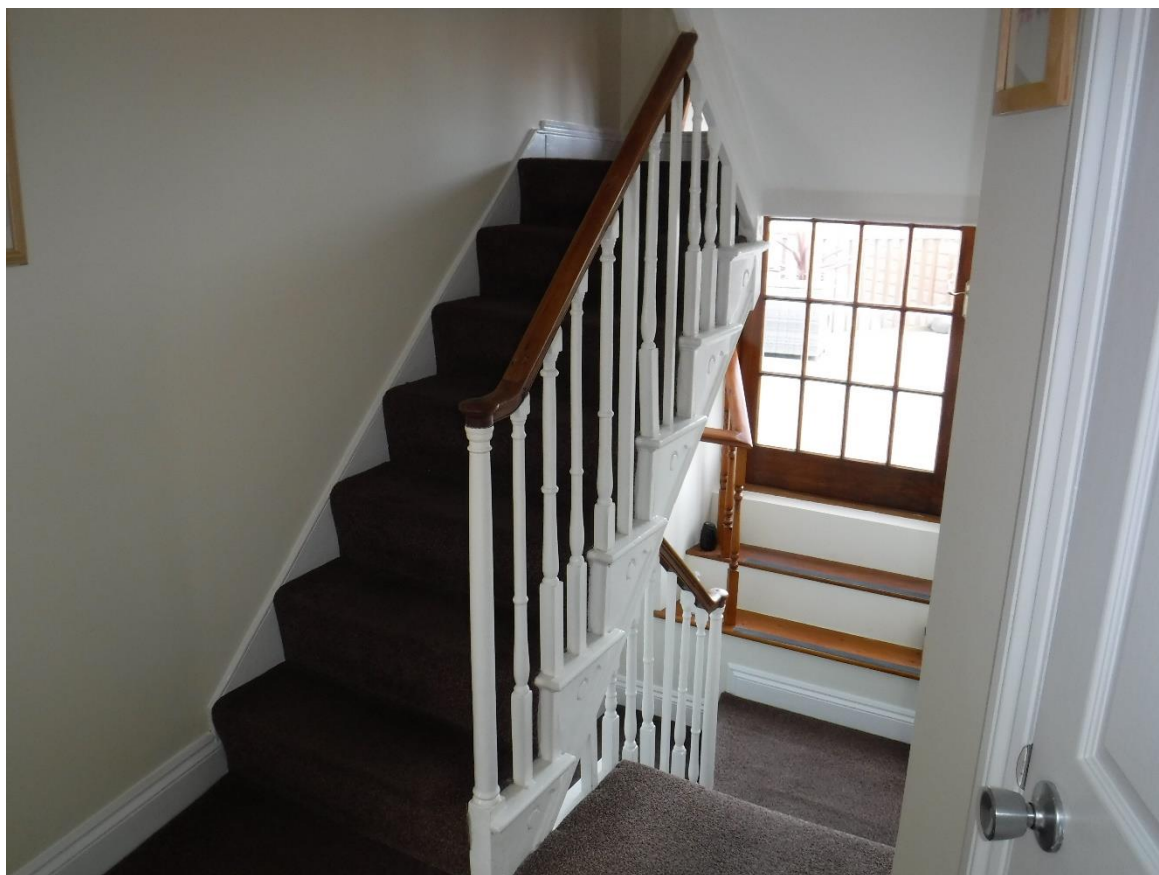
Fig 18 Half-turn in the staircase to the first floor.

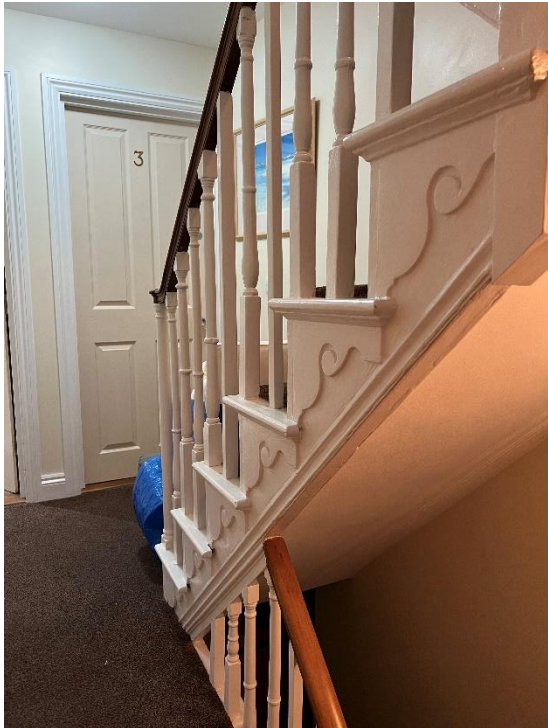
Fig 19 Staircase on first floor showing decorative moulded panels (photo: Joe Hayes).

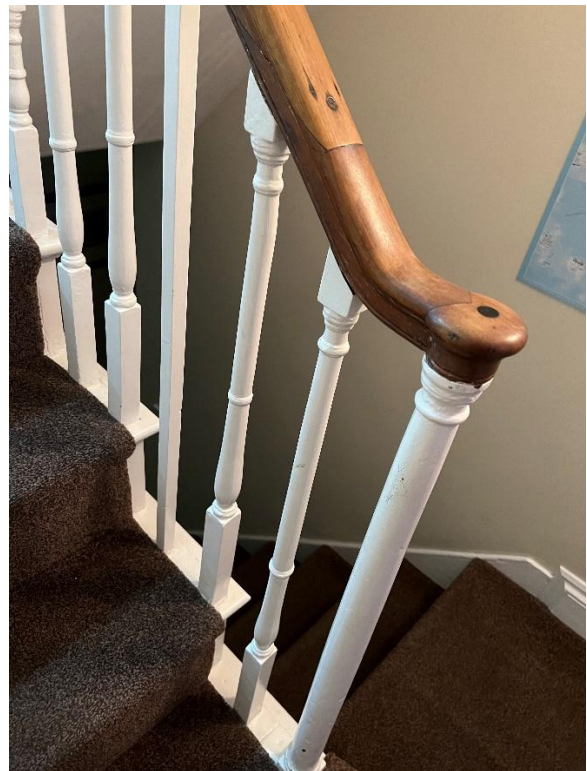
Fig 20 Detail of newel post and ramped rail on first floor (photo: Joe Hayes).

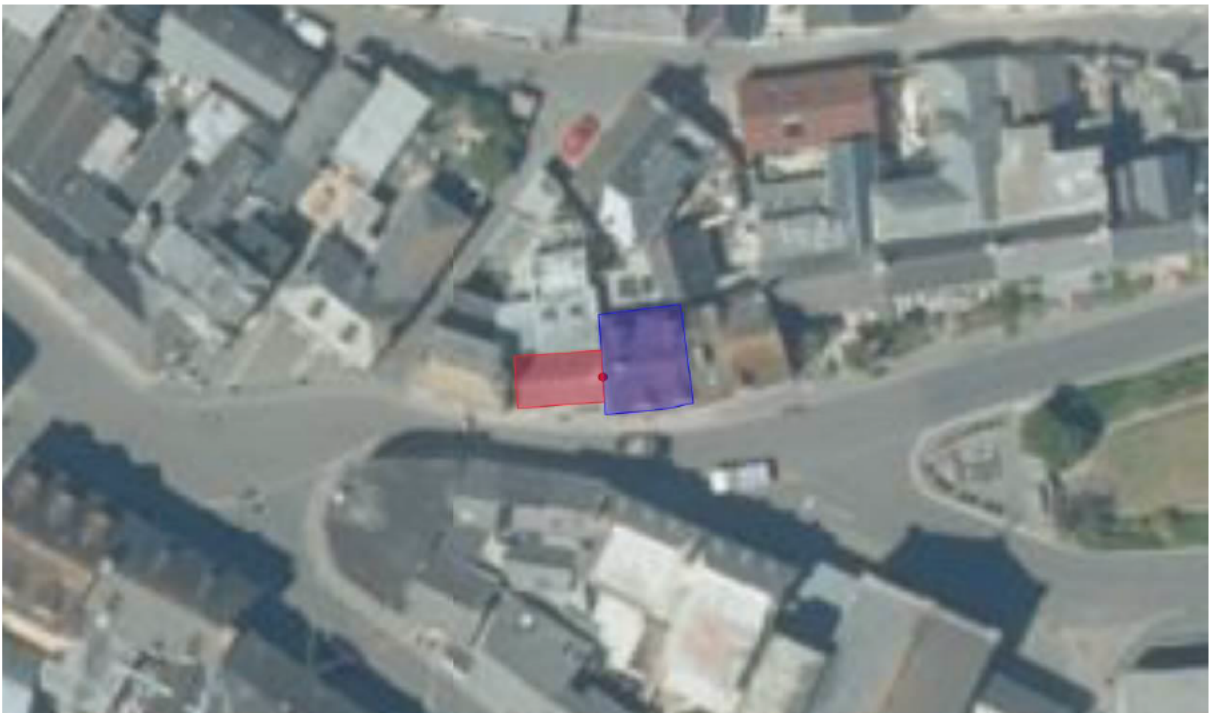
Map 02 – Showing the chimney (indicated by the red dot) on the western gable end of Freesia Guesthouse (indicated in blue) with the adjacent Bordeaux property (indicated in red).

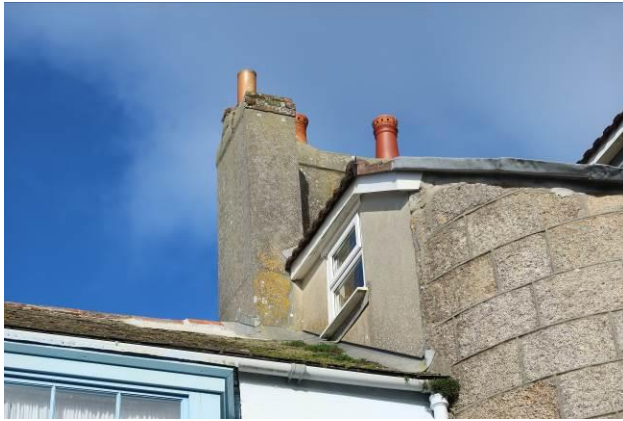
Photograph 1: Showing the chimney with the higher structure of Freesia Guesthouse to the right and the lower roof of Bordeaux to the left.

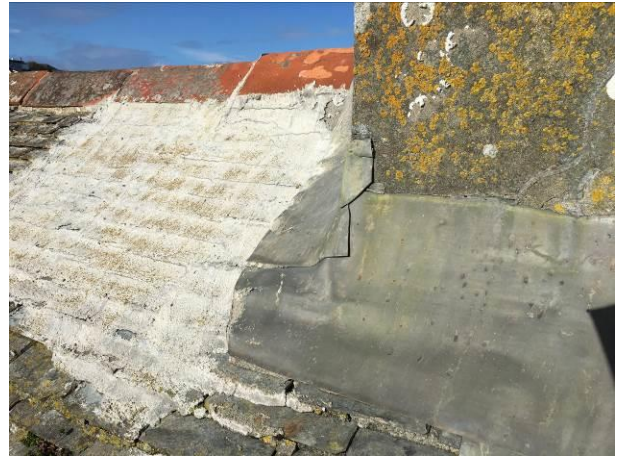
Photograph 2: An example of the tightly fitted flashing where the concrete-rendered chimney meets to the roof of Bordeaux.

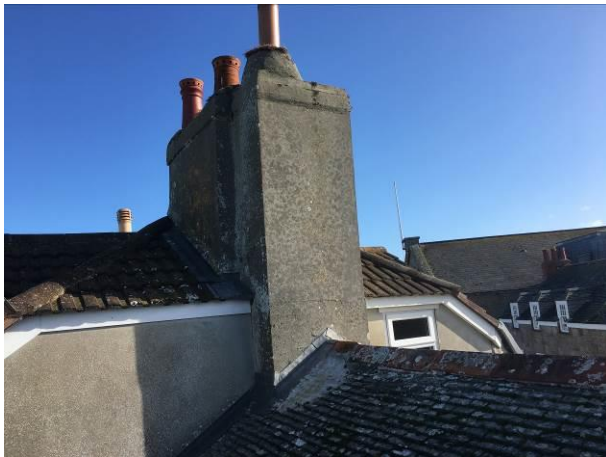
Photograph 3: Showing the hipped roof on the gable end of Freesia with the chimney meeting the lower roof of Bordeaux.

The gable wall of Freesia Guesthouse, above the roofline of Bordeaux, is rendered throughout and in good condition – no potential roosting features for bats were identified associated with this wall.

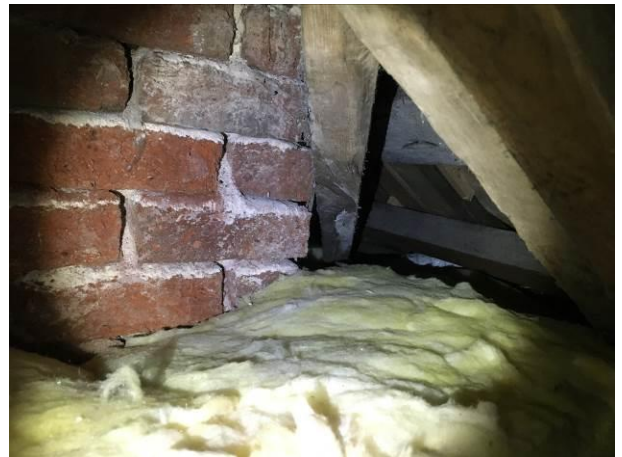
Photograph 4: Showing the chimney from within the roof space of Freesia guesthouse – the brickwork is well pointed and no cavities were noted.

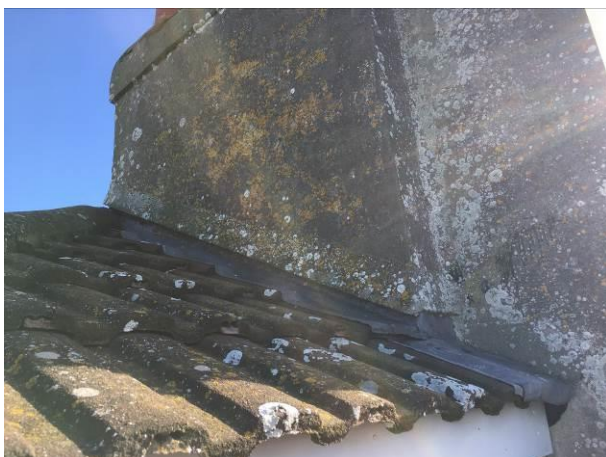
Photograph 5: Showing the well-fitted concrete roof tiles of Freesia abutting the chimney.

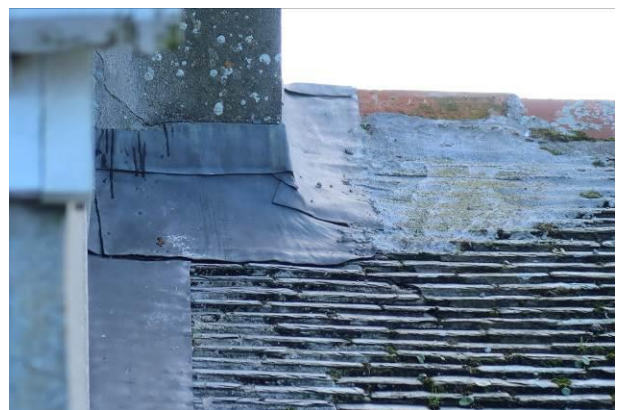
Photograph 6: Showing the well-fitted scantle slate tiled roof of Bordeaux.
