Bat Survey Report

Site: Valhalla, Tresco, Isles of Scilly, TR24 0QQ

30th November 2020

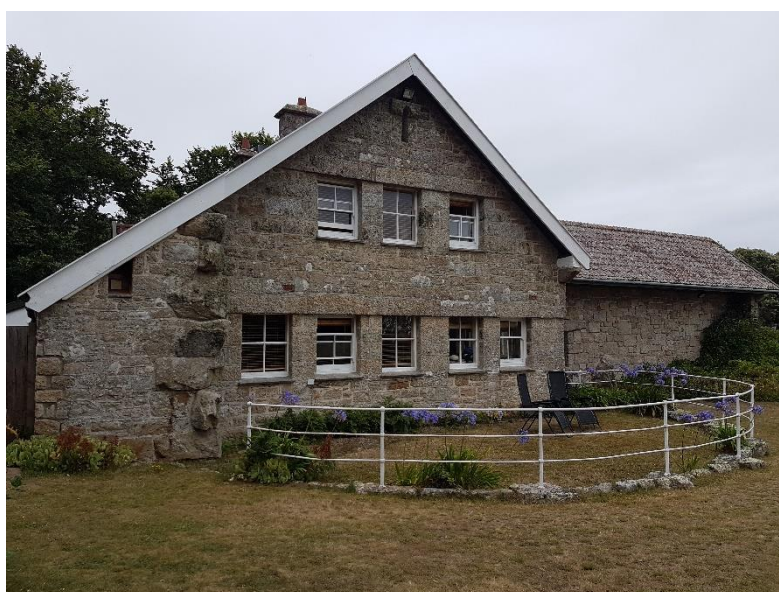
Figure 2: Southern elevation of Valhalla

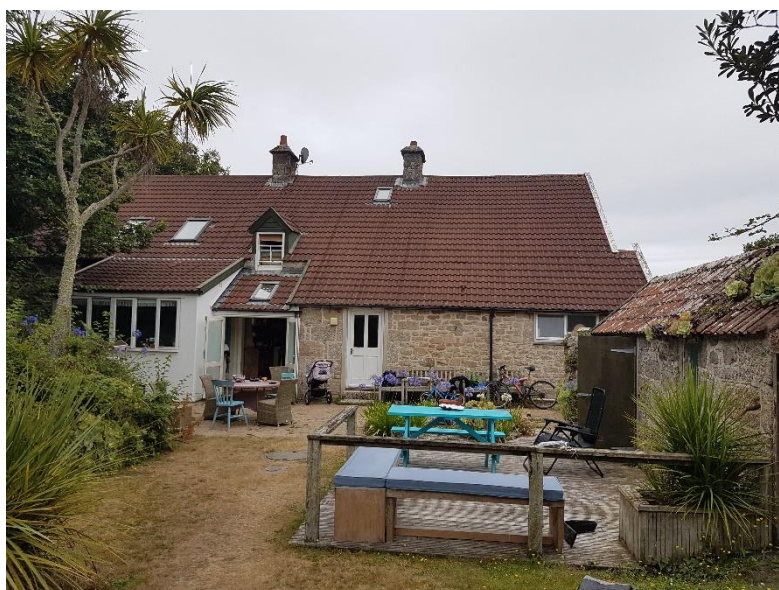
Figure 3: Western elevation of Valhalla and northern elevation of detached outbuilding

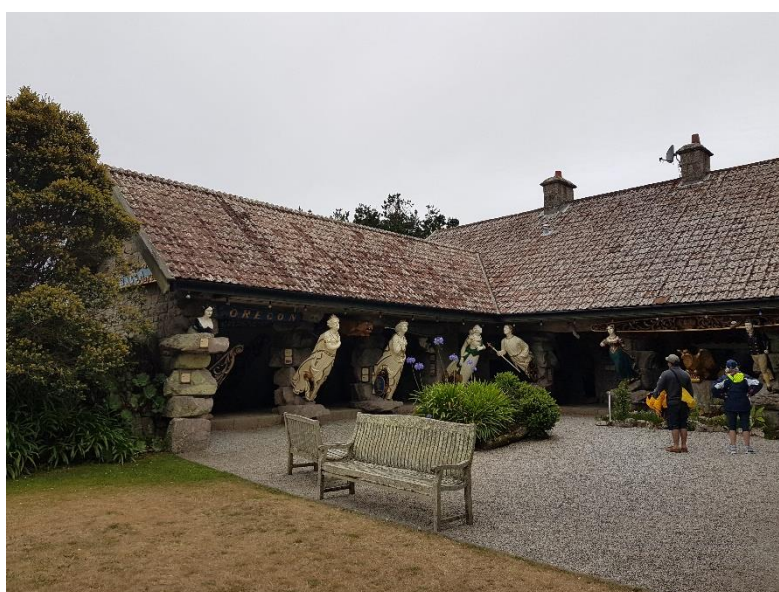
Figure 4: Northern and eastern elevations of Valhalla (showing Valhalla Museum)

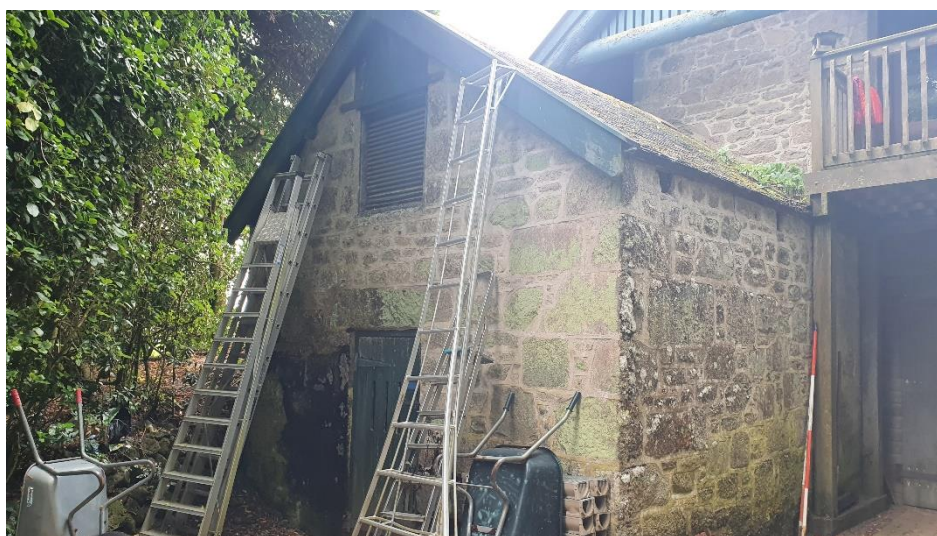
Figure 5: Northern elevation of attached outbuilding

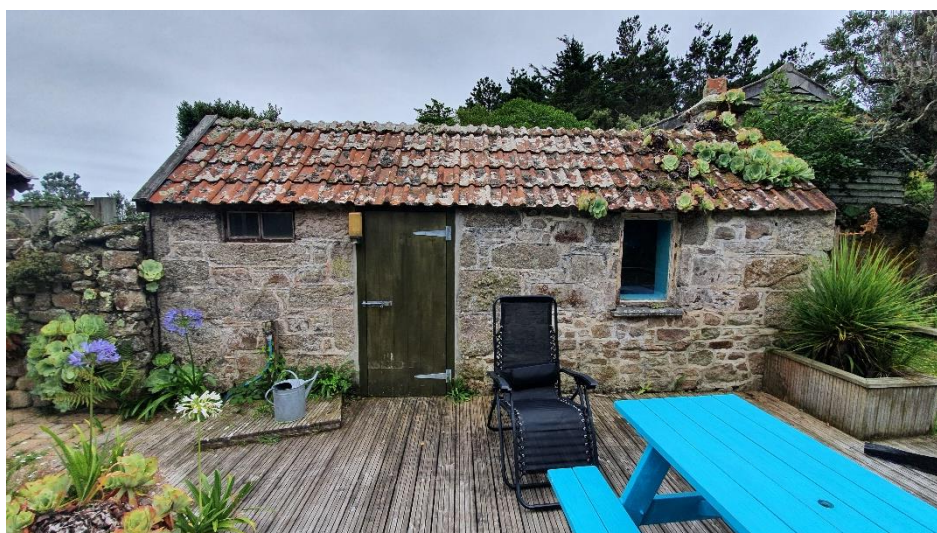
Figure 6: Northern elevation of detached outbuilding

The detached outbuilding has two small timber framed glazed windows and a timber door on the northern elevation. It features timber fascias and there is timber cladding on the eastern gable end. There are notable gaps underneath the fascia which provide potential roosting opportunities for bats and also provide potential access into the interior. The timber cladding is well-sealed (Fig 6).

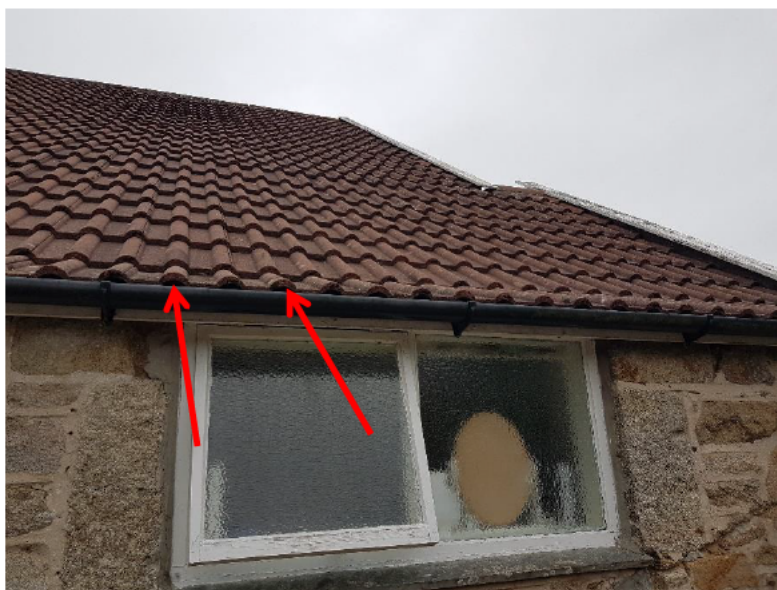
The western section of the property consists of a two-storey residential house on the ground floor and part of the first floor, with a self-contained apartment on the first floor at the northern end accessed via an external timber staircase. There are roof lights and a dormer window with a pitched roof in the western elevation of the roof. The building features plastic guttering, timber fascias, timber barge boards on the northern and southern ends, timber framed glazed windows and timber doors, slate and timber windowsills and two stone chimneys on the main part of the roof. There are notable gaps at the wall tops under the overhanging eaves, behind the fascia boards and at the ends of the interlocking roof tiles which provide potential opportunities for roosting bats and potential access into the roof voids. On the southern gable end there is also a large gap under the eaves which provides potential access for bats to the underside of the roof and potentially also the roof void above (Figs 7 to 9).

Figure 7: Gaps underneath the interlocking roof tiles on western elevation

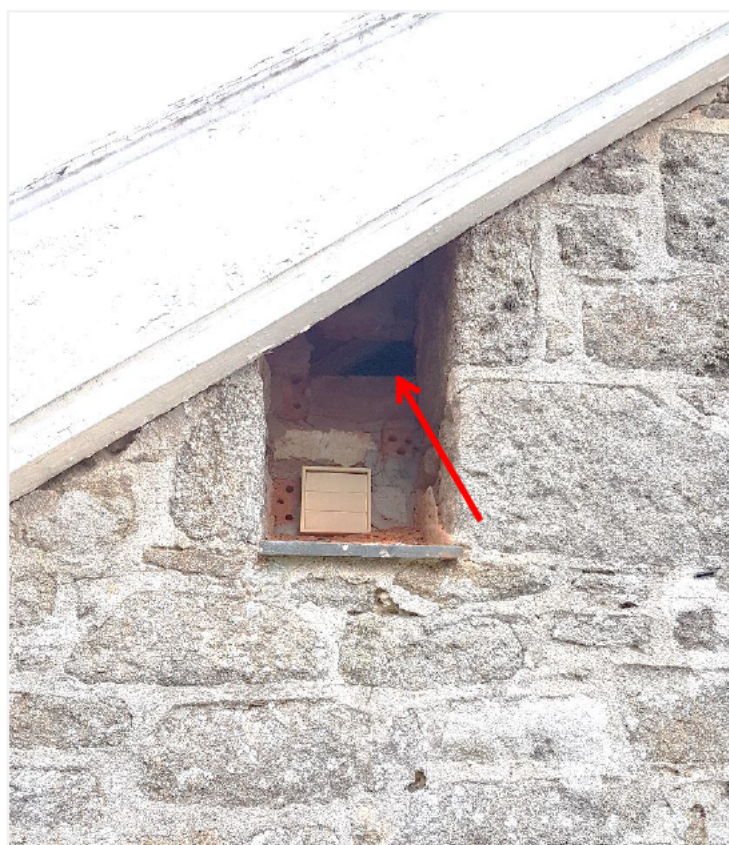
Figure 8: Gap under eaves on southern gable end

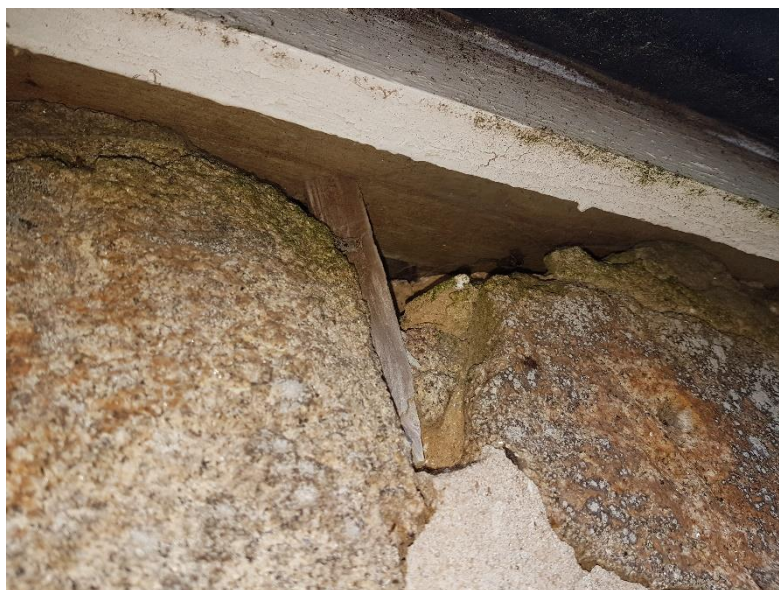
Figure 9: Gap on wall top behind fascia board on western elevation

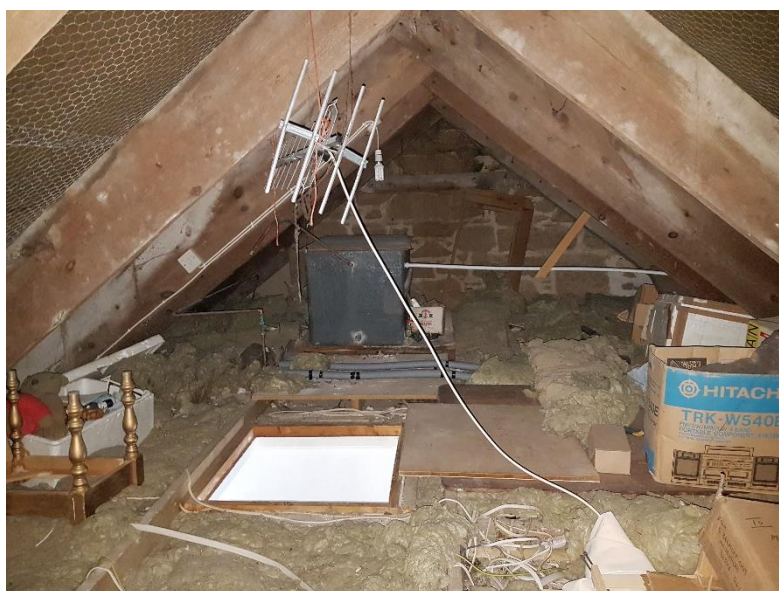
Internally, the roof over the house is partially vaulted with two separate roof voids above the first floor. A third separate roof void is present over the apartment in the north of the property. The two voids over the house are separated by an internal stairwell with a roof light above. The three voids are of similar composition internally; open from the floors, which are covered with rolled insulation, to the underside of the roof, which is lined with a bitumen-based roofing felt covered with chicken wire. The internal walls are bare stone and there are no crossing timbers. The roof void over the apartment is larger than the other two roof voids as the ceiling in this part of the property is lower. This void contains a water tank and some stored materials (Fig 10).

Figure 10: Interior of roof void over apartment (viewed towards the south)

- Although the roof void over the apartment is being retained post-development, it will be modified when the new extension is tied into the existing roof. Provision for day roosting brown long-eared bats will be made in the modified building by retaining the northern roof void over the apartment measuring c. 5m (length) x 5m (width) x 1.5m (height). Existing likely access into the roof void will be maintained by retaining the gap between the fascia board and barge board at the northern elevation, or by installation of a bat slate onto the western aspect of the roof with a corresponding slit created in the felt underneath to enable brown long-eared bats to access the roof void below. Alternatively, two raised ridge tiles with a gap underneath 15-25mm wide with corresponding slit in the roof membrane can be used to provide access to the roof void. The roof must be lined with type 1F bitumen as opposed to a synthetic breathable membrane.

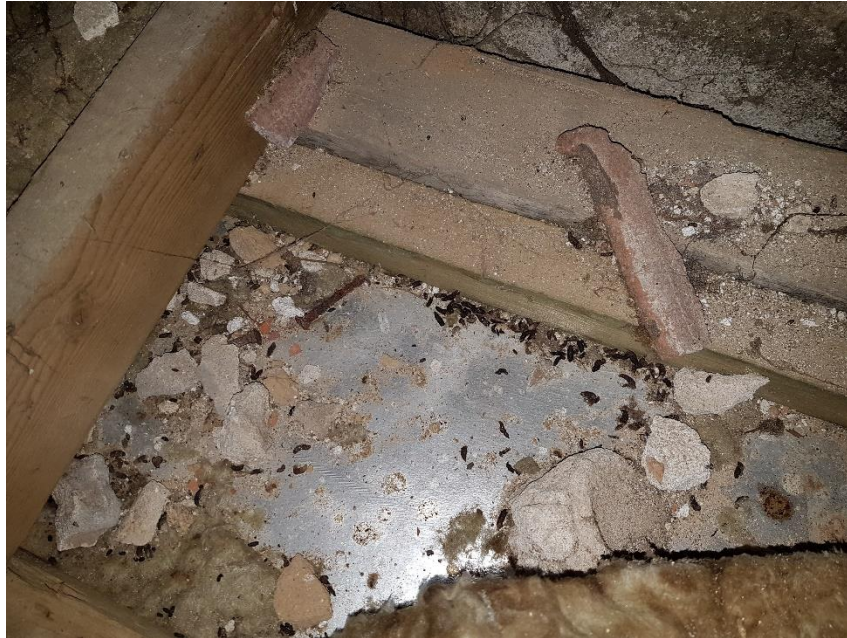
noted, with a small accumulation of droppings noted under the ridge in the centre (approximately 10 – 20 droppings) and a larger accumulation at the northern gable end below the ridge (50+ droppings). The droppings were characteristic of a long-eared bat spp., likely to be brown long-eared bat as the site is outside the known range of grey long-eared bat (Fig 11).

Figure 11: Accumulation of bat droppings at the northern gable end within roof void over the apartment.

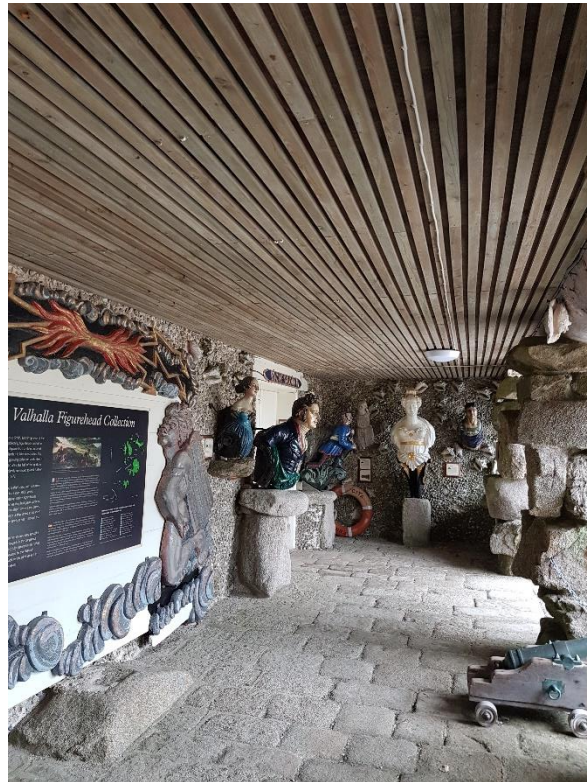
Figure 12: Interior of Valhalla Museum (viewed towards the west).

No evidence of use of this part of the building by roosting bats was noted. As it was not possible to inspect the interior of the roof void over the eastern extension the likely presence or absence of bats roosting within this area could not be determined. However, as far as we are aware, this section of the building will not be directly impacted by the proposed works.

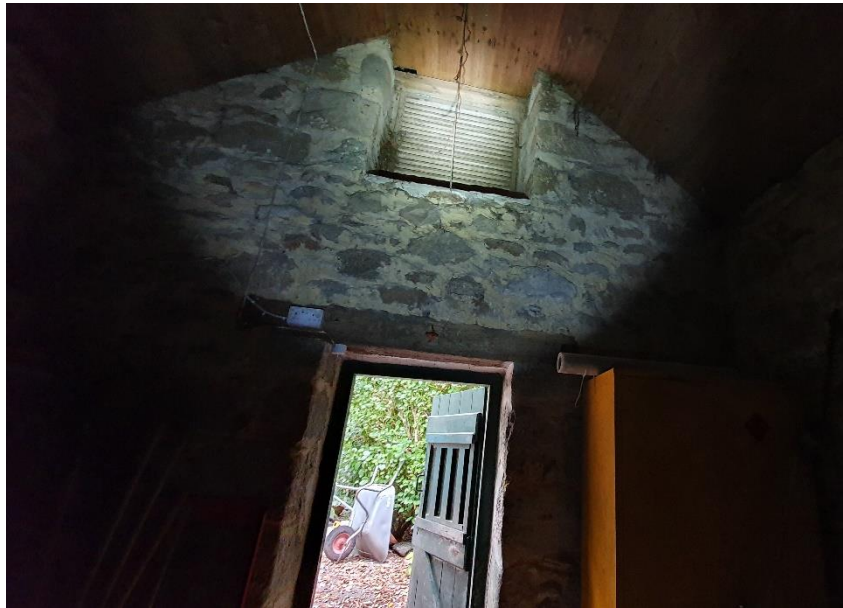
Figure 13: Interior of attached outbuilding (viewed towards the north).

No evidence of the use of the attached outbuilding by roosting bats was found. However, a small number of external features were noted on this part of the building which could provide potential access into the interior.

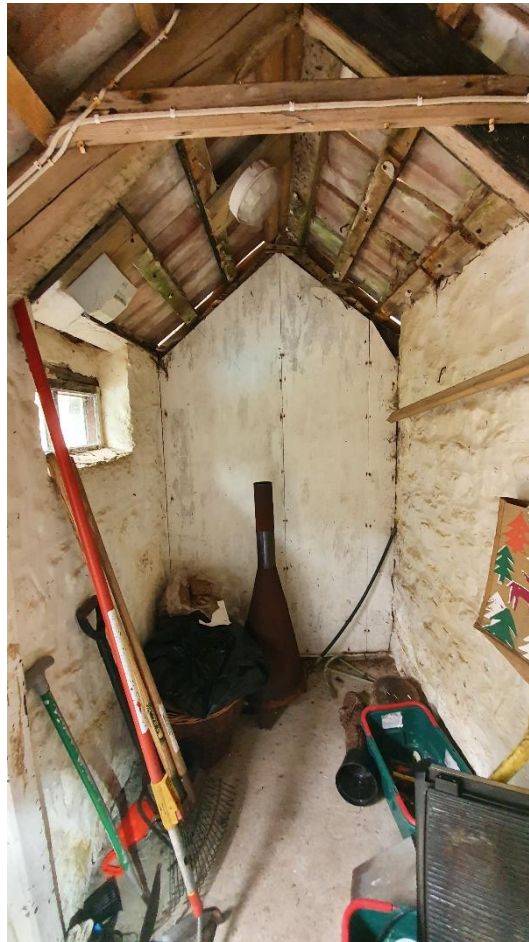
Within the eastern room approximately c.10 old bat droppings were noted on the windowsill and on the stonework in this room. It was not possible to determine the likely species of bat as the majority of droppings were degraded, although a single dropping characteristic of a pipistrelle bat spp. was noted.

Figure 14: Interior of eastern room within detached outbuilding (viewed towards the east).

Although bats are not currently, at the time of the survey, using the outbuildings, external features with potential to support bats were identified and old bat droppings were noted within the detached outbuilding during the visual assessment. The building contractors should be made aware that bats can roost unseen within the building structure. If, during works, a bat(s) is uncovered, the bat must not be handled and works must stop immediately (as soon as it is safe to do so). Advice must be sought from an experienced bat ecologist (Plan for Ecology Ltd: 01326 218839) or Bat Conservation Trust (Tel: 0345 1300 228). See Section 2.3 for relevant legislation.

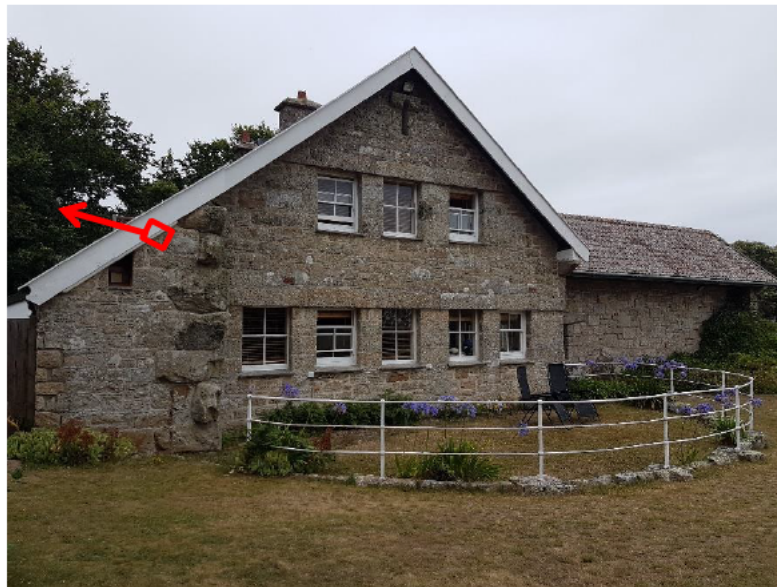
During the first emergence survey on 27th August 2020, three common pipistrelles were seen to emerge at 20:23, 20:35 and 20:37 from a gap behind the wooden fascia board on the south elevation of Valhalla (Fig 15). No bats were seen to emerge from the attached outbuilding or detached outbuilding during this survey.

Figure 15: Location of three common pipistrelles seen to emerge during first emergence survey (red arrow) from under the fascia board on the southern elevation of Valhalla.

The results indicate that at least three common pipistrelles use gaps between the wooden fascia board and stone wall on the southern elevation of Valhalla as day roosts. The common pipistrelle is a crevice dwelling bat species that typically roosts between slates/ tiles and the roofing felt, or beneath fascia boards/ soffits. This species is common and widespread throughout the UK. The population is considered to have increased since 1999 (BCT, 2020). Common pipistrelle is also considered common and widespread in Cornwall.

- As far as we are aware, the existing common pipistrelle day roost on the southern gable end of the building is not being directly impacted and will be retained. This feature must be protected during the construction and operational phases and the access point retained to ensure common pipistrelle bats can continue to roost within the building post-development. If, however, it is not possible to retain this roost feature and it is to be lost, its loss will need to be compensated by providing alternative provision, comprising a bat slate over Bitumen 1F felt. The bat slate, located on the western elevation of the roof, will be positioned three slates down from the ridge and will permit bats to roost between the roof tiles and bitumen membrane. Synthetic breathable roof membranes are not appropriate for use in bat roosts as they have been proven to cause harm to bats.

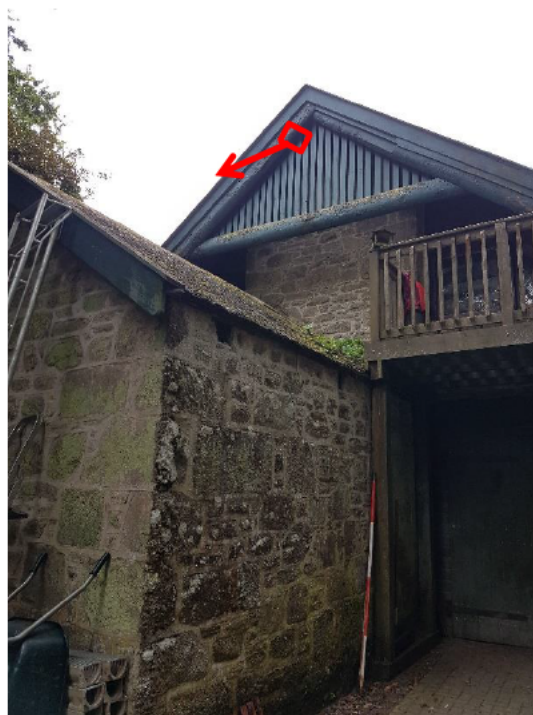
During the second emergence survey on 23rd September 2020, one brown long-eared bat was seen to emerge at 20:09 from under the wooden fascia board near the apex of the northern elevation of Valhalla (Fig 16). No bats were seen to emerge from the attached outbuilding or detached outbuilding during this survey.

Figure 16: Location of a brown long-eared bat seen to emerge during the second emergence survey (red arrow) under wooden fascia near the apex on the northern elevation of Valhalla.

The results indicate that the northern gable end of Valhalla, near the apex, is used as an occasional day roost by a small number of non-breeding brown long-eared bats (at least 1 individual). The brown long-eared bat roost is located underneath the wooden fascia/ barge board (Fig 16). The brown long-eared bat(s) access this part of the building via small gaps between the fascia board and the wooden panelling on the northern elevation. It is also possible that the brown long-eared bat roosts within the roof void over the apartment, gaining access via these gaps in the external wooden panels. NB. We presume all *Plecotus spp.* recordings are those of brown long-eared bat because Cornwall and the Isles of Scilly are outside the known range of the grey long-eared bat.

- As far as we are aware, the existing roost feature shown to be used by the brown long-eared bat i.e. a cavity underneath the fascia/ barge board on the northern elevation is not being directly impacted by the proposed works and is being retained. This feature must be protected during the construction and operational phases and the access point retained to ensure brown long-eared bats can continue to roost within the building post-development. If, however, it is not possible to retain this roost feature and it is to be lost, its loss will need to be compensated by providing alternative provision, comprising a bat slate or raised ridge tile over Bitumen 1F felt (as above for common pipistrelle), with access into the roof void below.
