ECOLOGICAL ASSESSMENT

SEAVIEW, MACFARLAND'S DOWN, ST MARY'S, ISLES OF SCILLY

Report date: 8th February 2022

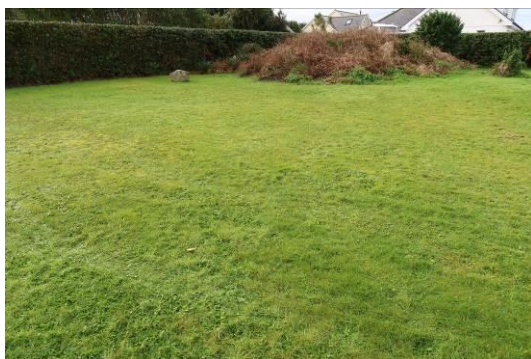
A large brash pile is present in the south-western corner of the garden. Though there are recent additions to this pile arising from ongoing maintenance of the garden, much is well established with significant growth of opportunistic ruderals such as bramble. This brash pile would provide excellent nesting habitat for breeding birds and small mammals.

Photo 01 – Showing the close-mown amenity grassland which dominates the site. The brash pile can be seen in the south-western corner of the garden.

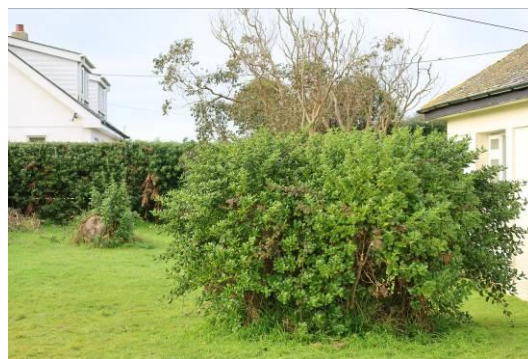
Photo 02 – Showing typical examples of the trees and shrubs set within the amenity grassland.

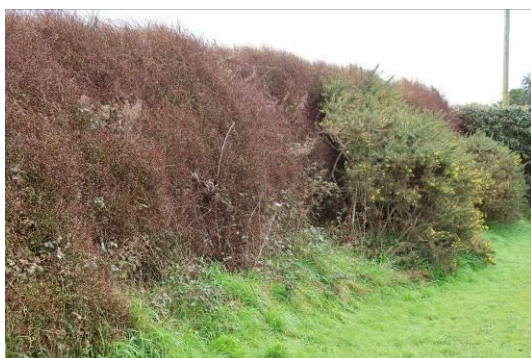
Photo 03 – Showing the maidenhair hedge on the eastern boundary with opportunistic gorse shrubs developing

To address the removal of the maidenhair hedgerow along the eastern boundary, compensatory planting in the form of two native boundary hedges between the new dwellings should be provided, along with the planting of three native standard trees approximately 10m apart along the length of the eastern boundary. To enhance the development and to provide a small net gain in biodiversity, all replacement hedgerows and standard trees should consist of native species, known to be present on the islands, or were once present on the islands. Shrubby or hedgerow species include hawthorn (*Crataegus monogyna*), blackthorn (*Prunus spinosa*) and hazel (*Corylus avellana*); whilst appropriate tree species include oak (*Quercus petraea*), birch (*Betula pendula*) and crab apple (*Malus sylvestris*).

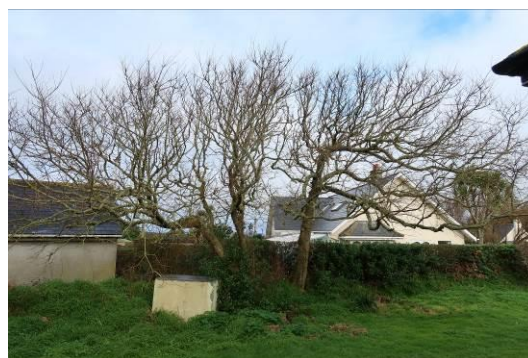
Two Dutch elm trees are present in the north-western corner of the site on the boundary set just in front of the Pittosporum hedge.

Photo 04 – Showing the Pittosporum hedge on the northern boundary with the two elm trees visible.

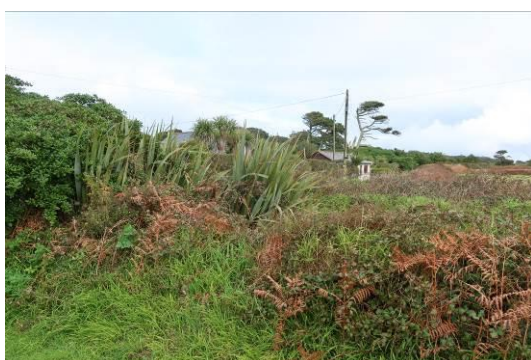
Photo 05 – Showing the overgrown wall in the north-eastern corner of the site – this would be disturbed for the creation of the soakaway.

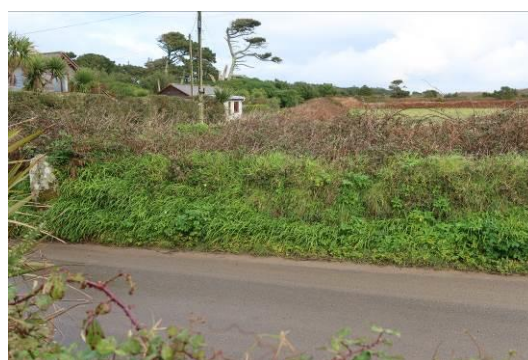
The field to the east of the property is separated from it by a single-track tarmacked road. The field boundary is a soil-filled double-stone wall which is of a similar character and condition to the one bounding the site and described above.

Photo 06 – Showing the view of the adjacent field from within the site – the road and separating wall can be seen.

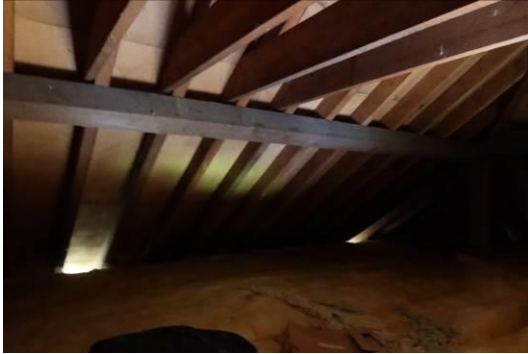
Photo 07 – Showing the interior of the roof – the beam structure can be seen along with light from the eaves where potential internal access could be gained.

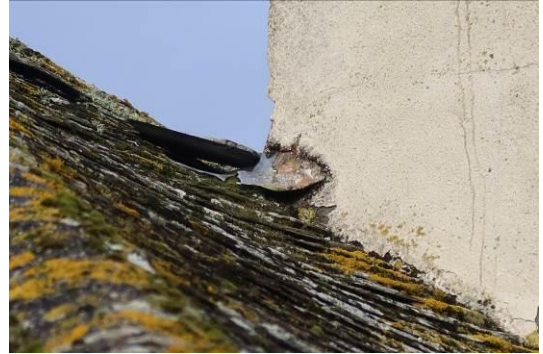
Photo 08 – Showing the slightly lifted flashing around the chimney – this appears to be superficial

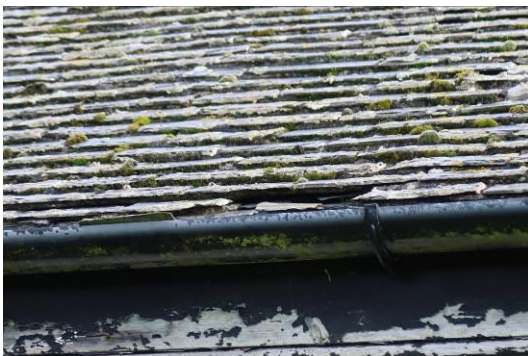
Photo 09 – Showing an example of the minor gaps in the tiles; otherwise the scandle tiles are well fitted with mortar beneath.

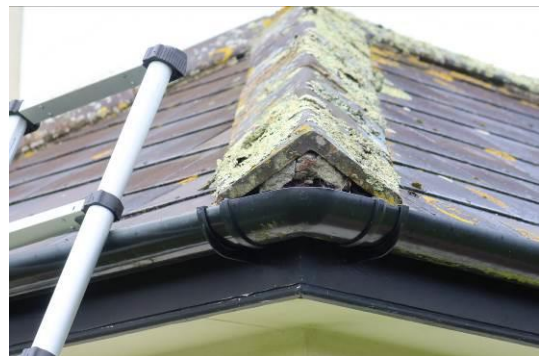
Photo 10 – Showing the damaged terminal hip tile in the south-east corner of the property – this was inspected at height and no roosting potential was identified.

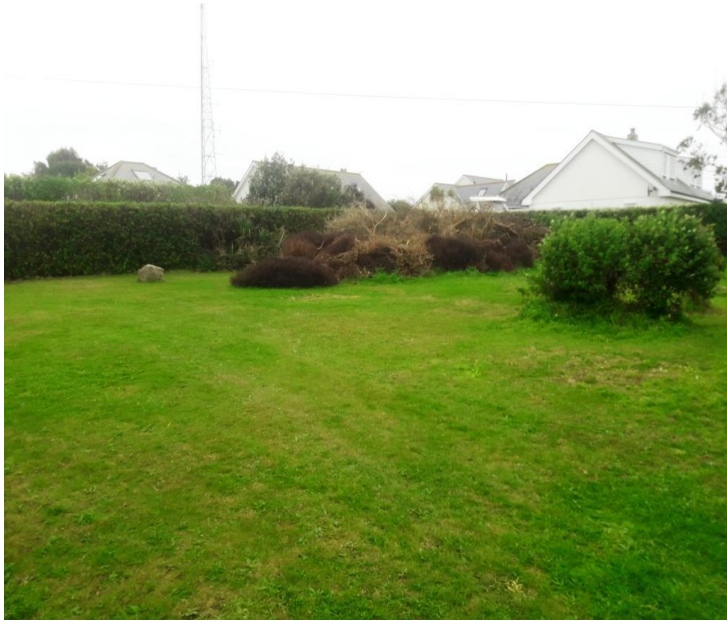
Photo 2. Expanse of improved grassland and brash pile in background

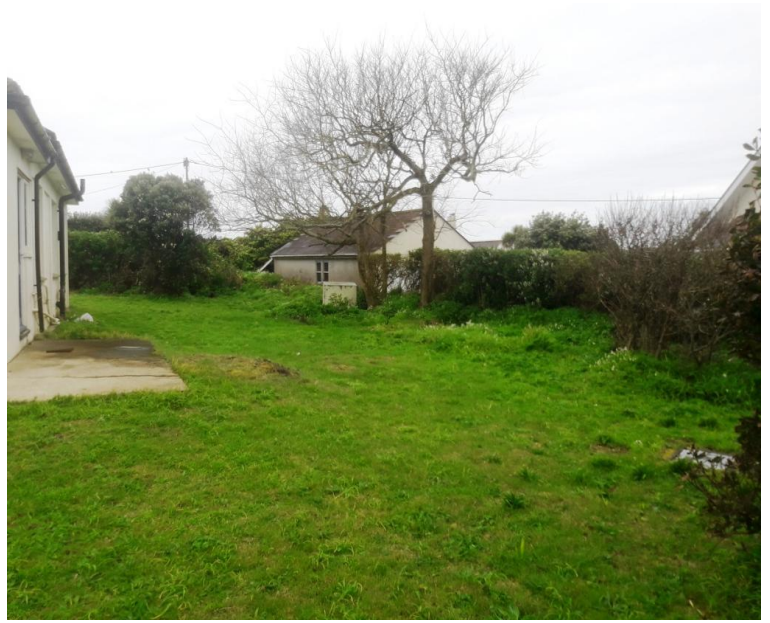
Photo 3. Expanse of improved grassland and Dutch Elm in background

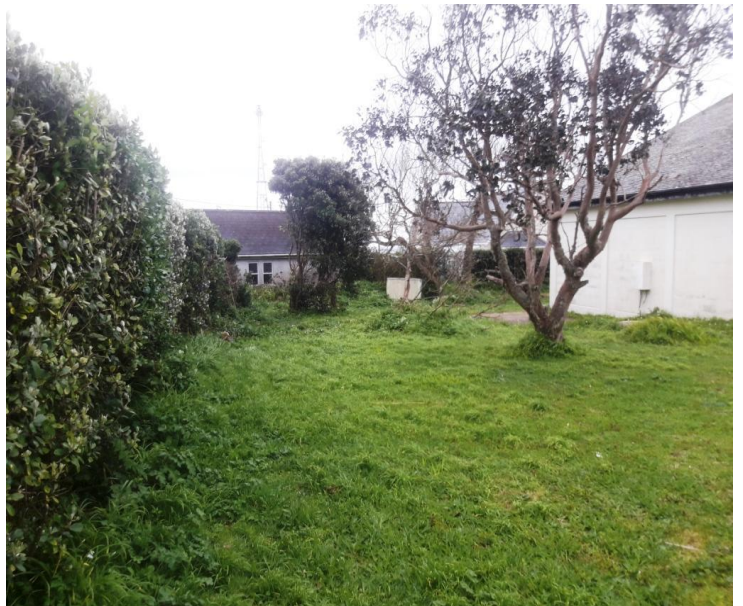
Photo 4 Disturbed grassland with Pittosporum hedge and Eucalyptus tree

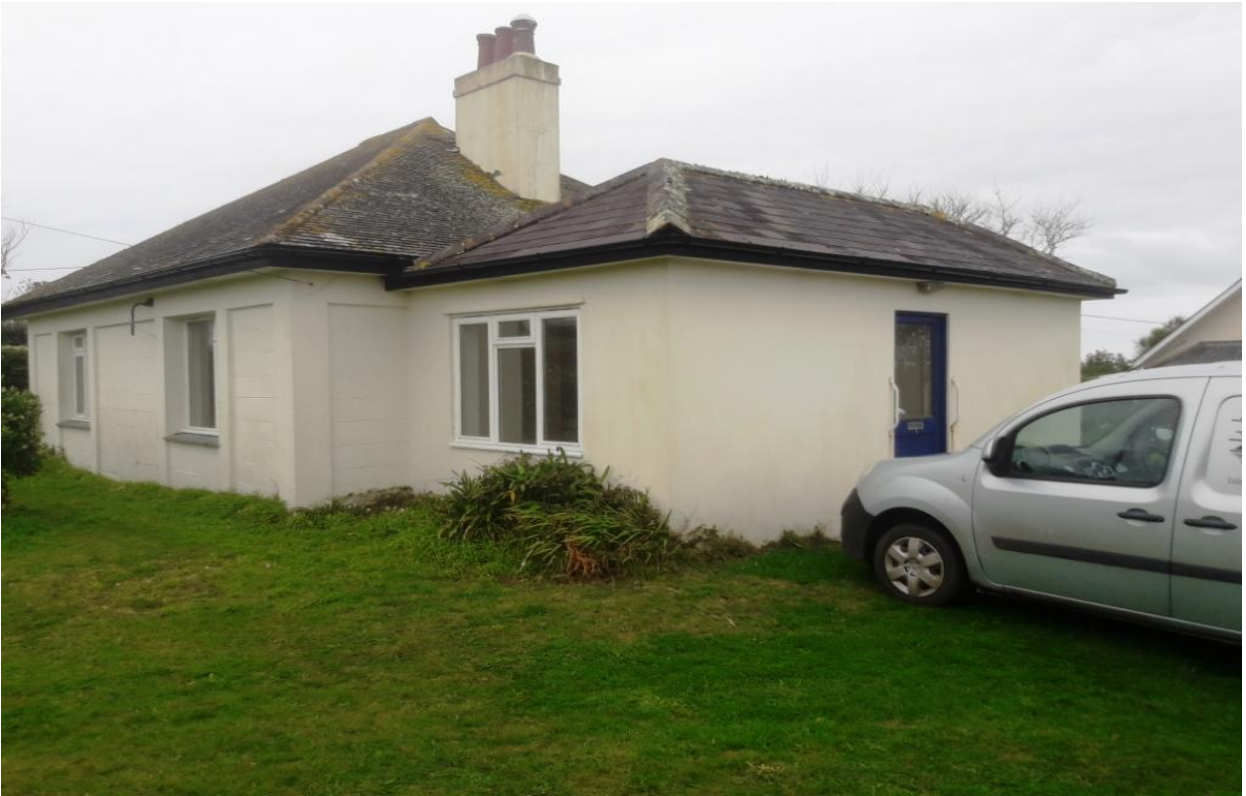
Photo 1. Eastern aspect of Seaview

The development is located at McFarlands Down, St Mary's (National Grid Reference SV9126212199). The application site is comprised of a detached block built bungalow with an east/west aspect (see photo 1). The footprint of the building is approximately 108m² and the total footprint of the site is approximately 1,377m² (red area, see Figure 1).

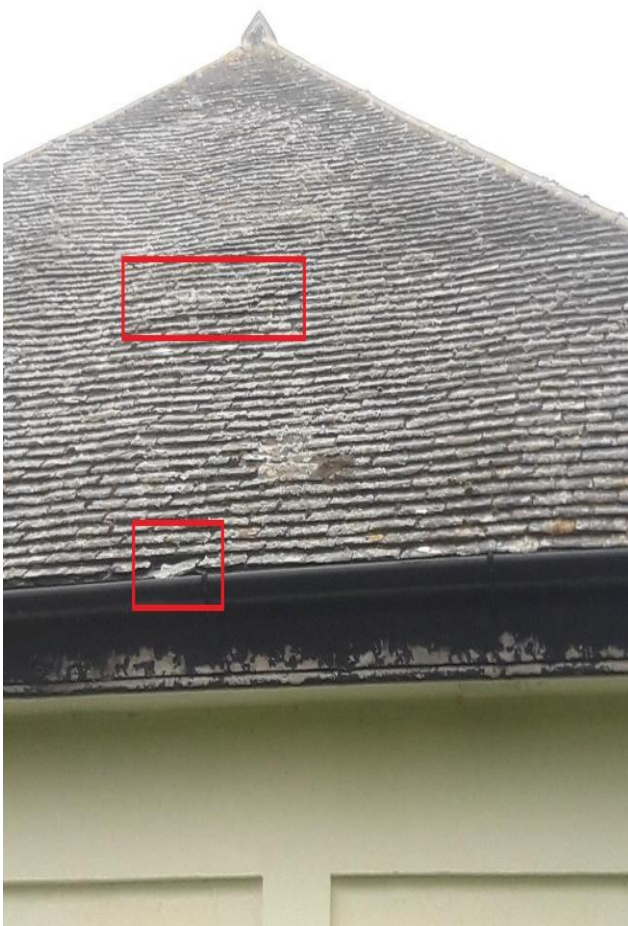
Photo 3.

- Missing tile just above guttering along with missing mortar below several tiles on western aspect of the original building which could permit access below these tiles (see photo 3.)
- Large gap at north-western eaves of roof of main building that permits access into the roof void (see photo 4.)

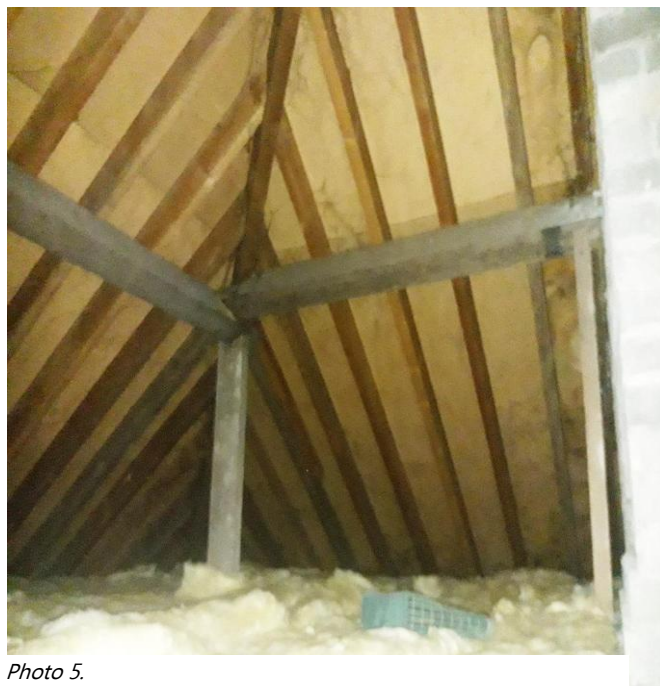
Photo 5.

The internal roof space of Seaview is restricted to the main building. No access was possible (no loft hatch) into the roof space of the more recent eastern extension. The internal roof space of the main building was of a Queen post and collar beam type construction (see photo 5.), with exposed purlins and rafters. The roof space behind this construction throughout was clad in hardboard, with only one area of baton and scantle tiles exposed on the western elevation, where it appears an old chimney stack was once present. No roof felt was noted. Some evidence of water ingress was

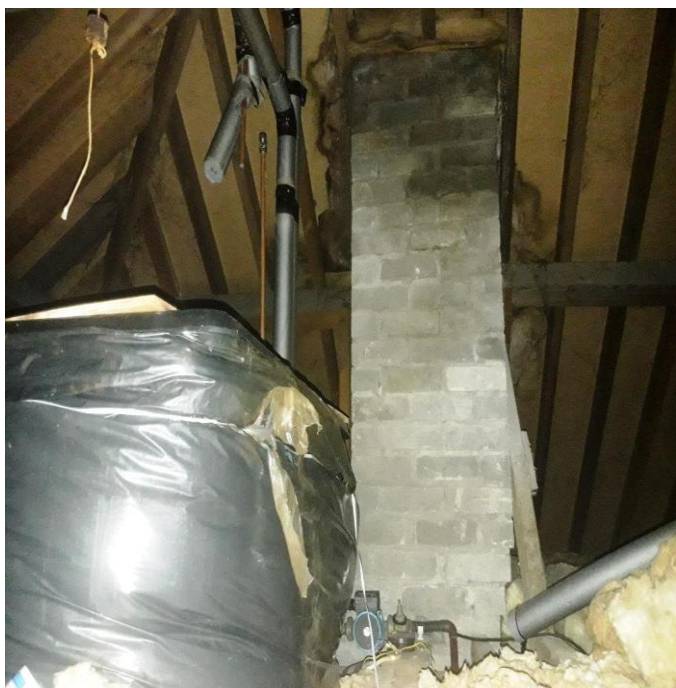
Photo 6.

apparent around the eastern chimney stack (see photo 6.), but with no obvious entry point into the roof void. Examination of the insulated floor and the tops of the chimney stack, water expansion tank and pipes revealed no small mammal or bird droppings. Examination of the queen post, purlins and rafter joints revealed no obvious claw marks, grease or urine stains (see photo 7.). Throughout, extensive cobwebs were present thickly coated in dust suggesting that these had been present for some time (see photo 7.).

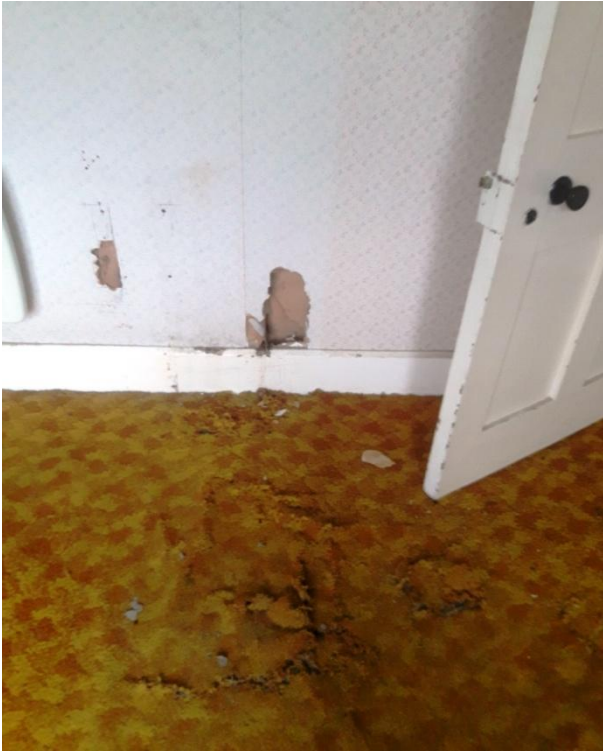
Photo 8.

As the building is proposed to be demolished the internal floor space was also inspected. Examination with endoscope of holes in partition walls and/or cupboards was undertaken (see photos 8 & 9.). Throughout this inspection no evidence (droppings, urine and grease stains, grease marks or bats) was noted).
