## **Bat Survey Report**

Site: Dolphin House, Tresco, Isles of Scilly TR24 0QQ

17<sup>th</sup> September 2020

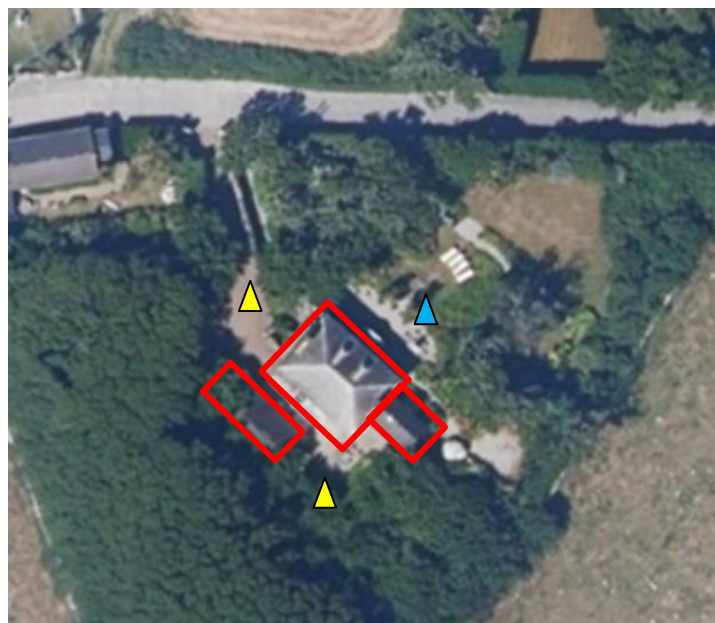
Figure 1: Emergence/re-entry surveys – surveyor locations. Dolphin House and its outbuildings are outlined in red. Yellow triangles show surveyor locations on both surveys, blue triangle shows location of surveyor 3 on the second survey

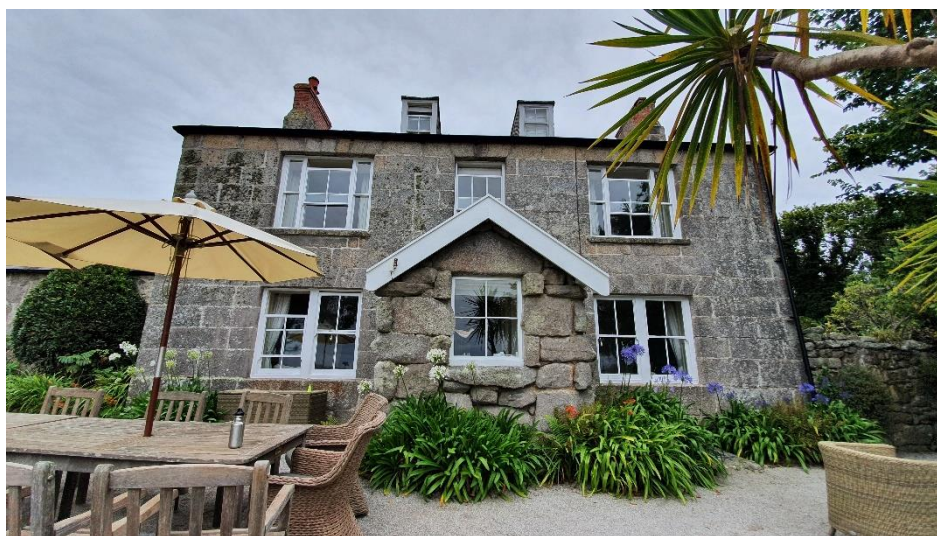
The property 'Dolphin House' consists of a three-storey Grade II listed stone cottage with a pitched, hip-ended roof covered with traditional slate and clay ridge tiles. On the south-eastern elevation is a single storey extension with a pitched slate roof, and on the south-western elevation is a two-storey extension with a mono-pitched roof covered with slate. The latter is proposed to be demolished. The north-eastern elevation features a small porch with a pitched slate roof.

Figure 2: North-eastern elevation of Dolphin House

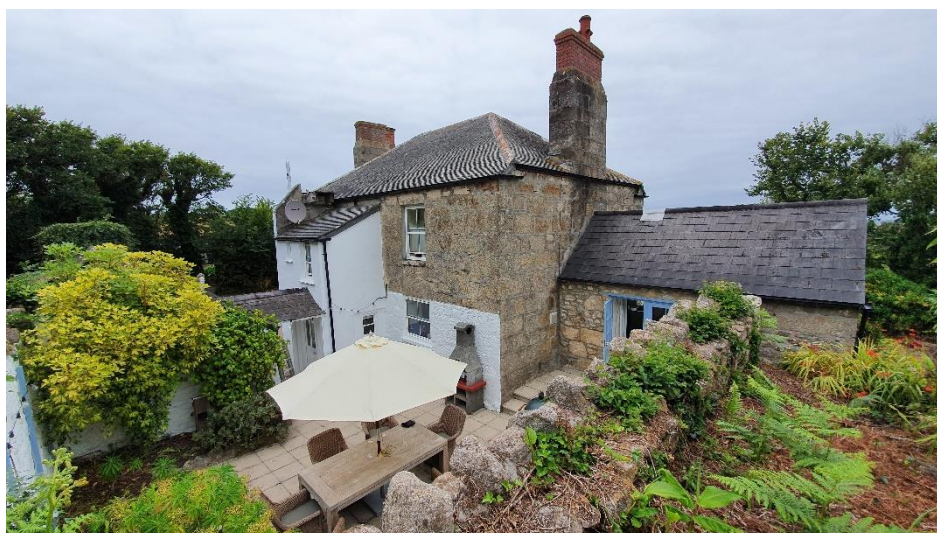
At ground floor level on the south-western elevation, the main cottage is attached to a single-storey outbuilding via a covered, open-sided walkway with a pitched slate roof. Attached to the north-western elevation of this outbuilding is a redundant roofless stone structure. The outbuilding and roofless structure are built into an earth bank along their south western elevations. A stone retaining wall to the south of the cottage, together with the extensions and outbuildings, creates a sheltered courtyard at the rear of the property (Figs 2 to 5).

Figure 3: South-western elevation of Dolphin House

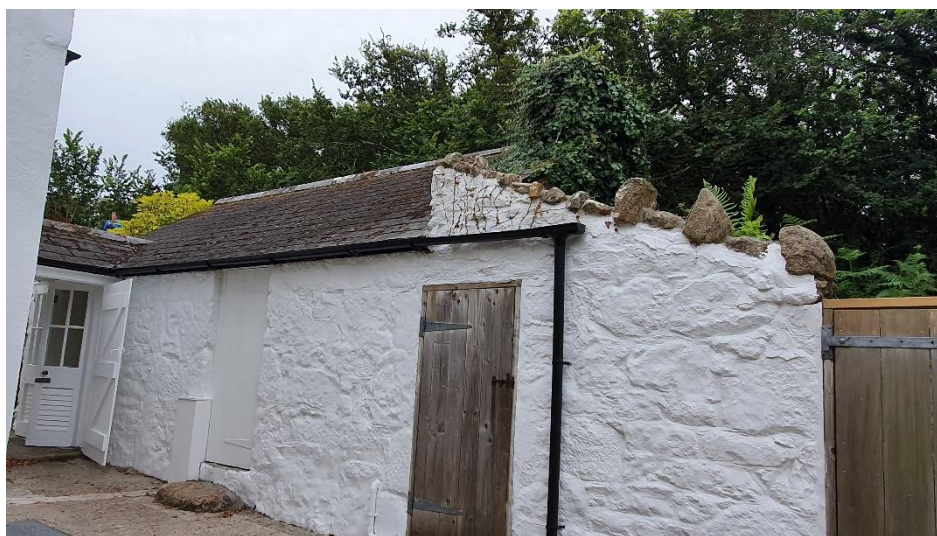
Figure 4: North-eastern elevation of outbuilding and part of roofless structure

The outbuilding and single-storey extension feature hanging slates on their gable ends with notable gaps behind which provide potential roosting opportunities for crevice-dwelling bats. These gaps could also enable access for bats into the interior of the roof void over the outbuilding.

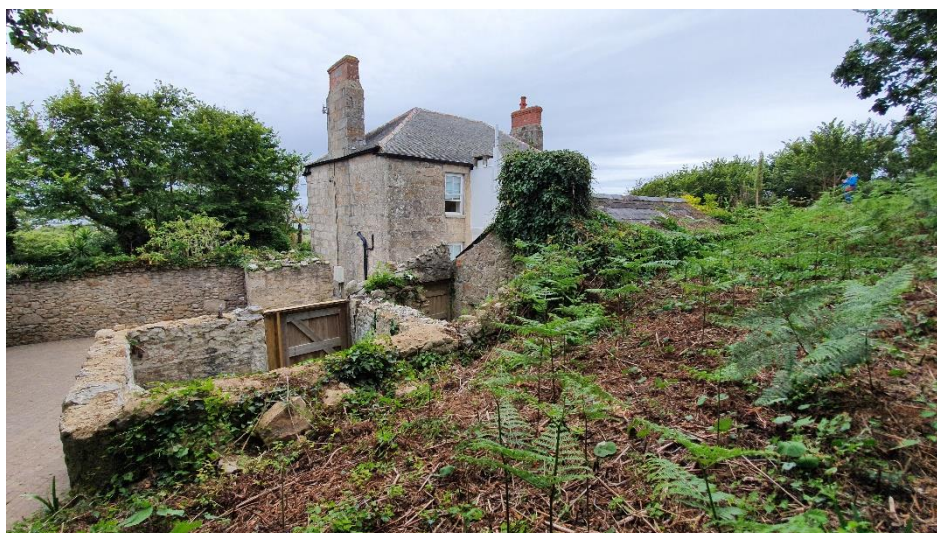
Figure 5: South western elevation of Dolphin House and roofless structure (viewed from top of earth bank)

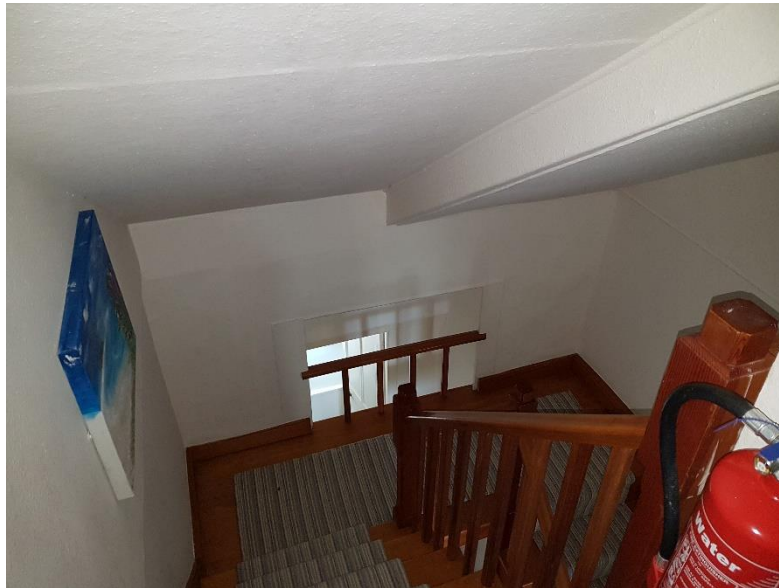
Internally the cottage is built into the underside of the roof creating a second floor with vaulted ceilings, the interior of the single-storey extension contains a vaulted ceiling and the underside of the roof within the two-storey extension has been boarded. Therefore, there are no accessible roof voids within these parts of the building (Figs 6 and 7).

Figure 6: Interior of second floor stairwell within Dolphin House (viewed towards the south-west)

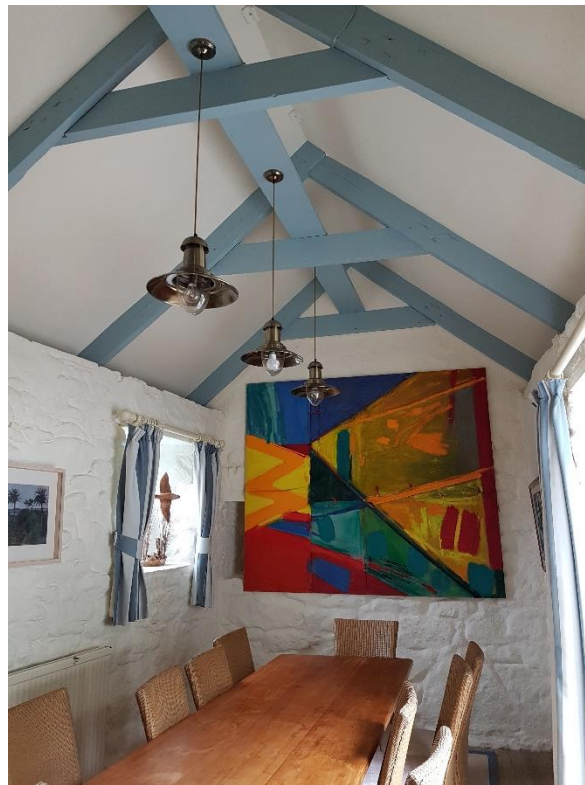
Figure 7: Interior of single-storey extension (viewed towards the south-east)

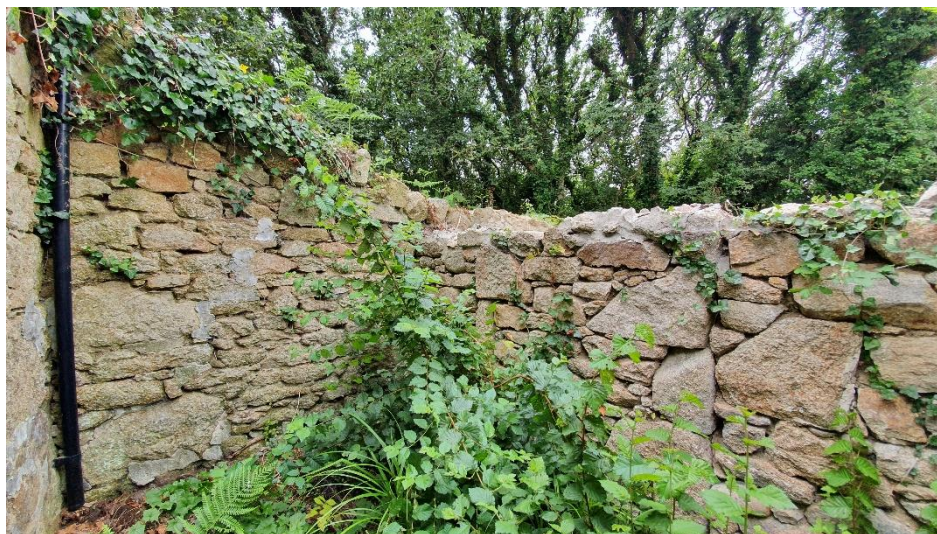
The interior of the outbuilding consists of a single room open from the concrete floor to the underside of the roof, which is partly bare slate and partly boarded creating a narrow roof void above. The interior of this roof void could not be accessed. This room is light internally and is in regular use as a utility room. The interior of the roofless structure consists of two rooms with bare stone walls and earth floors with ephemeral vegetation. The rooms are accessed via timber doors on the north eastern elevation. There are crevices present within the internal walls with some potential for crevice-dwelling bats, although this building is open and exposed to the elements which would have reduced the overall likelihood of bats roosting within this building (Fig 8).

Figure 8: Interior of roofless structure (viewed towards the north-west)

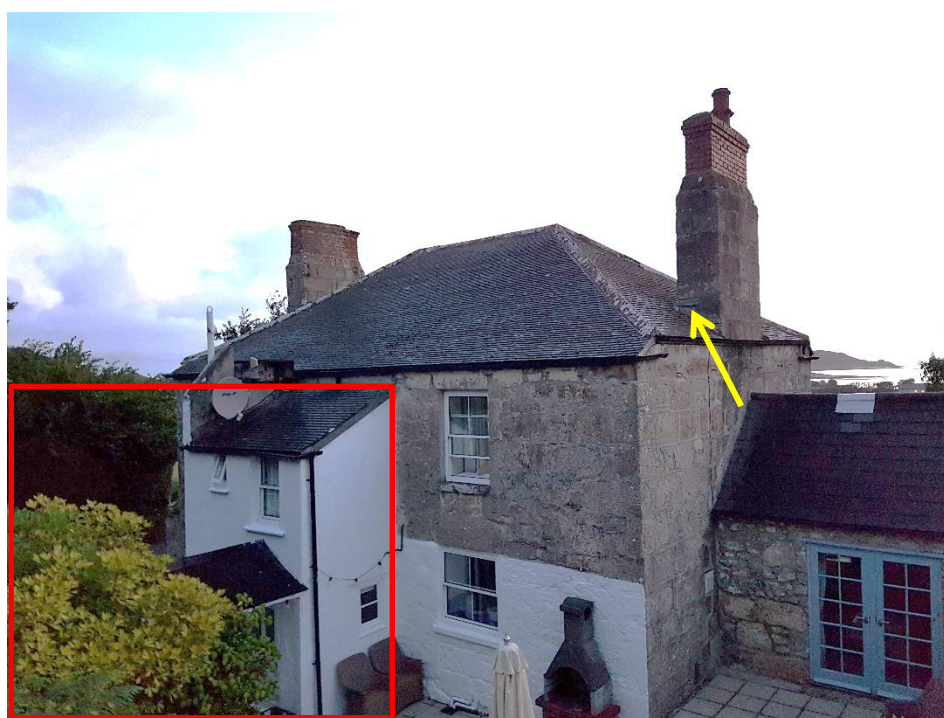
No bats were seen to emerge from the buildings subject to the proposals during the first (emergence) survey. During the second (re-entry) survey a single common pipistrelle was seen to re-enter a gap underneath lead flashing on the south western elevation of the south eastern chimney on the main cottage (Fig 9).

Figure 9: Re-entry location of a single common pipistrelle bat into a gap under lead flashing on the south western elevation of the south eastern chimney on 28<sup>th</sup> August 2020 (yellow arrow). Red outline shows approximate extent of proposed works at Dolphin House (including outbuildings further to the west).

The cottage likely supports an occasional day roost for a single non-breeding common pipistrelle. The location of the roost is likely within a gap underneath lead flashing on the south western elevation of the south eastern chimney on the main cottage. This roost is considered to be of **low conservation significance** for common pipistrelle.

In order to avoid disturbance to bats roosting within the chimney, it is recommended that a precautionary approach should be adopted:

- Prior to demolition of the existing two-storey extension, the roof over this part of the building will be 'soft striped' under an ecological watching brief between March and October (a time of year when any bats present are least likely to be negatively impacted), or when the temperature is consistently above 8°C. A licensed bat ecologist will oversee removal of the roof. In the unlikely event that a bat(s) is uncovered, works will be stopped, and Natural England consulted. Under this scenario, it will be necessary to obtain an appropriate licence from Natural England to permit continuation of works.

- Building contractors will be notified about the presence of bats in the adjacent chimney on the cottage and informed that if a bat/s is uncovered during works, then work must stop immediately (as soon as it is safe to do so) and advice sought from licensed bat ecologist/s (Plan for Ecology Ltd, 01326 218839)

- No exterior lighting will be installed close to the identified roost feature within the south eastern chimney
