### PERMISSION FOR DEVELOPMENT

Application No: P/22/064/FUL Date Application Registered: 12<sup>th</sup> September 2022

Site address: The Kavorna Hugh Street Hugh Town St Marys Isles Of Scilly  
Proposal: Replace existing scantle tiles with natural slate tiles to southern section of main building (Listed Building)

## **A Heritage Statement**

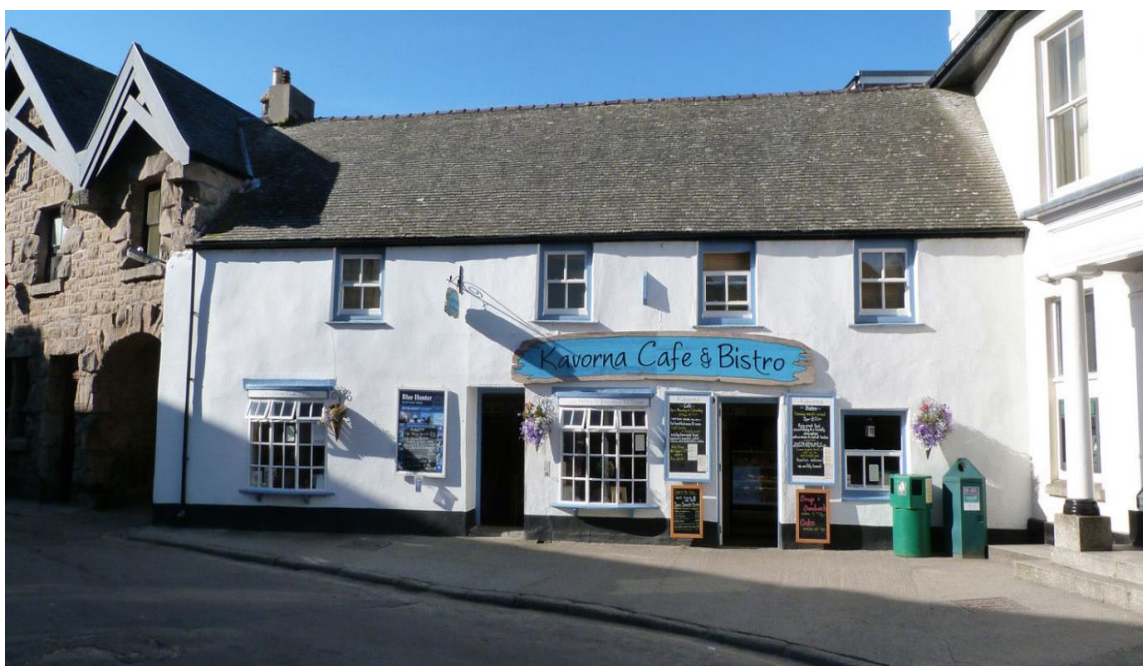
**Fig. 1: The north-east, front elevation of Kavorna, with the Grade II-listed Post Office to the left, and Grade II-listed Lloyds Bank to the right.**

the harbour frontage (Figs. 3, 5, 10 and 11). Kavorna comprises part of a succession of historic buildings along both sides of Hugh Street, which include the nineteenth-century and Grade II-listed Lloyds Bank, immediately to the north-west (NHLE1141218) (Fig. 1), and the Grade II-listed Post Office immediately to the south-east (NHLE 1291788) (Figs. 1 and 6).

- 4.9 Kavorna displays the pleasing and harmonious design of a traditional vernacular building which reflects local historic character (Figs. 1, 6 and 7). As such, it is a building which makes a considerable contribution to the character and appearance of Hugh Street. It therefore comprises an important element within eastward and westward views along Hugh Street, and this aspect of setting contributes to the significance of the building (Fig. 12). The colour and texture of its slate roofs comprise an important aspect of the aesthetic quality of Kavorna, and thus contribute to its design aesthetic values and historic character (Figs. 1, 4, 6 and 16). In common with those of surrounding buildings, the slate roofs of Kavorna contribute to the appearance and character of surrounding streetscapes and this part of the wider Conservation Area.

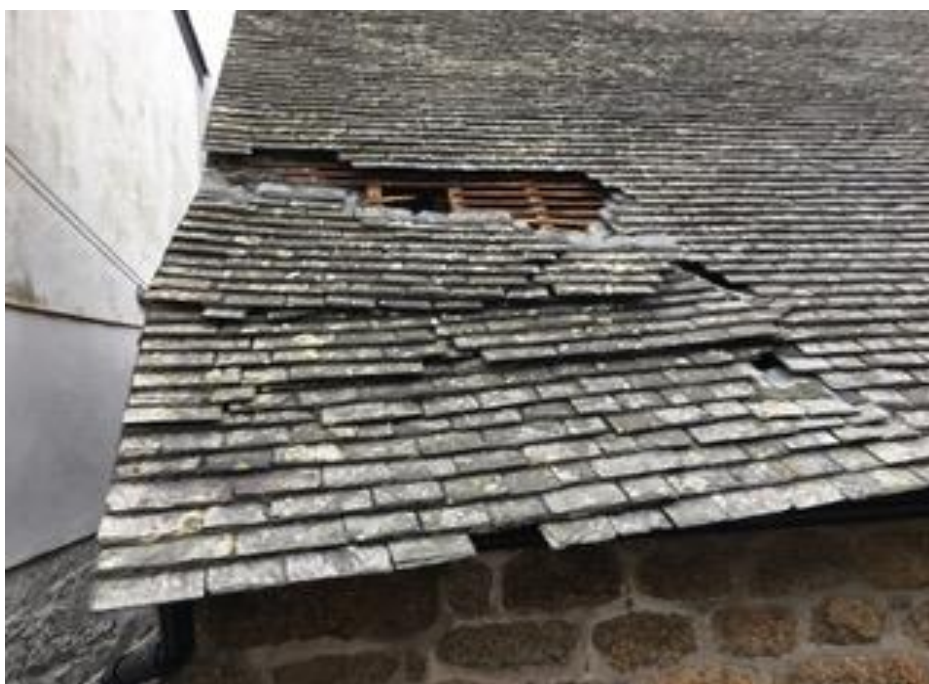
**Fig. 4: Slippage of slates on the south roof of the rear south wing, in 2021 (Paul Osborne).**

- 1.3 The rear, south wing of Kavorna has suffered from severe rippling of the slate scantle tiles on its northern side (Figs. 4, 15 and 16). The area affected by rippling finally collapsed during a storm in August, 2021. In 2019, the southern side of the south wing also suffered from a rippling slip, which was successfully repaired at that time (Figs. 7 and 16). Accordingly,

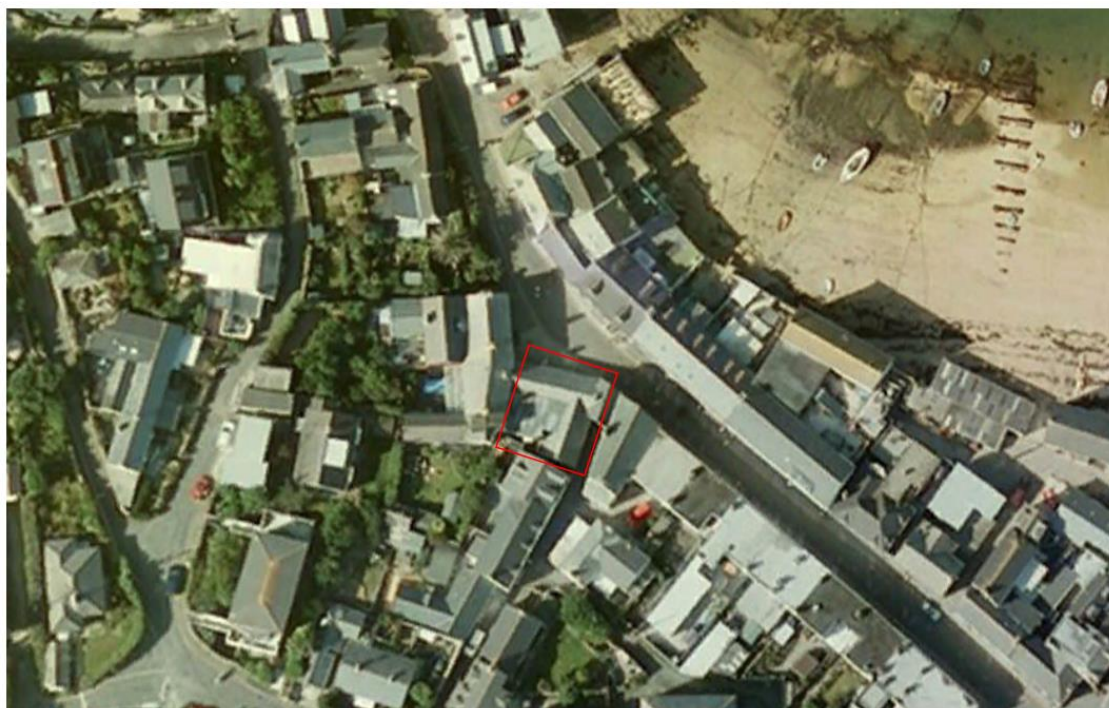
**Fig. 5: Aerial image of 2005, of Kavorna, and its rear wing, within their built context (Geoinformation Systems).**

- 1.2 Hugh Town, St Marys, comprises the only truly 'urban' settlement on the Scilly Isles. Within this, Hugh Street has possibly the greatest sense of enclosure, which is partly relieved by an informal square at its eastern end (Figs. 3 and 5). Street frontages within Hugh Street are almost continuous, and include a number of shopfronts and town houses of predominantly nineteenth-century date (Fig. 12). The historic core of Hugh Town is associated with fine urban grain and relatively high building density, with a focus on enclosed streets rather than

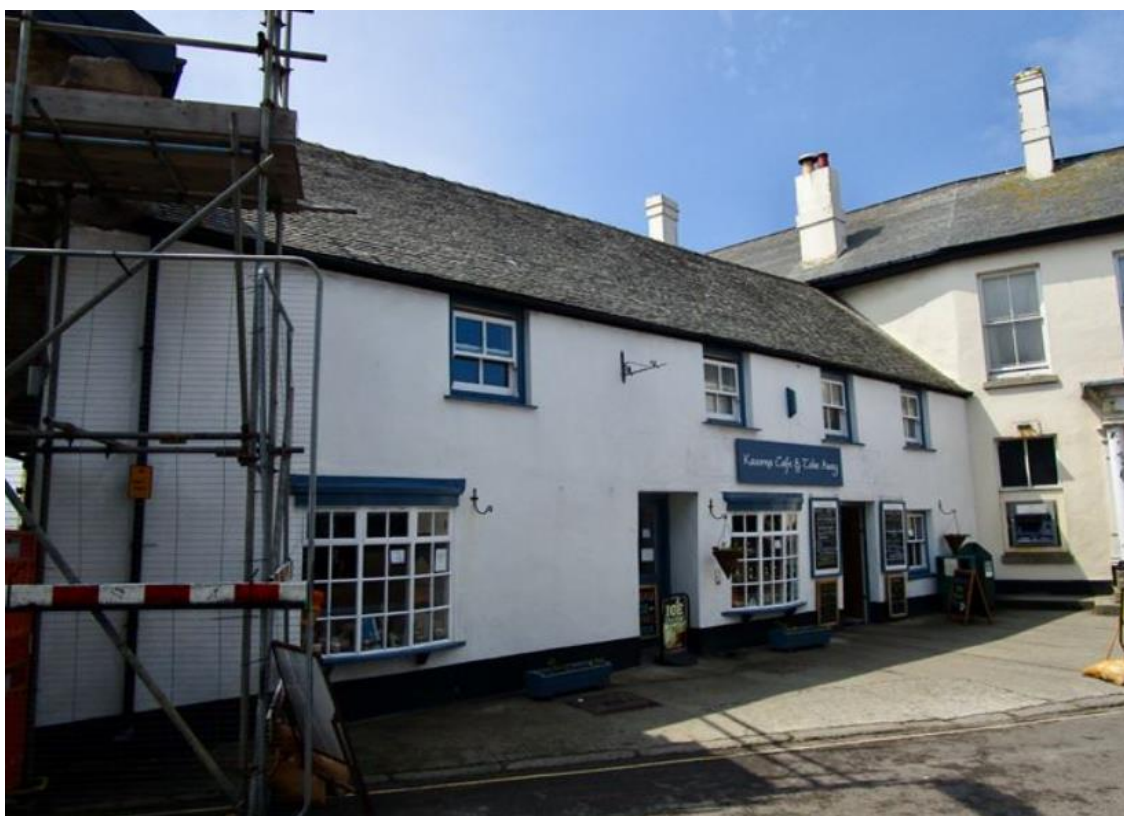
Fig. 6: View, looking west, of the north-east, street-front elevation of Kavorna.

- 4.5 It has been suggested that an existing house was subdivided in the later nineteenth century, although there is no evidence of this, and the current distribution of doors and windows on the front elevation of the building (Figs. 2 and 6)) suggests that the two dwellings were constructed to a plan. Kavorna had evidently been converted to a single dwelling by the time of the Ordnance Survey map of 1931 (Fig. 11). There are no records of the original plan-form of the building, or of the structural and internal changes that were made at that time.

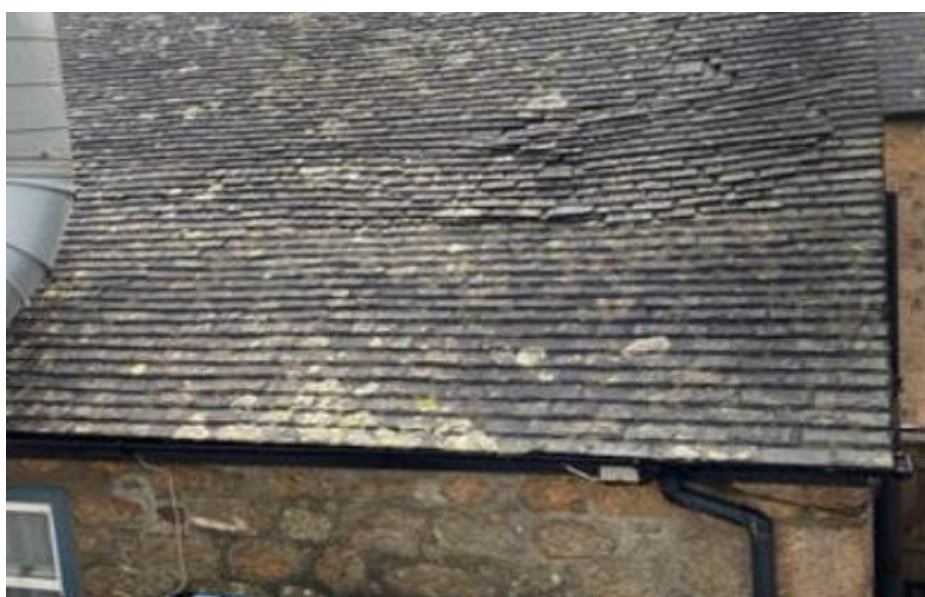
**Fig. 7: The north-west elevation of the south wing of Kavorna, showing slate rippling, with details of traditional vernacular construction.**

- 4.3 Kavorna has an L-shaped ground-plan, with the rear southern wing comprising an original element, with coursed, roughcast granite walls and a scantled slate roof (Figs. 4, 7 and 16). It is probable that the northern end of this original building extended, gable-end on, to the street frontage, although extensive nineteenth and twentieth-century alterations make it difficult to determine the precise structural relationship between the two principal phases of the building. The proportions and fenestration of the later, north range, although altered by later insertions, suggest a date not much later than *c.* 1800 (Figs. 1 and 6), and it is possible that the division of Kavorna into two separate dwellings may date from this phase of construction. The present internal floor-plan of the building is unfortunately not informative in this respect (Fig. 8).

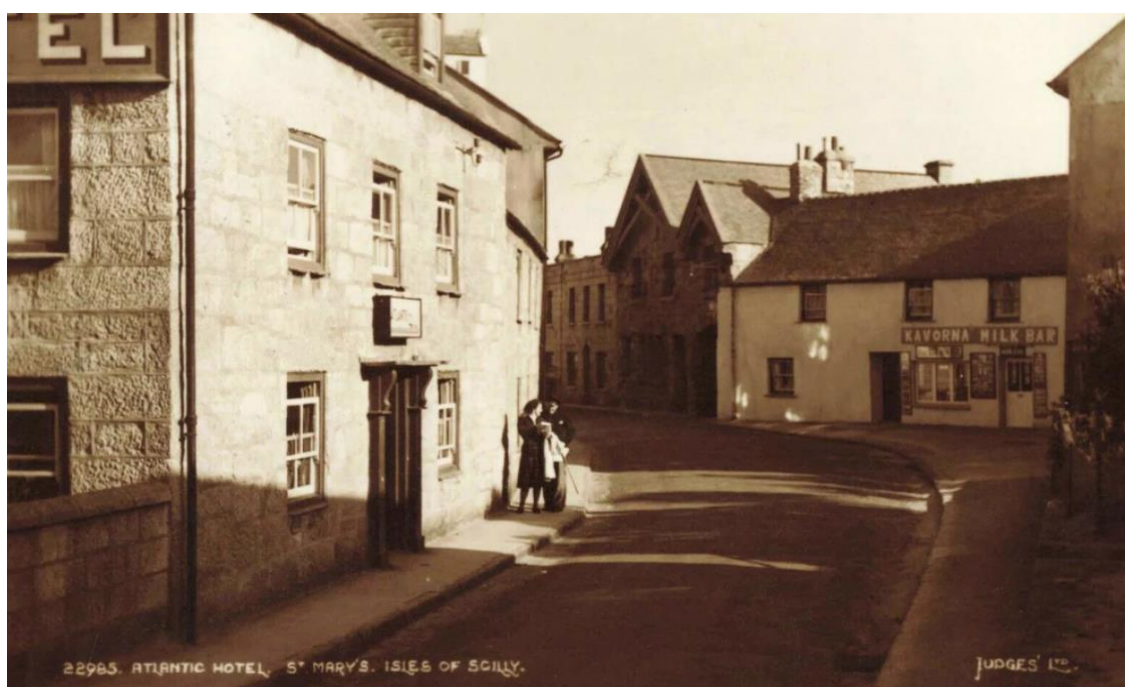
**Fig. 12: A Postcard of c. 1930, looking east along Hugh Street, with Kavorna to the left of the picture.**

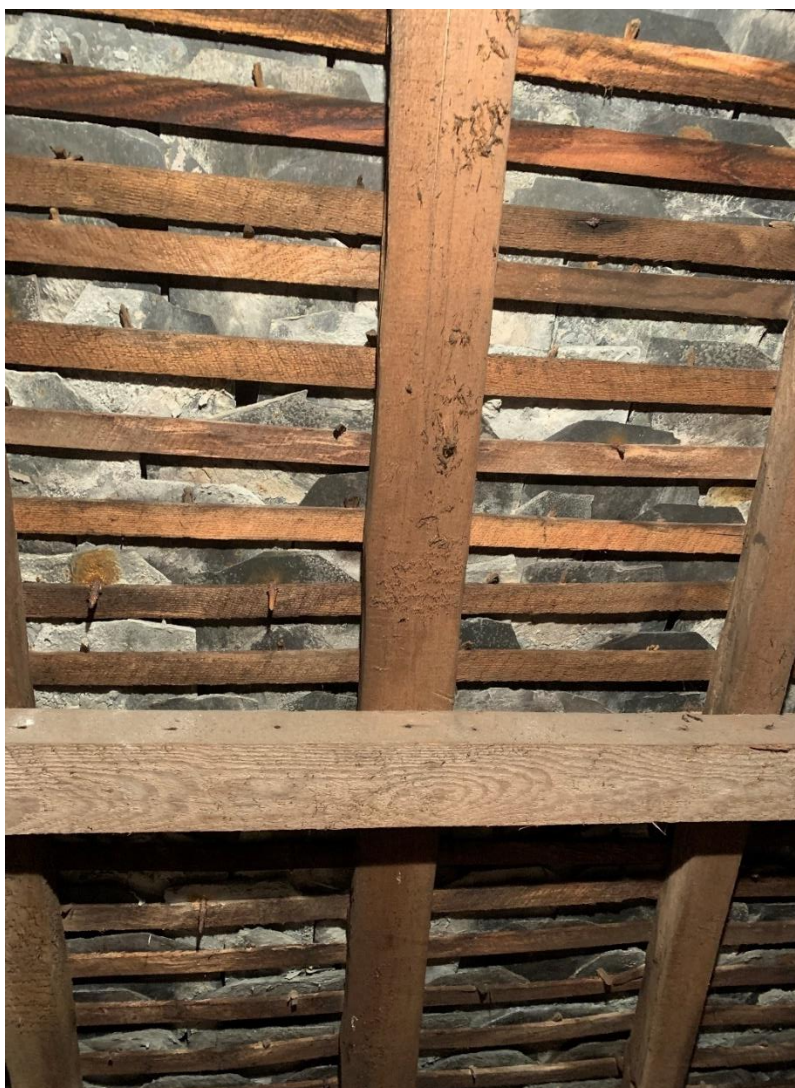
**Fig. 14: Internal details of roof construction: purlin, common rafters and battens.**

- 5.3 The purlins support jack rafters, which are set at irregular intervals of between 300mm and 400mm. These are also of machined softwood, mostly measuring approximately 70mm by 50mm in section, although some are of thinner, flatter section (Figs. 13 A-H; 14; 15 C and D). Battens are highly irregular, mostly comprising rough-sawn strips averaging 40mm to 50mm in width, and displaying considerable variation in thickness and section (Figs. 13 A-H; 14; 15 A-F). These are set on rafters, at intervals of between 60mm and 100mm. In some areas, the condition of rafters and battens suggests relatively recent repair and replacement (Fig. 14).

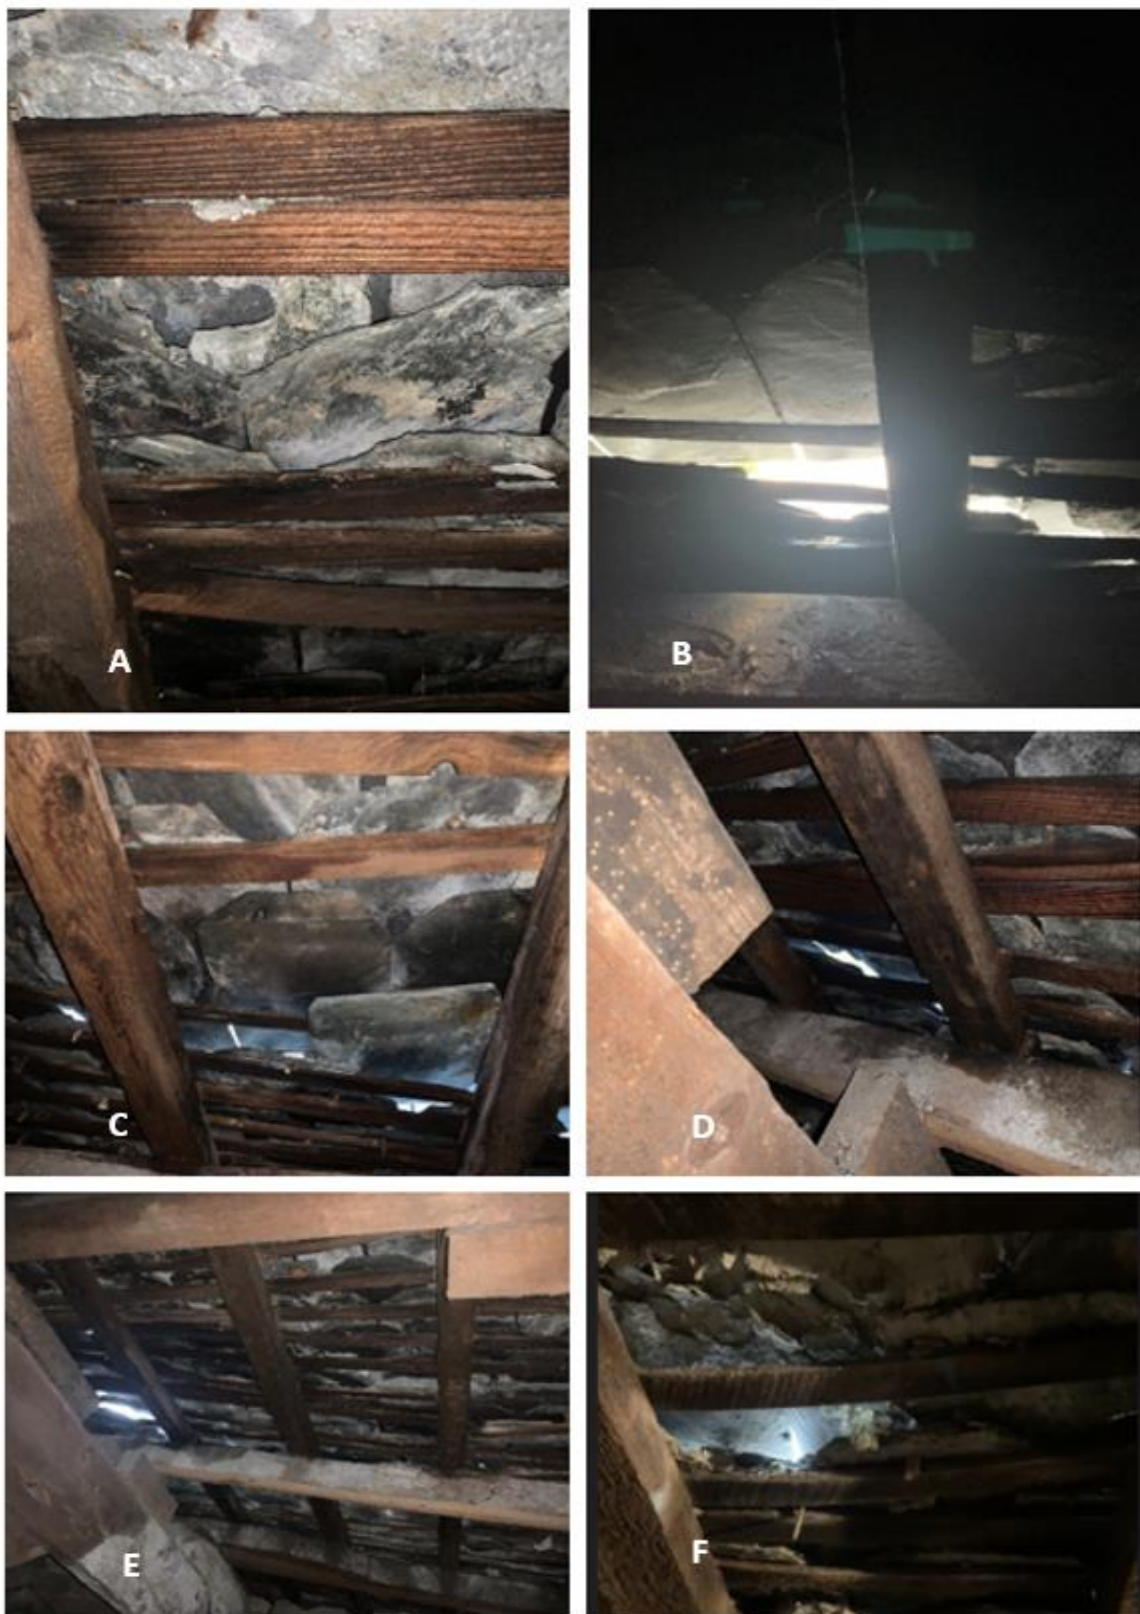
Fig. 15, A-F: Internal evidence of deterioration of roof battens and slate slippage.

- 5.5 The failure of parts of the slate roof results from deficiencies in original roof construction and choice of materials. None of this work can reasonably be dated earlier than the mid-nineteenth century, when it is assumed that a thatched roof was replaced. Within close proximity to the shoreline, the maritime climate has resulted in extensive corrosion of iron fixings, particularly of the iron nails securing the scantle slates (Fig. 13D). This is evident in the iron-staining visible on the undersides of a number of slates. In addition, it is clear that the smaller iron nails securing battens to rafters have also been subject to corrosion and failure, resulting in the downward slippage and displacement of battens under the accumulated weight of slates (Figs. 13F; 15B, C and F; 17B and F). A number of battens appear to be of insubstantial thickness, and are possibly not adequate to support the weight of slates, and a number of these

display evidence of *in situ* decay, possibly as a result of slight water ingress during winter storm conditions (Figs. 15A-F; 17A-H).

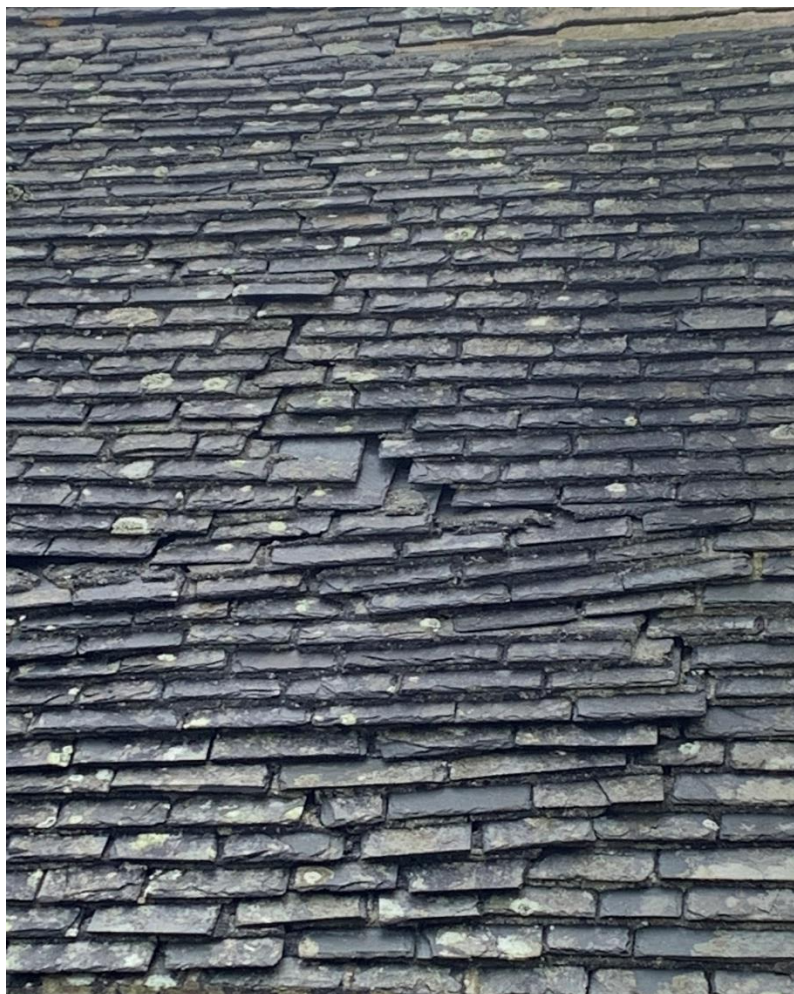
**Fig. 16: Cumulative downward displacement of slates on the north-west side of the south wing of Kavorna.**

- 5.6 It is also possible that the corrosion and failure of head-nails has enabled downward slippage and displacement of slates which have imposed additional weight on battens further down the roof-slope, thus causing them to break or become displaced, particularly if iron fixings have become corroded (Figs. 15B, C, D and F; 16; 17B). Given the cumulative weight and down-pressure of slates at mid-point on the roof-slope, this could result in a cumulative effect, causing the rippling noted on the north-west side of the south wing (Fig. 16).

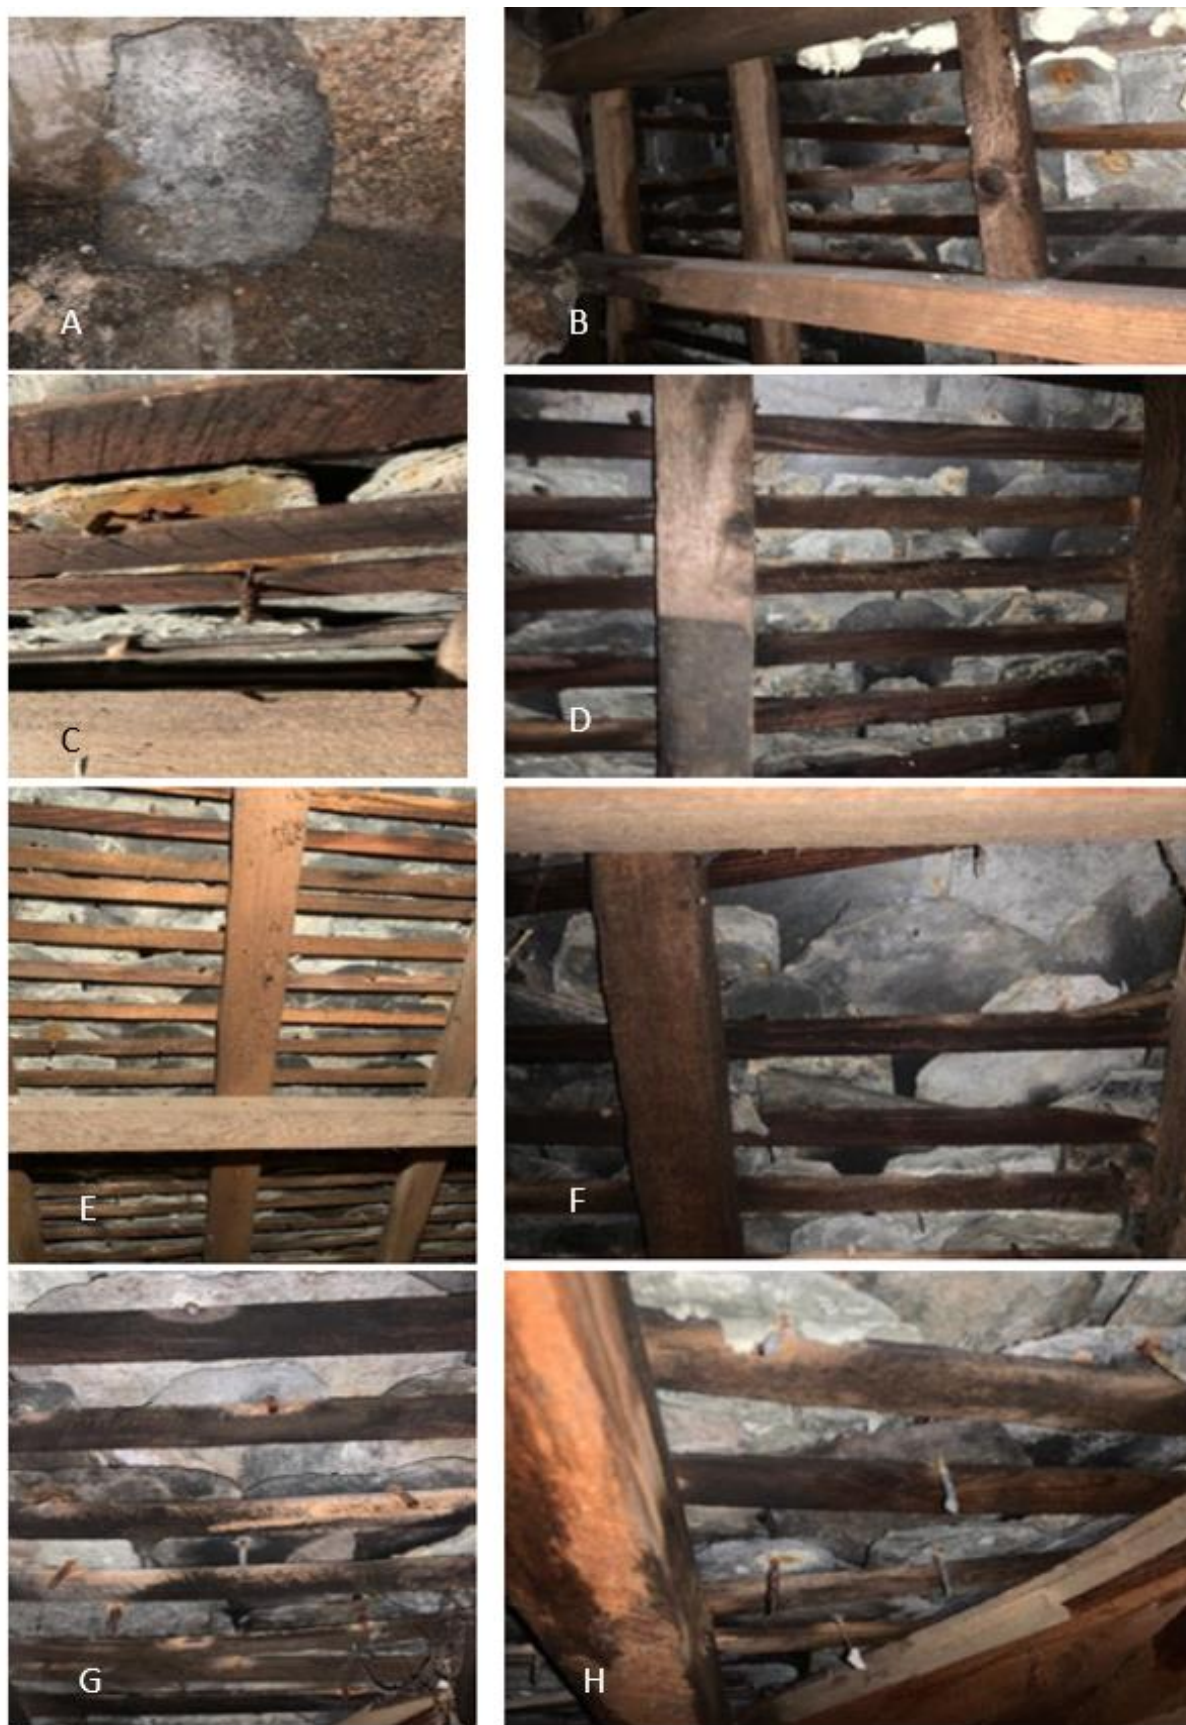
Fig. 17, A-H: Internal evidence of roof structure and deterioration.

5.8 Internal inspection further confirmed that damaged parts the roof were now affected by water ingress, but that the battens appeared to be in a moderate condition. Consequently, the roof failure was considered to be principally due to corrosion of the iron head-nails. It was also noted that many slates were in a poor condition, having become porous and fragmented, with some displaying a white, powdery texture. This may indicate the long-term exposure of these slates to weathering, particularly in a relatively exposed, coastal environment.

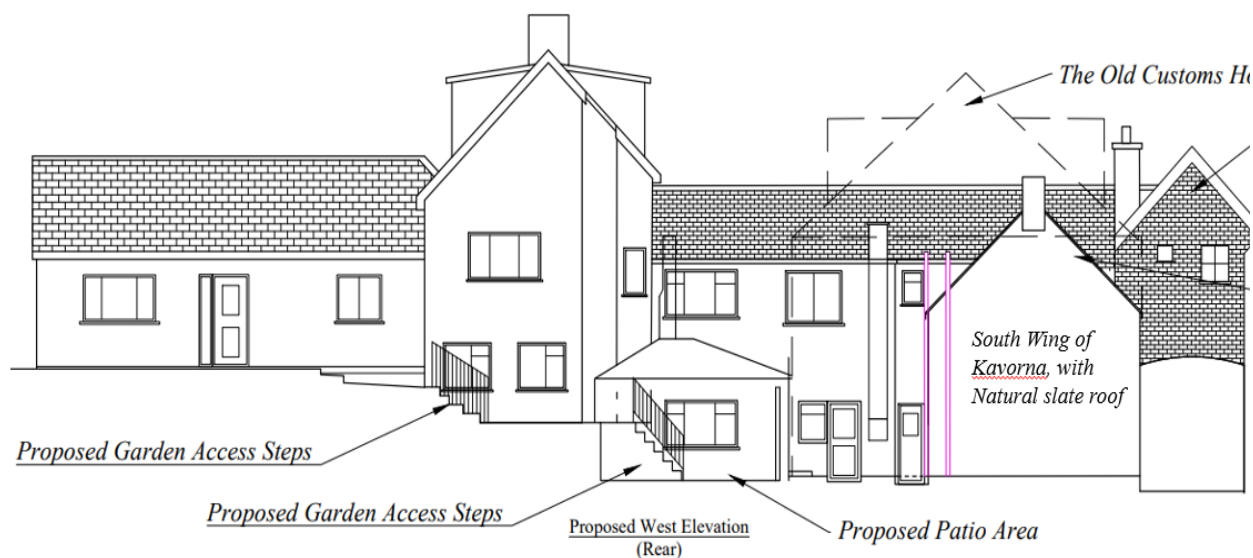
Fig. 18: Drawing of the rear, south-west elevation of Kavorna, with location of the south wing (Paul Osborne).

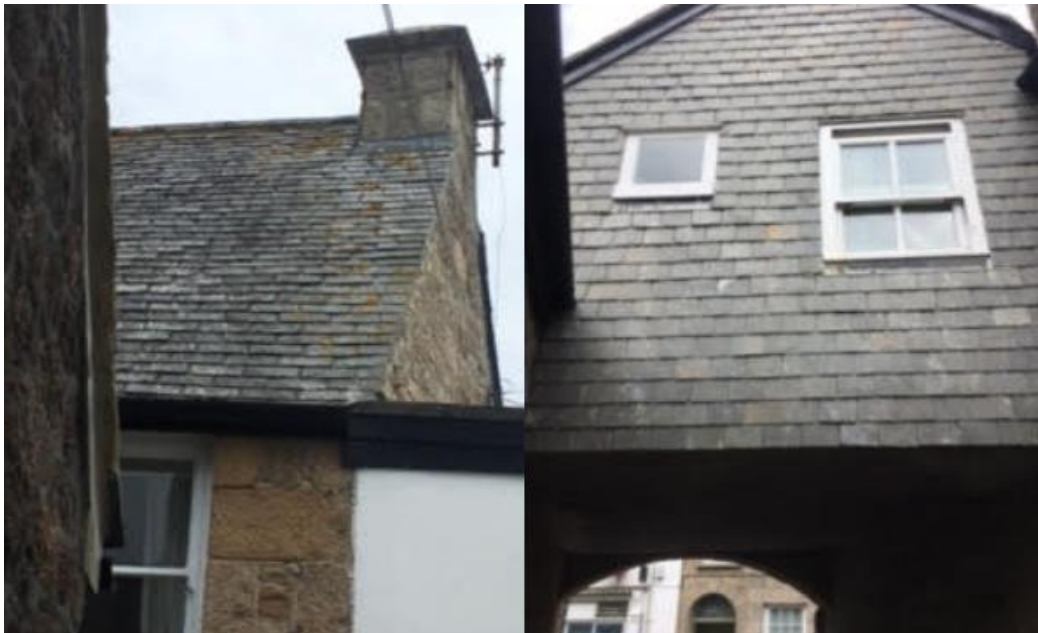
Fig. 20: Natural 'Camborne' slates on the roof and clad wall of the adjoining Post Office building (Paul Osborne).

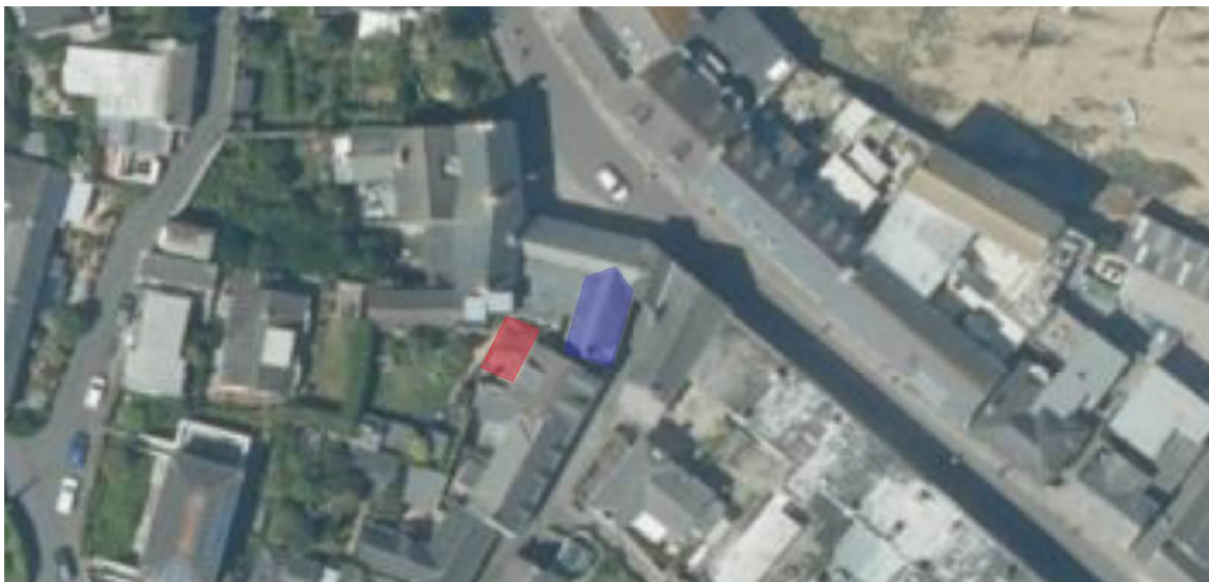
**Map 02** – Showing the roof to be replaced (blue) and the outbuilding (red) at Kavorna.

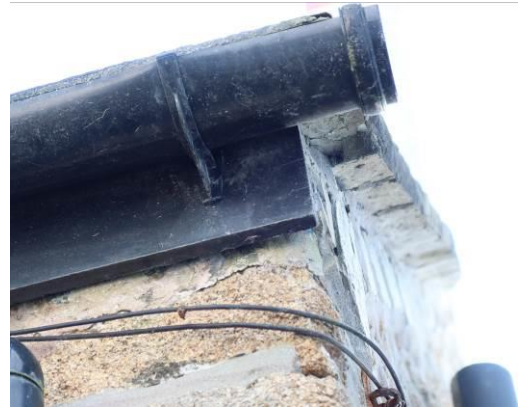
**Photograph 2:** Showing fascia board and guttering which runs along the eaves, along with the well-sealed gable end.

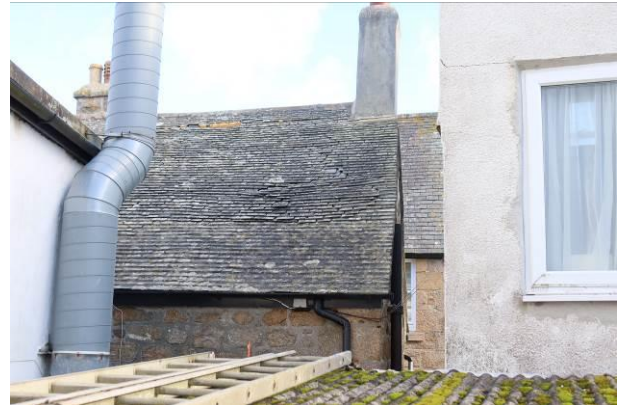
**Photograph 4:** Showing eastern pitch of the roof to be replaced.

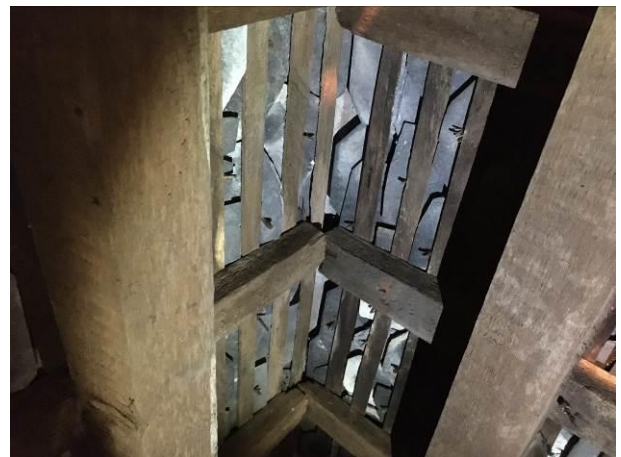
**Photograph 6:** Showing the internal pitch of the roof – no ridge board/beam is present.
