PRELIMINARY ECOLOGICAL ASSESSMENT

STEAMSHIP HOUSE, HUGH TOWN, ST MARY'S, ISLES OF SCILLY

Client: rlt architects Our reference: 22-11-1 Planning reference: Report produced in advance of submission Report date: 26th November 2022 Author: James Faulconbridge BSc (Hons), MRes, MCIEEM Contact: ios.ecology@gmail.com

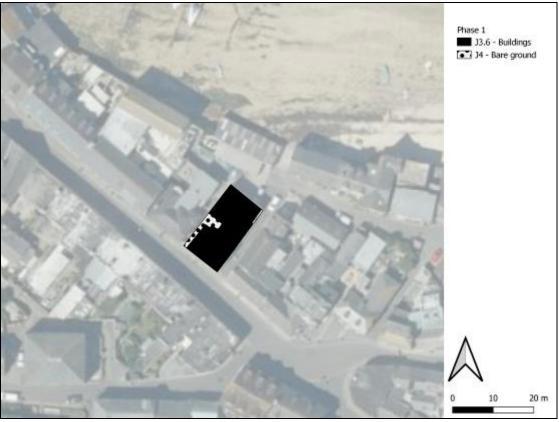
Map 03 – Showing the broad Phase 1 Habitat designations associated with the Site. Reproduced in accordance with Google's Fair Use Policy.

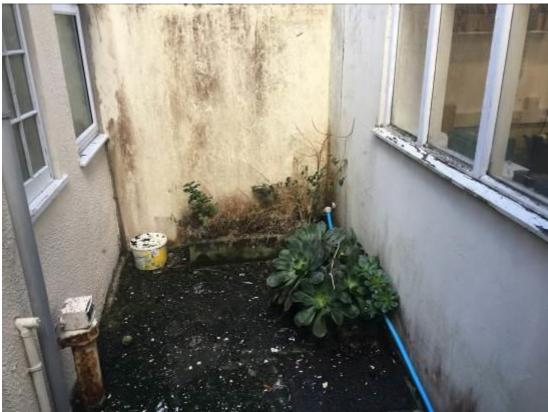
There is an enclosed courtyard within the building complex – this is dominated by concrete with individual ornamental plants. These are not considered to represent a habitat which requires further consideration in the context of this ecological evaluation.

Photo 01 – Showing the courtyard and individual ornamental plants which comprise the extent of vegetation within the Site.

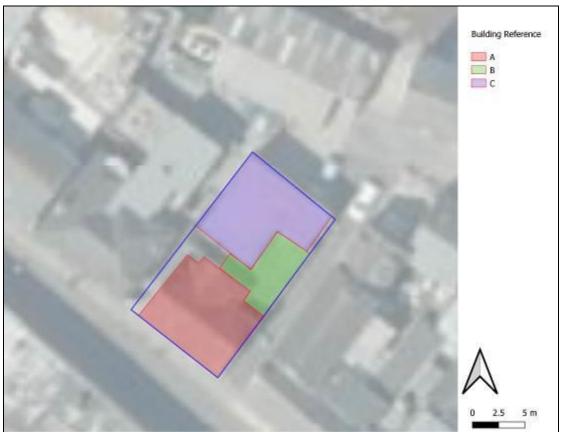
The buildings within the Site were differentiated by their construction and style for the purposes of assessing their potential to support roosting bats. These delimitations are identified in Map 04.

Map 04 – Showing the structurally distinct components of the contiguous building complex within the Site boundary (indicated by the blue line). The two-storey pitched-roof component (A) is shown in red; the single-storey pitched-roof component (B) is shown in green; and the two-storey flat-roof component (C) is shown in lilac. Reproduced in accordance with Google's Fair Use Policy.
