## PERMISSION FOR DEVELOPMENT

Application P/23/019/FUL No:

- Applicant: Mrs Lesley Jones 1 Porthcressa Terrace Hugh Town St Mary's Isles Of Scilly TR21 0JW
- Site address:1 Porthcressa Terrace Hugh Town St Mary's Isles Of Scilly TR21 0JWProposal:Replacement of existing scantle roof covering to the main elevation and dormers<br/>at the rear of the property and the adjoining property (2 Porthcressa Terrace)<br/>using dry laid natural slate.

# PRELIMINARY ROOST ASSESSMENT (PRA)

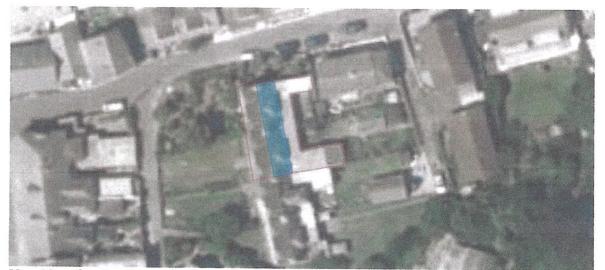
Map 02 – Showing the roof to be replaced (blue) which includes the eastern pitch of both 1 and 2 Porthcressa Terrace. The footprint of the properties are indicated with the red line for reference – the building structures to the east are single-storey flat-roof components whilst to the west is the western pitch of the main roof.
