ECOLOGICAL ASSESSMENT

COOTAMUNDRA, MCFARLANDS DOWN, ST MARY'S, ISLES OF SCILLY

Report date: 23rd April 2023

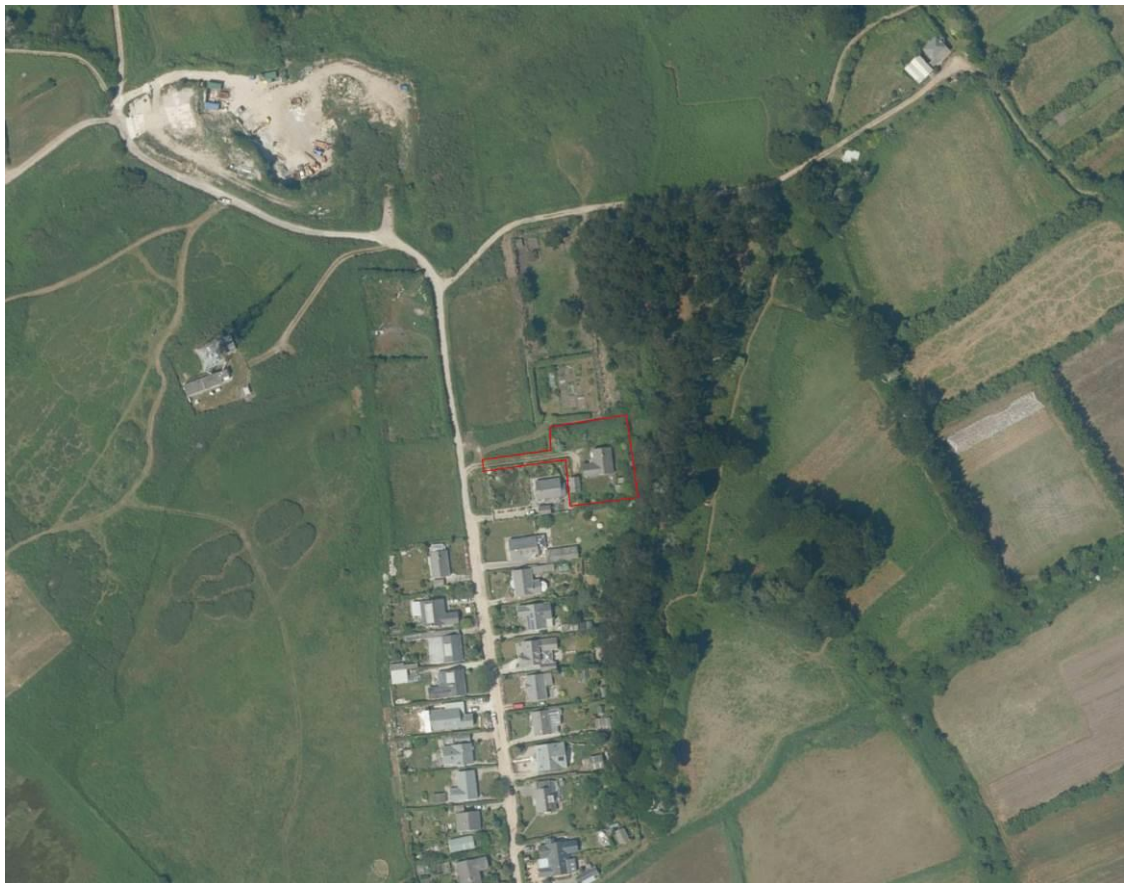
Map 02 – Showing the landscape and habitats immediately surrounding the site (indicated in red). Reproduced in accordance with Google's Fair Use Policy.

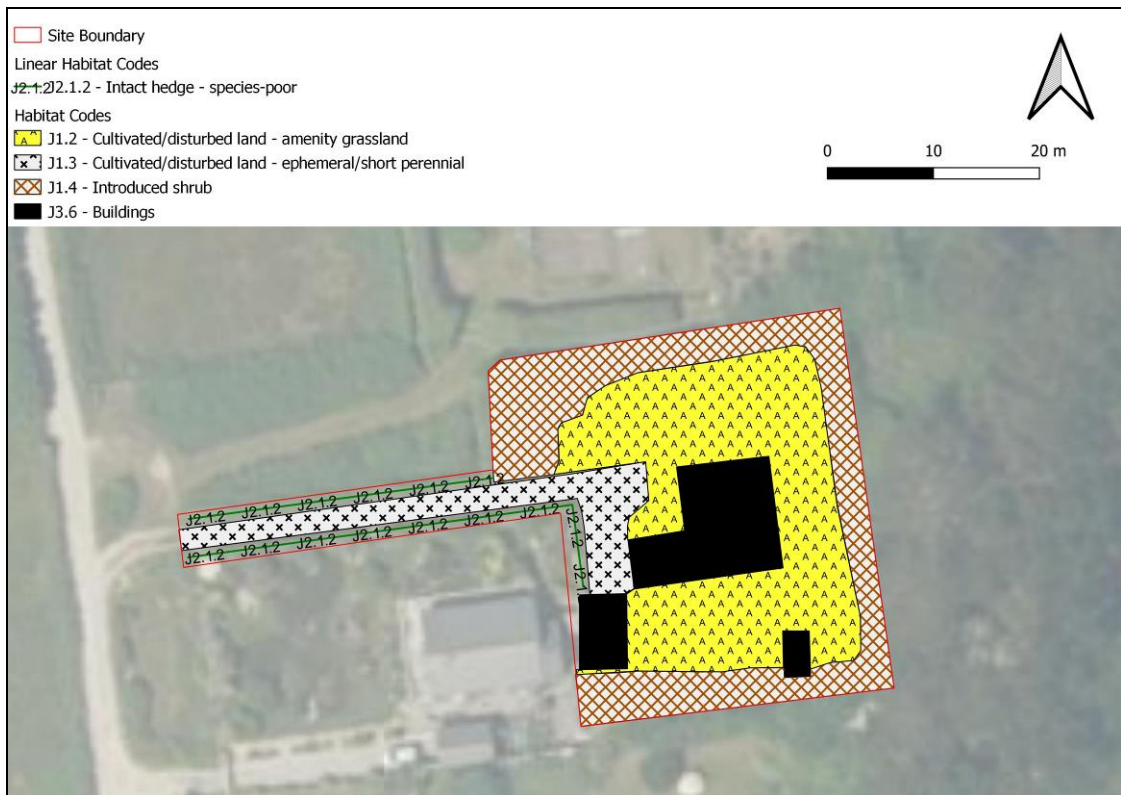
Map 03 – Showing the broad Phase 1 Habitat designations associated with the Site. Base map reproduced in accordance with Google’s Fair Use Policy.

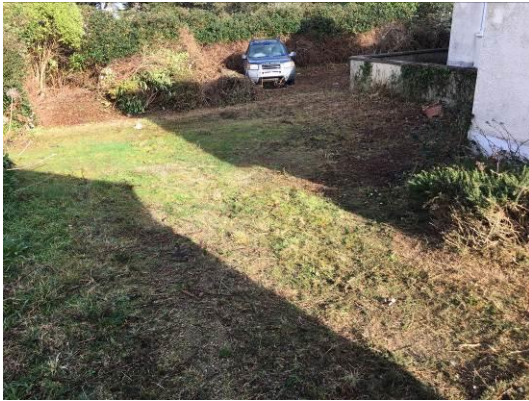
Photo 03 – Showing the area of compacted gravel which has been colonised by opportunistic ephemeral vegetation at the front of the property.

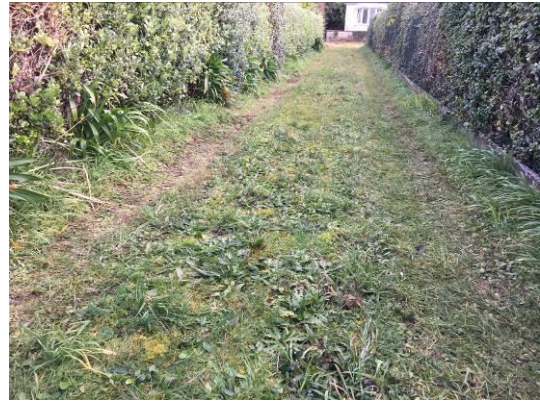
Photo 04 – Showing the ephemeral vegetation along the track which runs to the property.

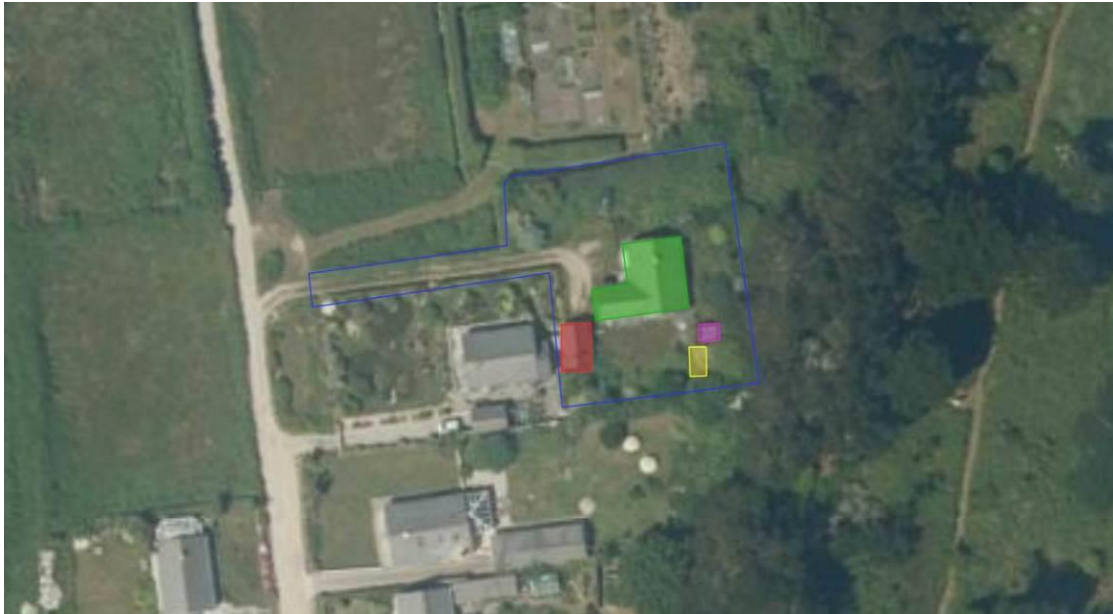
There are four distinct structures associated with the property – these are all proposed for demolition as part of the current proposals. For clarity, these buildings will be described and assessed individually. The individual components are identified in Map 04.

Map 04 – Showing the main house (green wash) within the blue line site boundary. The single-storey garage is shown in red; the oil tank shelter is shown in magenta; and the glasshouse is shown in yellow

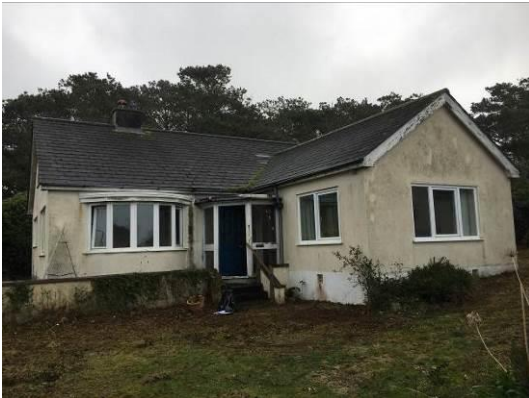
The main dwelling house is a dormer bungalow which is rendered externally in good condition. Occasional cracks are present, but these, are superficial only. The doors and windows comprise a combination of wooden and uPVC units which – whilst they are deteriorating in places – are well-fitted offering no gaps around the frames. There is a bay window and porch at the front of the property, both with flat roofs – no structural features offering roosting opportunities were noted associated with these.

Photograph 5: Showing the main existing dwelling on the site.

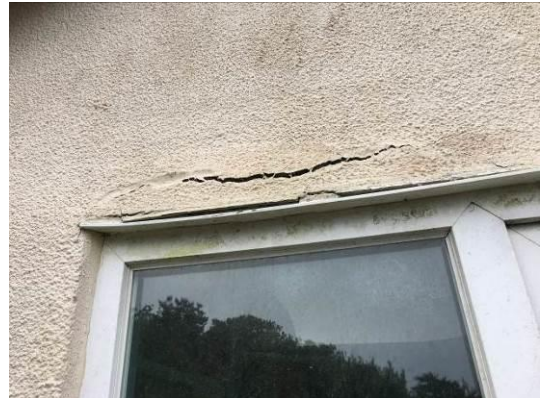
Photograph 6: Showing an example of the well-fitted window frames with no gaps or crevices. Cracks and damage in the render, as illustrated, are superficial and not suitable to support bats.

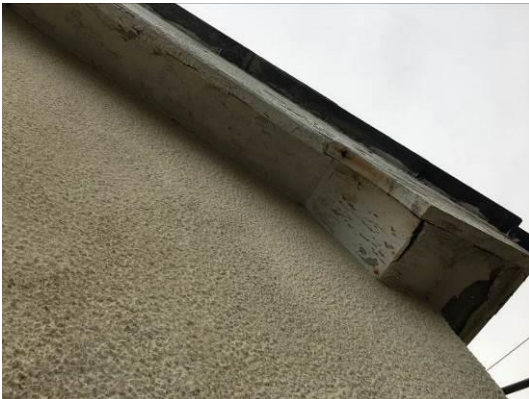
Photograph 7: Showing the good condition of the boxed soffits throughout the majority of the property.

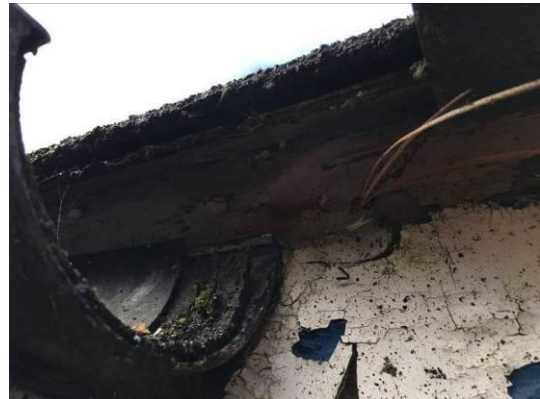
Photograph 8: Showing an example of the eaves where the guttering is displaced, demonstrating the lack of access for bats.

- Open or broken windows;
- The letterbox which appears to provide access to the nest identified in the porch;
- The gap in the soffit on the north-western corner of the dwelling house;
- The gap in the soffit on the south-western corner of the garage unit.

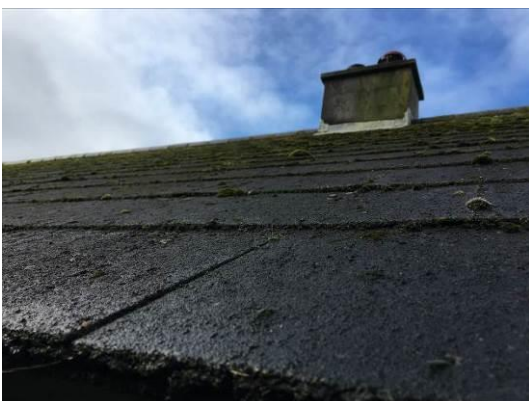
The roof is covered with slate-effect tiles which are thin but well fitted – no gaps were noted which could potentially provide a roosting opportunity for bats. There are rounded ridge tiles present – these too were well fitted with no gaps. The roof verge at the two gables were inspected and found to provide no gaps or access features; similarly the structure of the eaves permits no potential access. The valley between two roof pitches was well-sealed with no lifted flashing. The chimney is rendered and in good condition with no gaps in the flashing which joins the main roof. There are boxed soffits throughout the gables and eaves – these were all tightly fitted with the exception of a single location at the north-western corner. This would not provide access to the gable soffit due to the construction, but does support an old nest which was found during a video endoscope inspection. This entirely fills the gap along the eaves, indicating no current or recent occupation by bats. Video endoscope inspection confirms this.

Photograph 9: Showing the tight fit of the roof tiles, with no gaps noted throughout.

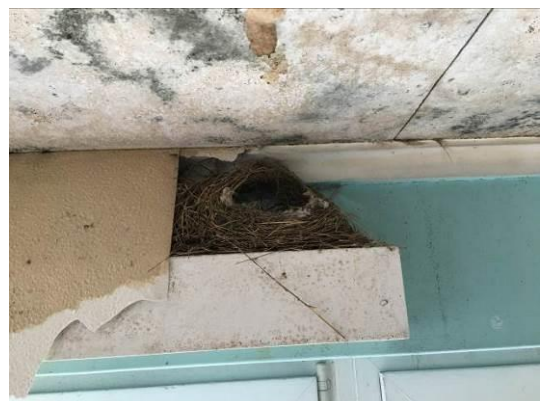
Internally, the property is in significantly poorer condition, arising from a long period without occupation and water damage caused by a leak during this time. There are occasional open or damaged windows which have permitted access for birds – a nest was located in the kitchen and another in the porch.

Photograph 10: Showing an example of one of the birds nests within the property, resulting from lack of occupation.

Works affecting all structures on site can be undertaken without constraint if completed outside of the breeding season which runs from March – September inclusive. This is also the recommended approach to any minor clearance works related to shrubs and small trees within the grounds of the property.

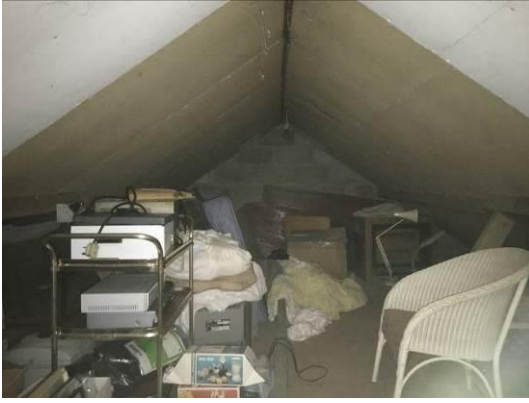
Loft spaces are present above the tie-beam of the A-frame roof timbers and also built into the eaves. The void at the apex was small and could not be accessed fully – however inspection from the loft hatch reveals well-fitted underfelting and insulation. Those voids built into the eaves were used for regular storage and were boarded out internally with insulation above. Occasional evidence of mice was noted, but a comprehensive inspection did not identify any evidence of bats.

Photograph 11: Showing the interior of one of the boarded out loft components within the property - this example is at the apex but those at the eaves are of equivalent construction.

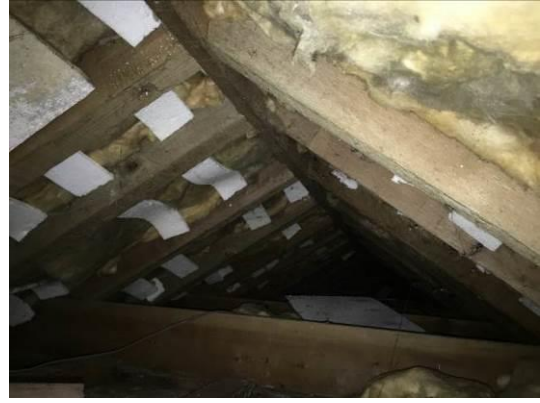
Photograph 12: Showing the main loft above the tie-beam in the main dwelling.

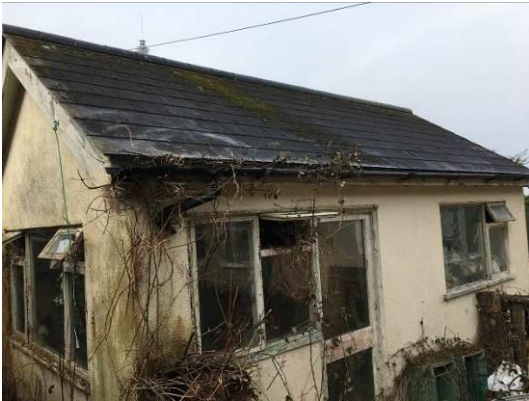
The garage unit is built using the same construction style and materials as the house – the pitched roof uses the same roof covering; the boxed soffits are equivalent; and the exterior is rendered in the same material as the house.

Photograph 13: Showing the single-storey garage.

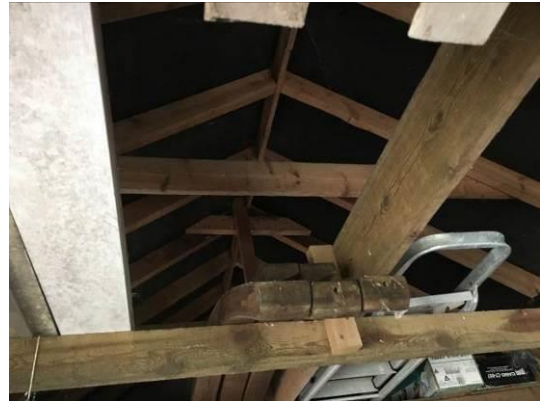
The roof is well-fitted with no gaps noted. Window and door frames are well-fitted with no gaps noted; however the windows were open in places. The internal A-frame roof timbers were well-fitted and in good condition – the terminal structures adjacent to the breeze-block walls were tightly adjoined to the wall with no gaps behind. A ridge board is present with underfelting in good condition above the timbers. A damaged soffit in the south-western corner would potentially provide access into the garage, but does not offer a roosting opportunity in its own right due to the lack of a suitable enclosed or terminal apex cavity. An inspection using a video endoscope did however identify the presence of a nest in this location. The remaining boxed soffits were in good condition with no gaps noted. There was evidence of mice in this building, but no evidence of access or occupation by bats was identified. The only potential features would be free-hanging from timbers, or use of idiosyncratic roosting features associated with stored garage items and equipment.

Photograph 14: Showing the interior of the single-storey garage with A-frame timbers and well-fitted underfelting.

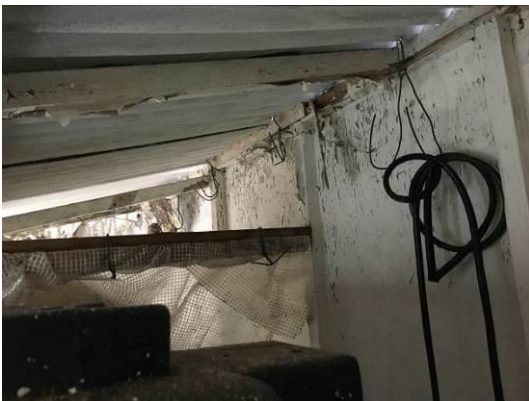
A shelter has been built around the oil tank adjacent to the glasshouse – this is a combination of ply and corrugated sheet materials around a wooden frame. An aviary is present at the eastern end of this structure. The shelter was fully inspected – no evidence of occupation by bats was noted and the structure did

Photograph 15: Showing the roof of the canopy sheltering the oil tank.

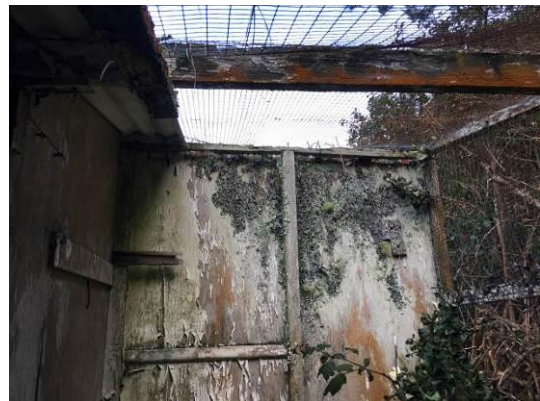
Photograph 16: Showing the aviary located at the end of the oil tank shelter.

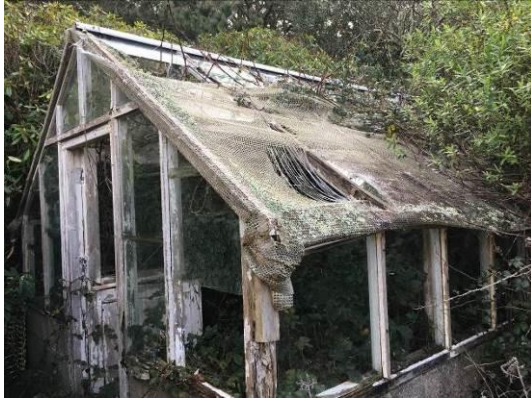
A derelict glasshouse is present in the corner of the garden – this is a timber-framed structure built onto a breeze block lower wall. The door was open and there are frequent broken panes allowing ease of internal access for birds. An old grape vine is present along the apex, with dense brambles in the base. No suitable roosting opportunities for bats were noted associated with this structure.

Photograph 17: Showing the glasshouse.

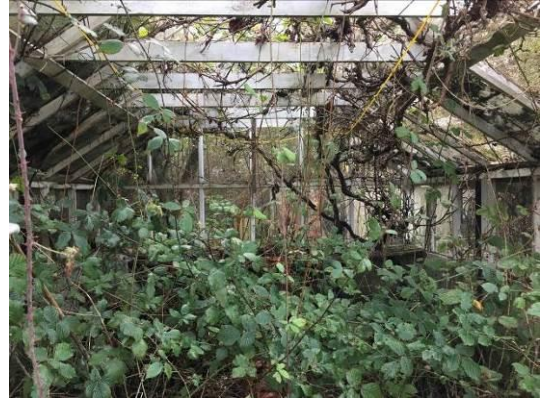
Photograph 18: Showing the interior of the glasshouse with overgrown grape vine and brambles.
