# ECOLOGICAL ASSESSMENT JULY 2023 UPDATE

## TOWN HALL, ST MARY'S, ISLES OF SCILLY

*Report date: 11<sup>th</sup> July 2023*

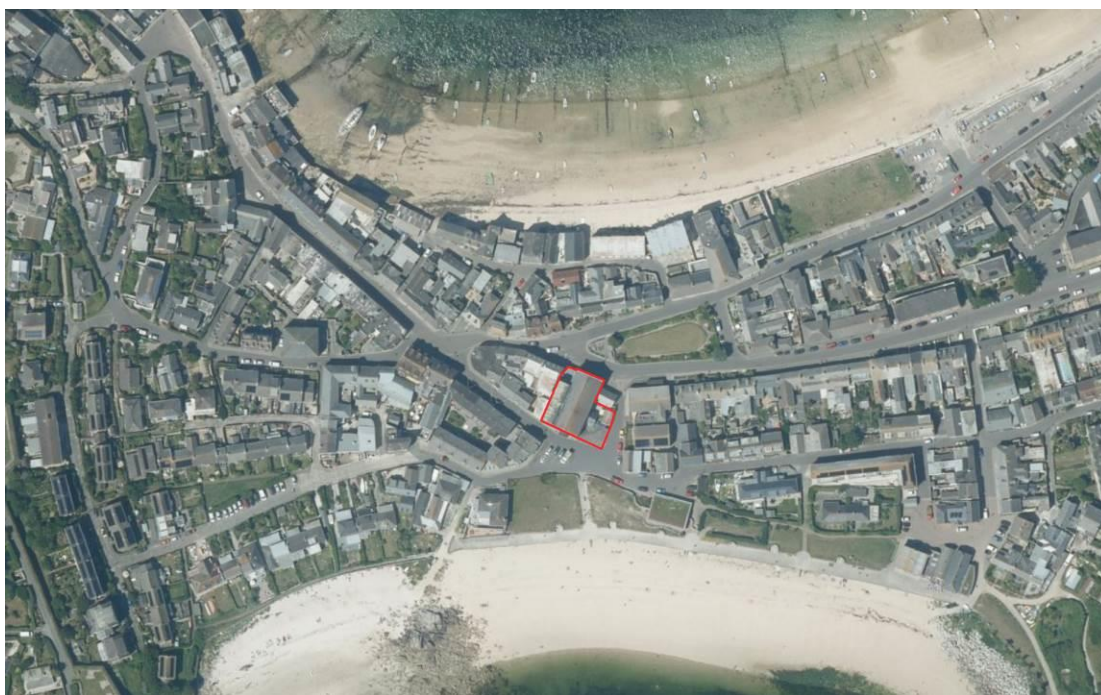
**Map 02** – Showing the landscape and habitats immediately surrounding the site. Reproduced in accordance with Google’s Fair Use Policy.

Roads immediately bound the Site to the north and south. The eastern boundary has an attached cottage with a small outbuilding along with a tarmacked parking area. The buildings of Spanish Ledge and others directly abut the Site along its western aspect.

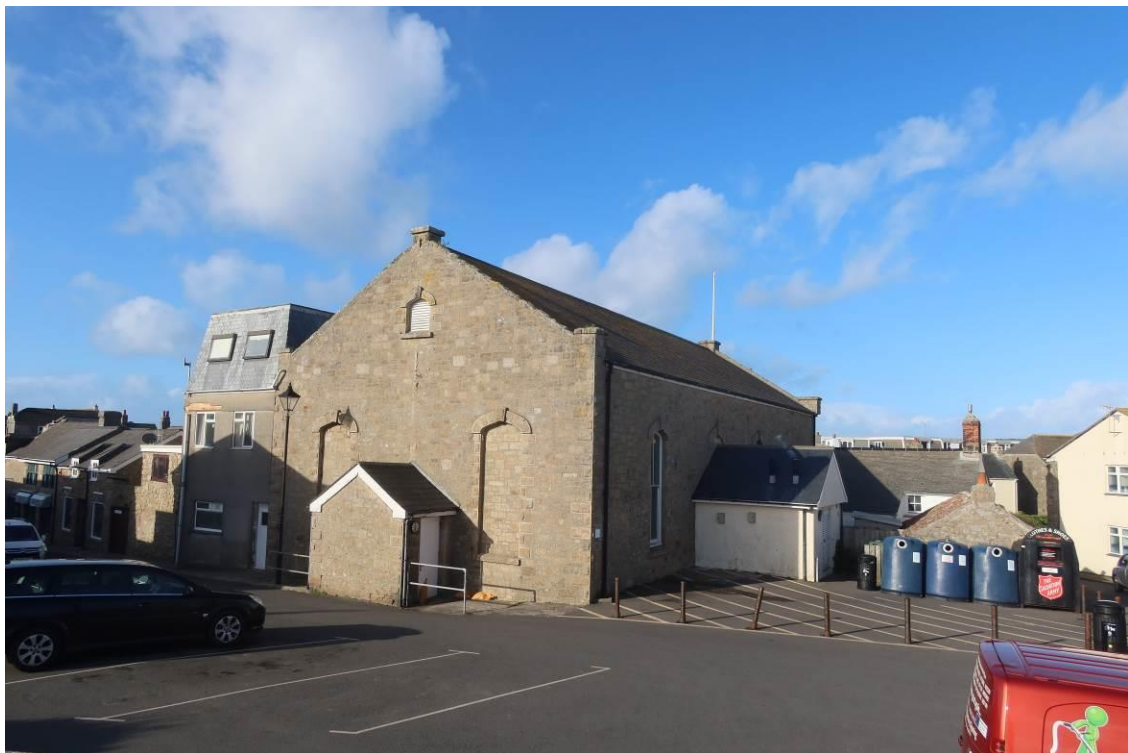
**Photo 01** – Showing the main town hall building with the plant room to the right; the rear porch and the more modern extension to the left. The cottage and stone shed can be seen behind the glass collection point to the right of the photograph. The area of hardstanding included in the proposed development is the hatched area enclosed by bollards visible to the right.

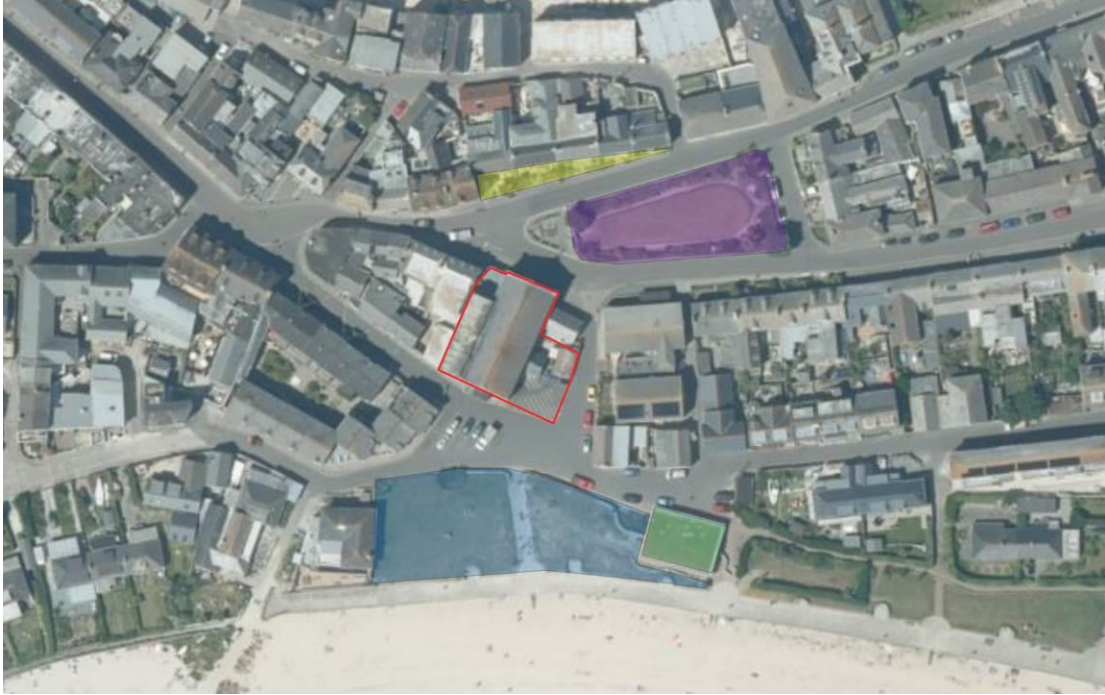
**Map 03** - Showing the Site indicated with the red line in relation to proximate offsite habitats including Parade Gardens (purple wash); ornamental planting along Parade (yellow wash); the lawns and ornamental planting along Porthcressa (blue wash) and the sedum-roofed Tourist Information building (green wash).

This is an area of closely-mown lawn which is popular with visitors due to its proximity to Porthcressa and the TIC. The species composition reflects its coastal location but it is highly managed and subject to high levels of visitor pressure. Its ecological functionality of relevance to this assessment is likely to be limited to pollinator resource during the summer season.

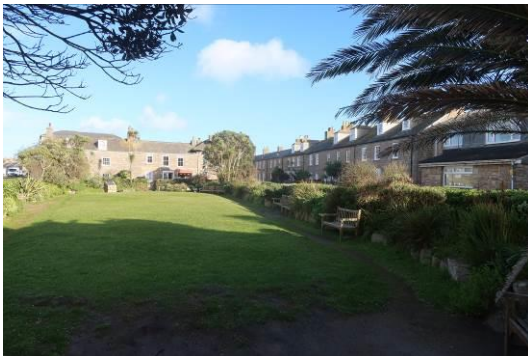
This is an area dominated by amenity grassland lawn with ornamental, predominantly non-native planting around the peripheries. It is highly managed and largely municipal in character; however it will provide limited resource for pollinators and foraging habitat for common bird species.

**Photo 02** - Showing the Parade Gardens

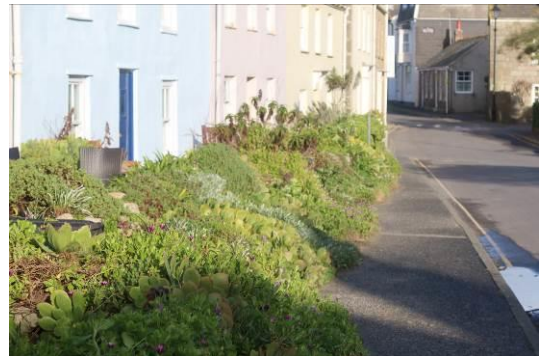
To the north of the Site is an area of attractive, sprawling ornamental planting growing along a wall and creeping across into the garden and pavement. This is likely to provide limited ecological value due to its small size and relative isolation from other habitats; however the abundance of flowers will provide resource for pollinators.

**Photo 03** - Showing the ornamental planting along the north side of The Parade.

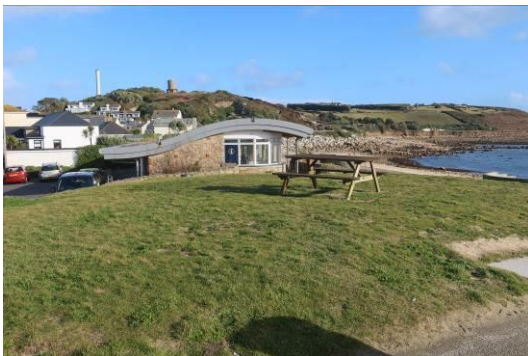
**Photo 04** - Showing the lawn with picnic benches along Porthcressa.

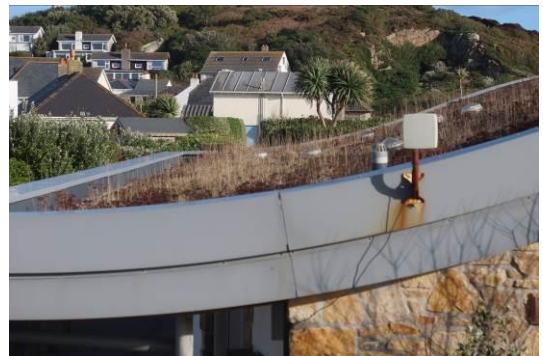
The Tourist Information Centre (TIC) was completed in 2013 with a sloping sedum roof. The range of species growing here will provide pollinator resource during the flowering season.

**Photo 05** - Showing the sedum roof of the Tourist Information Centre.
