BAT PRESENCE/ABSENCE SURVEYS (PAS) JULY 2023 UPDATE

TOWN HALL, ST MARY'S, ISLES OF SCILLY

Client: Council of the Isles of Scilly

Planning reference: P/22/033/COU

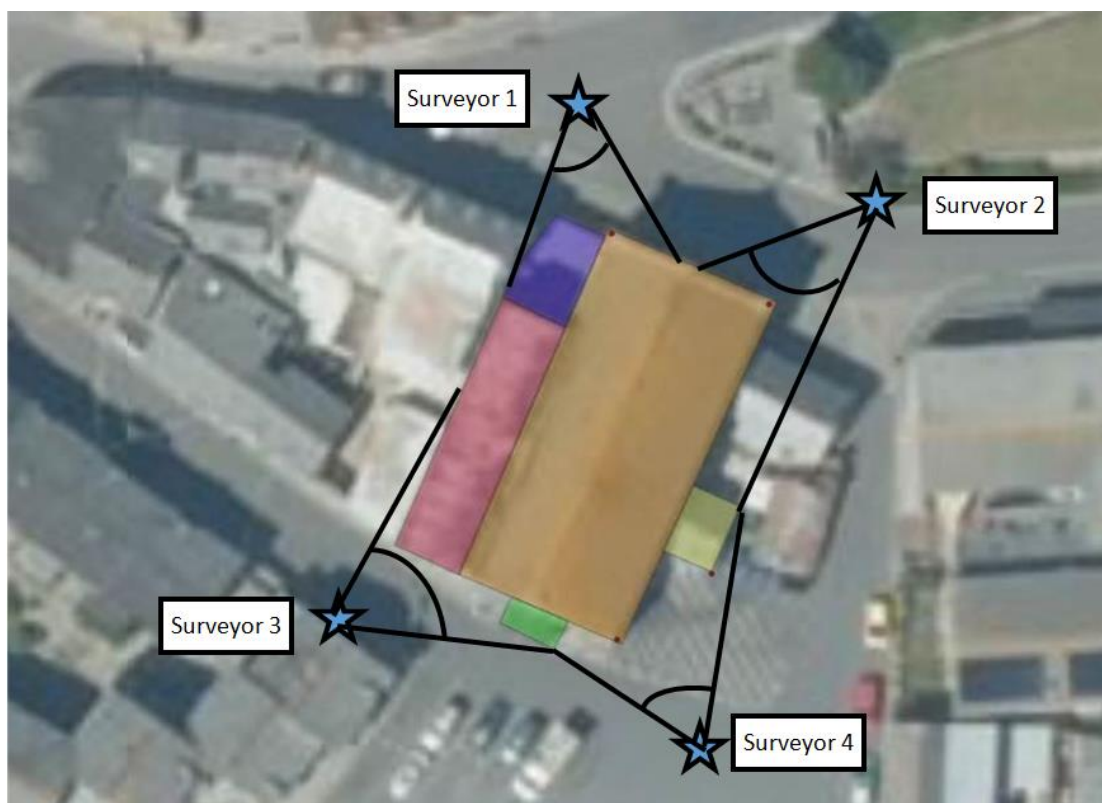
In order to ensure that the different elements of the building received a survey effort in line with the Best Practice Guidance appropriate to their potential (as identified in the PRA survey) four surveyor positions were identified in 2022. These are identified in Map 01 below.

Map 01 – showing surveyor positions around the building. The different elements of the building are identified by different colours - the main hall (orange), 1970's extension (pink); front porch (purple); rear porch (green) and plant room (yellow).

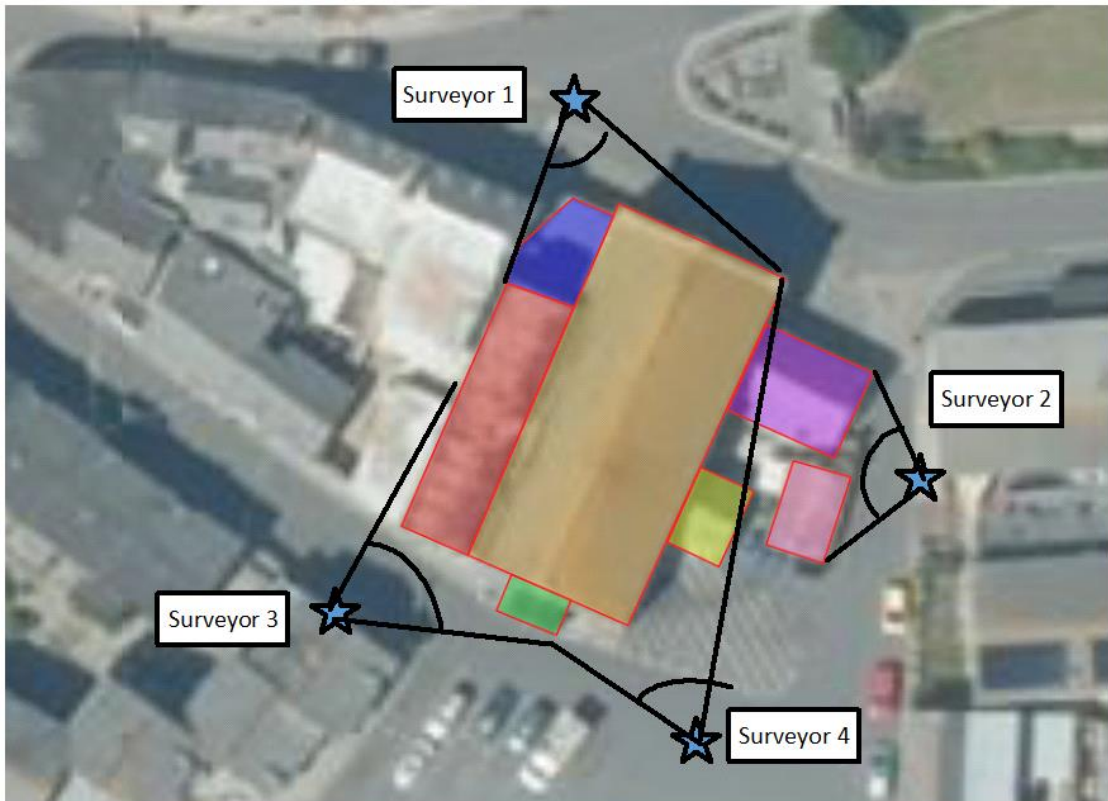
In order to ensure that the different elements of the building received a survey effort in line with the Best Practice Guidance appropriate to their potential (as identified in the PRA survey) four surveyor positions were identified in 2023. The arrangement was varied from 2022 in order to explicitly include the cottage and stone barn which were functionally included through sight lines in 2022. These are identified in Map 02 below.

Map 02 – showing surveyor positions around the building. The different elements of the building are identified by different colours - the main hall (orange), 1970's extension (red); front porch (blue); rear porch (green), plant room (yellow), cottage (dark purple) and stone shed (light pink).
