PERMISSION FOR DEVELOPMENT

Site address: Camelia Holy Vale St Mary's Isles of Scilly TR21 0NT
Proposal: Installation of 3 velux type roof lights in south facing roof.

PROPOSED INSTALLATION OF 3NO. CONSERVATION ROOF LIGHTS

CAMELIA COTTAGE, HOLY VALE, ST MARY'S, ISLES OF SCILLY

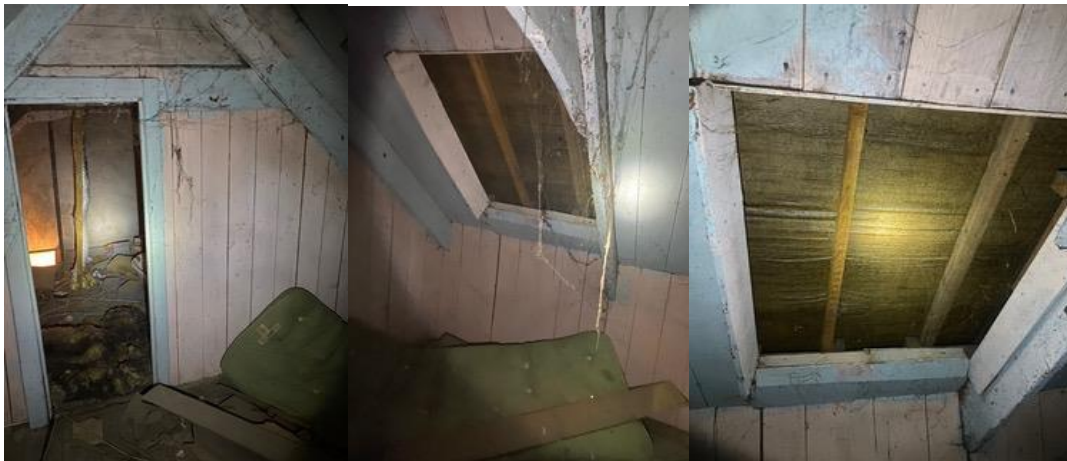
Photos of existing roofed over windows to be re-instated with Velux style roof lights

This application is to install three roof lights into the slate roof reinstating natural light to the second floor. Camelia Cottage is part of a granite terraced building at the rear and to the west of Holy Vale Farm house and adjacent to the recently converted Holy Vale Barns and Greenhouse which have also utilised conservation roof lights in their conversion from agricultural buildings. The roof windows will be flush with the slope of the roof, are black framed and designed to be in keeping with the style of the slate terraced roof in a similar way to the west facing roof light on the adjoining slate roofed property to the east of Camelia. The roof lights are proposed to restore natural light to a second floor which has evidence of previous dormers that were subsequently roofed over during a re-roofing believed to have been over 40 years ago.

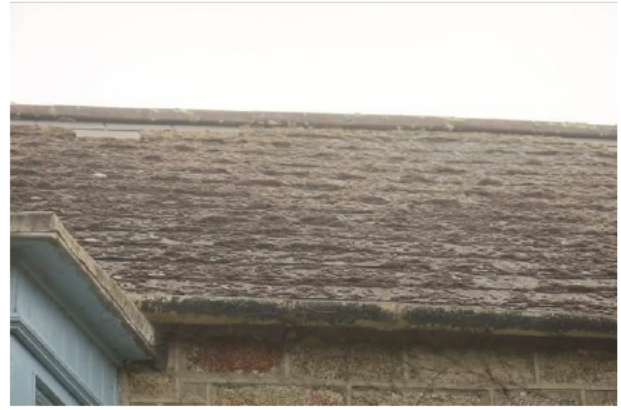
Photograph 2: Showing the tight fit of the roof tiles and abundant moss. The guttering attachment directly to the wall, without soffit or fascia, can also be seen.

Externally, the roof is in good condition with few gaps between roof or ridge tiles. There is abundant moss on the southern pitch which further acts to seal any minor gaps which may occur. No fascias or soffits are present – the guttering is attached directly to the granite wall at a height which would restrict a direct fly-in for roosting bats but would nonetheless permit access. The proximity to a tree with a large canopy would provide a covered/vegetated access point.

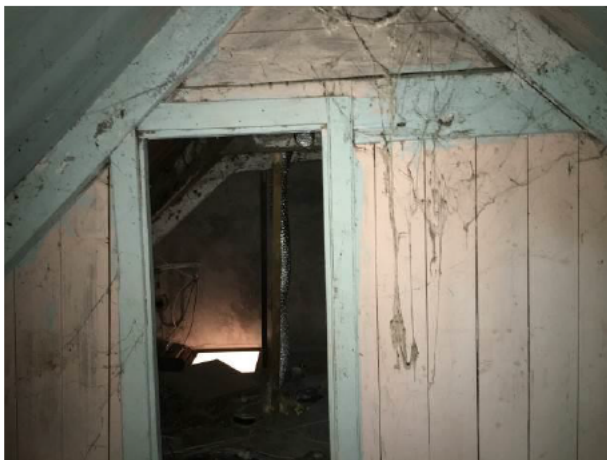
Photograph 3: Showing the timbers which underboard the loft space and also create an internal partition.

The loft space is under-boarded and clad loosely with timbers in a poor structural condition. In places this restricts visibility of the ridge and roof especially towards the apex, though a void above the cladding is present. Roofing felt is present throughout, though in variable condition. There is evidence of redundant dormers and roof-lights within the timber roof structure, though these have been boarded out and removed from the standard pitched roof – it is understood that this was undertaken as part of a previous re-roofing and reformatting project. There is little or no insulation present. The space has evidently been used as living space in the past but was dusty and dirty at the time of survey with no use for storage or other purposes. No gaps suitable to provide roosting opportunities were noted between timbers though occasional minor cavities may occur – there is potential for bats to free-hang from timbers. The irregular nature of the roof and the inclusion of the redundant exterior wall, capped chimney and roof pitch precluded comprehensive access for inspection.

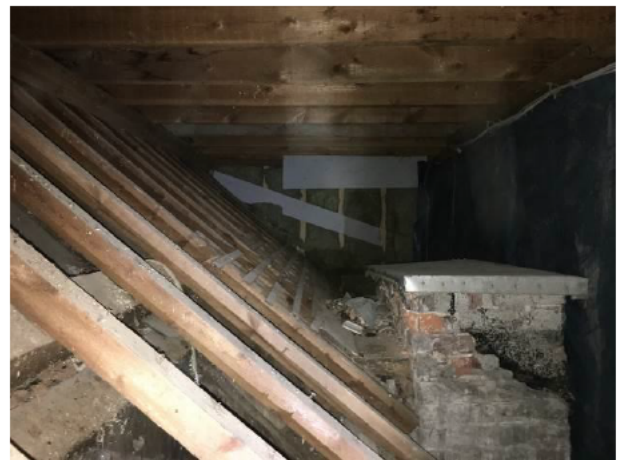
Photograph 4: Showing the redundant northern roof structure sealed within the flat-roof extension on the northern aspect of the building. Accessed and visible from the loft space of the property.

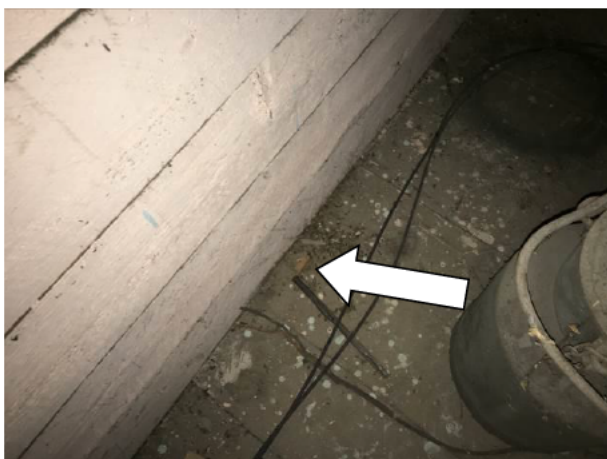
Photograph 5: Showing the accumulation of droppings – primarily rat and mouse with individual droppings characteristic of brown long-eared bat – at the western end of the loft space. The confirmed bat dropping was identified suspended in a cobweb immediately above this.

A small number of individual droppings were noted in the western edge of the loft space – these are largely rat and mouse though a dropping caught in a spider's web above was sent for DNA analysis and was confirmed as brown long-eared bat (see Appendix 1). The droppings were not fresh, but are likely to be from the 2023 active season. As a precautionary assessment, it is likely that at least 5-6 droppings within this location are brown long-eared bat based on this analysis, indicating an occasional day- or night-roost. However the location of the droppings is below a gap in the timber clad component of the loft and it is possible that the droppings identified may be from a larger roost concealed at the ridge, from which just a small number of dropping have fallen to a visible location and are thus apparent. For this reason, further surveys would be required to characterise the roost based on these limitations on inspection, assessment and interpretation.

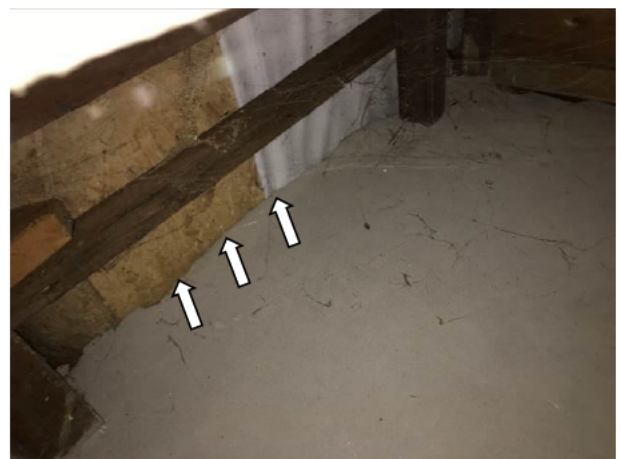
Photograph 6: Showing the concrete wall between Camelia and Magnolia Cottages with minor gaps at the top which a bat could potentially use to access between the loft spaces.

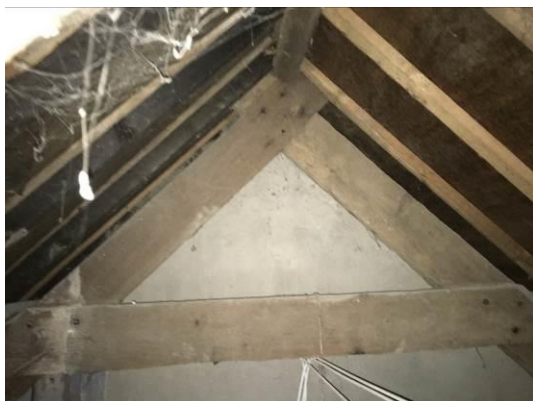
Photo 01 – Showing the terminal timber A-frame adjacent to the wall

The loft space of Magnolia Cottage is similar in structure to that of Camelia Cottage, though it does not have the relic northern pitch enclosed within the loft as there is not a flat-roof building tied into this property. There are stone block walls at the gable and up to the eaves, except for the party wall to Camelia Cottage which is breeze block with a concrete render. The roof is supported by timber trusses in good condition with no gaps noted between the timbers and the roof is under-felted throughout.

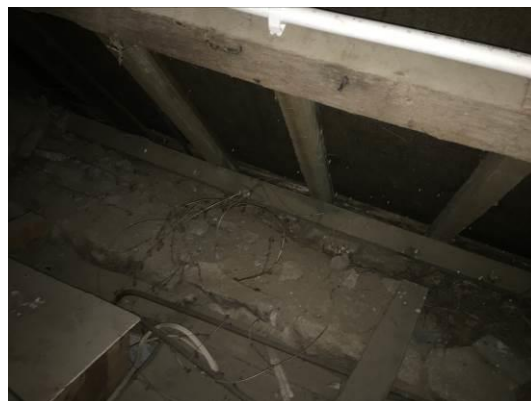
Photo 02 – Showing the eaves of the loft space

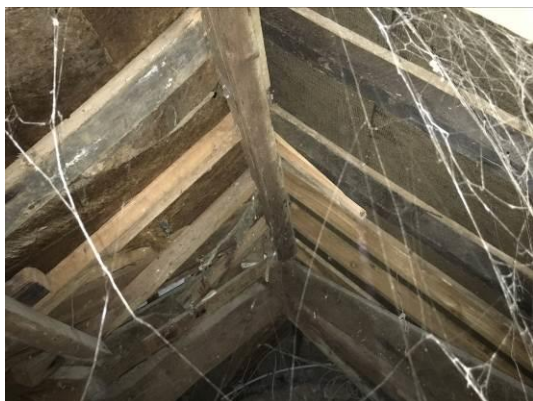
Photo 03 – Showing the timber roof structure with underfelting above

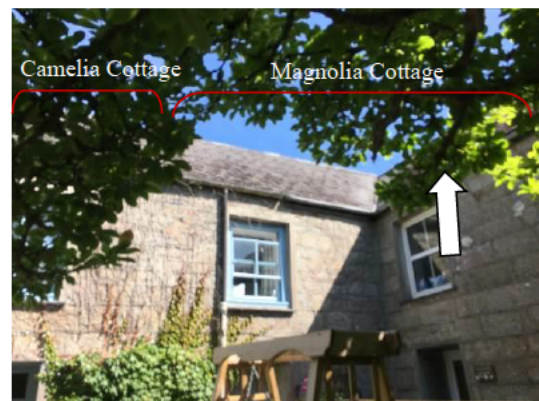
Photo 06 – Showing the approximate location where the bat access tile would be installed in the western pitch of Magnolia Cottage (white arrow).
