BAT PRESENCE/ABSENCE SURVEYS (PAS)

CAMELIA COTTAGE, HOLY VALE, ST MARY'S, ISLES OF SCILLY

Report date: 26th July 2023

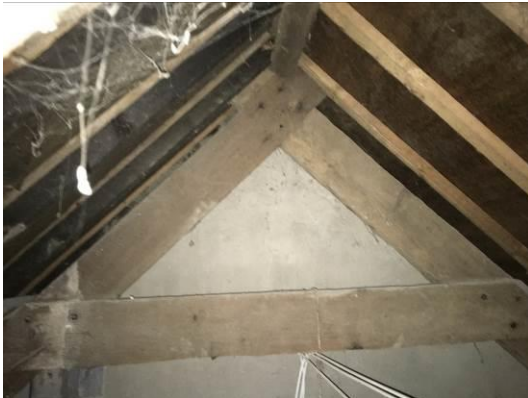
The loft space of Magnolia Cottage is similar in structure to that of Camelia Cottage, though it does not have the relic northern pitch enclosed within the loft as there is not a flat-roof building tied into this property. There are stone block walls at the gable and up to the eaves, except for the party wall to Camelia Cottage which is breeze block with a concrete render. The roof is supported by timber trusses in good condition with no gaps noted between the timbers and the roof is under-felted throughout.

Photo 01 – Showing the terminal timber A-frame adjacent to the wall

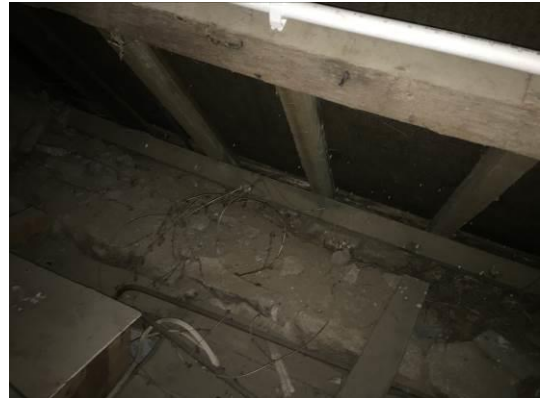
Photo 02 – Showing the eaves of the loft space

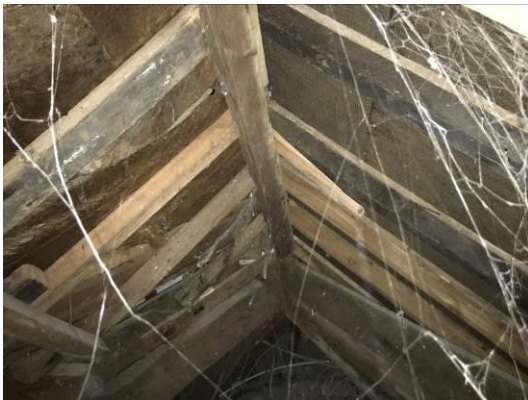
Photo 03 – Showing the timber roof structure with underfelting above

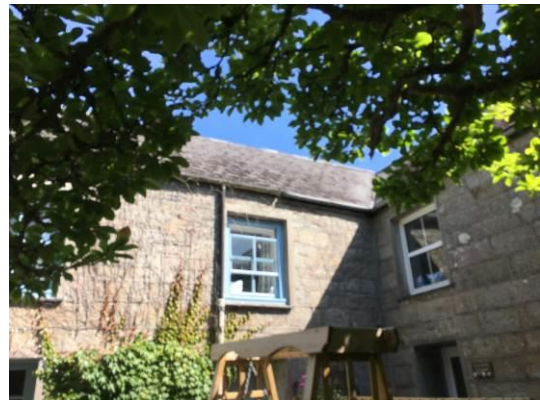
Photo 04 – Showing Magnolia Cottage from the exterior. The southern and western pitches of the roof can be seen.

The key aspect of the enhancement would be to introduce a bat access feature to the loft space. This would be on the western aspect of the roof, close to the eaves in order to secure a sheltered fly-out for bats. The Leadworx Bat Access Tile has been demonstrated to successfully provide an access to roof spaces for bats and is the preferred model. Similar products could be used subject to agreement with the LBW. A small cut in the retained roofing membrane would be required to allow bats to access the roof void through the newly created access feature. The Bat Access Tiles are designed to allow access to bats, whilst maintaining the weatherproof nature of the roof itself, thereby ensuring the roof is not compromised.

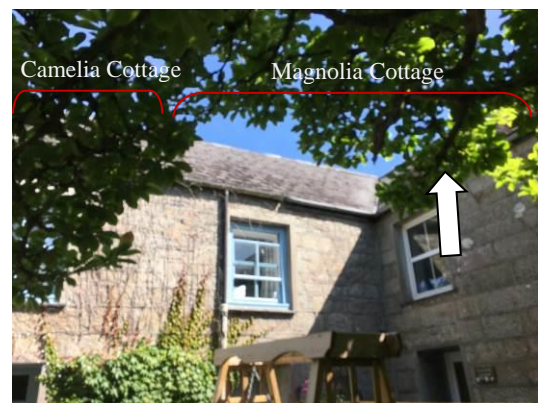
Photo 06 – Showing the approximate location where the bat access tile would be installed in the western pitch of Magnolia Cottage (white arrow).
