PRELIMINARY ROOST ASSESSMENT (PRA)

CAMELIA COTTAGE, HOLY VALE, ST MARY'S, ISLES OF SCILLY

Report date: 27th June 2023

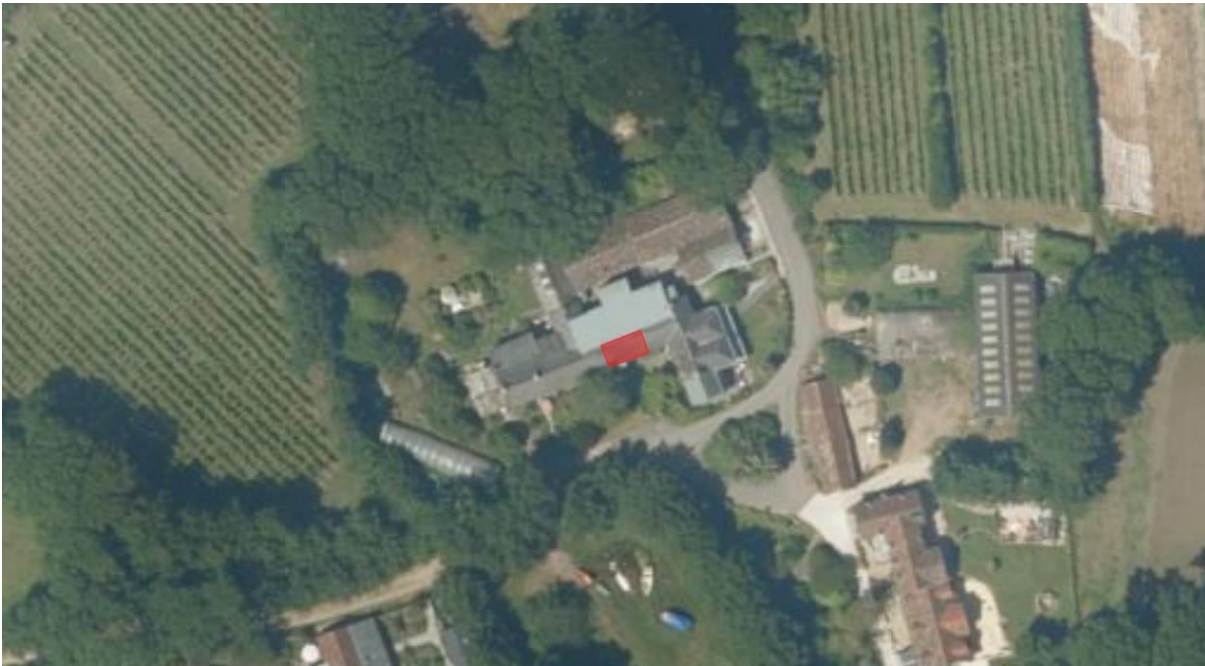
Map 02 – Showing the southern pitch of the roof (red wash) on the context of the wider building complex. The flat-roof component which occupies the northern pitch of the roof of Camelia Cottage can be seen to the north. Reproduced in accordance with Google’s Fair Use Policy.

It was not possible to inspect the flat-roof component on the northern aspect or the main pitch into which it ties due to intervening buildings under alternate ownership. No direct or indirect impacts to this structure are identified based on the proposals under consideration, though this may represent a potential access point for bats.

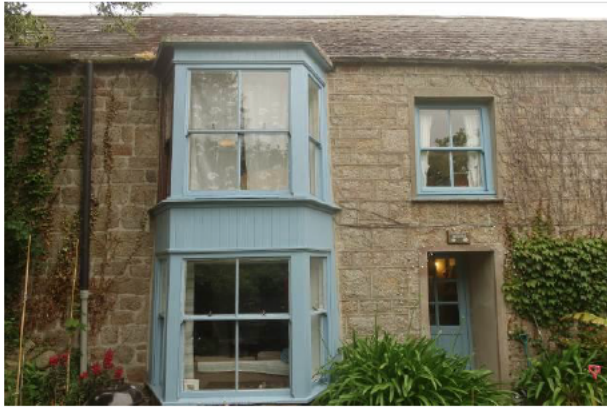
Photograph 1: Showing the front of the building with the bay windows visible.

The property is a granite-built mid-terrace cottage. There are well-fitted timber window and door frames in concrete surrounds – these did not offer gaps or other opportunities which could be used by roosting bats.

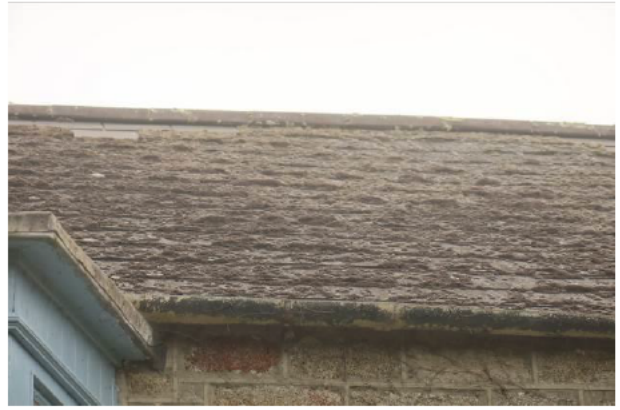
Photograph 2: Showing the tight fit of the roof tiles and abundant moss. The guttering attachment directly to the wall, without soffit or fascia, can also be seen.

Externally, the roof is in good condition with few gaps between roof or ridge tiles. There is abundant moss on the southern pitch which further acts to seal any minor gaps which may occur. No fascias or soffits are present – the guttering is attached directly to the granite wall at a height which would restrict a direct fly-in for roosting bats but would nonetheless permit access. The proximity to a tree with a large canopy would provide a covered/vegetated access point.

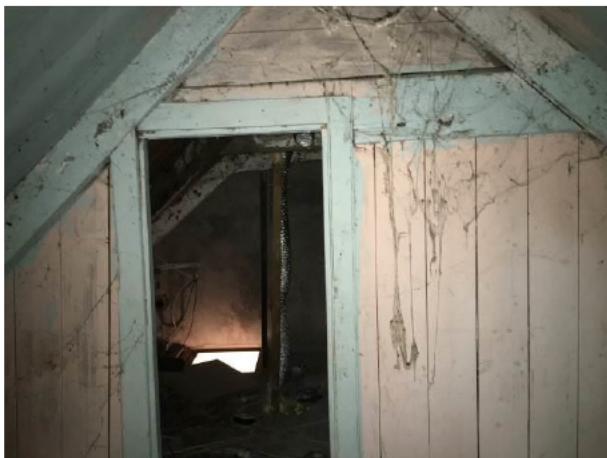
Photograph 3: Showing the timbers which underboard the loft space and also create an internal partition.

The loft space is under-boarded and clad loosely with timbers in a poor structural condition. In places this restricts visibility of the ridge and roof especially towards the apex, though a void above the cladding is present. Roofing felt is present throughout, though in variable condition. There is evidence of redundant dormers and roof-lights within the timber roof structure, though these have been boarded out and removed from the standard pitched roof – it is understood that this was undertaken as part of a previous re-roofing and reformatting project. There is little or no insulation present. The space has evidently been used as living space in the past but was dusty and dirty at the time of survey with no use for storage or other purposes. No gaps suitable to provide roosting opportunities were noted between timbers though occasional minor cavities may occur – there is potential for bats to free-hang from timbers. The irregular nature of the roof and the inclusion of the redundant exterior wall, capped chimney and roof pitch precluded comprehensive access for inspection.

The timber cladding would conceal evidence of bats roosting between the timbers and the roof structure above. The location of the confirmed dropping below a gap in the timber cladding would not preclude the possibility that the small number of droppings relate to a larger roost from which only a small proportion of droppings are apparent in the accessible space. This possibility would need to be assessed through further surveys which use alternative techniques to overcome the limitation.

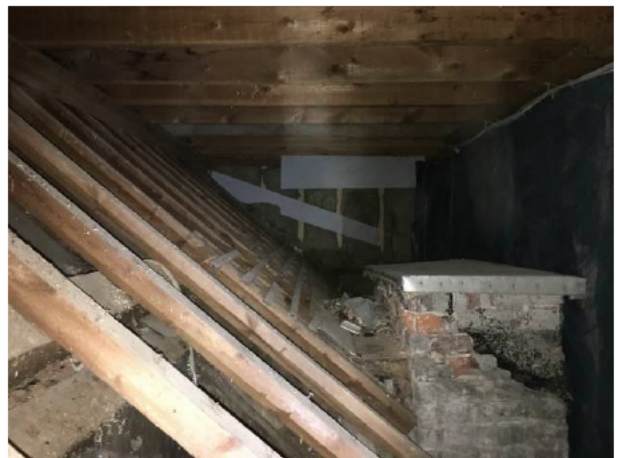
Photograph 4: Showing the redundant northern roof structure sealed within the flat-roof extension on the northern aspect of the building. Accessed and visible from the loft space of the property.

The rear of the property to the north has a flat-roof extension built into the roof which encloses the old pitch on the northern aspect. Within the loft space, the remnants of the chimney and stripped roof can be seen on this aspect. The internal rooms and living space within this flat-roof component of the building are not a part of Camelia Cottage site but part of a neighbouring property.

It was not possible to view the northern pitch of the roof due to the presence of the flat-roof extension belonging to a neighbouring property. No direct or indirect impacts to this side of the roof are proposed, so this constraint is relevant only to the potential for bats to use this aspect to access roosting locations within the loft space. The significance of this limitation will depend on the results of the further PAS surveys undertaken on the southern side of the building.

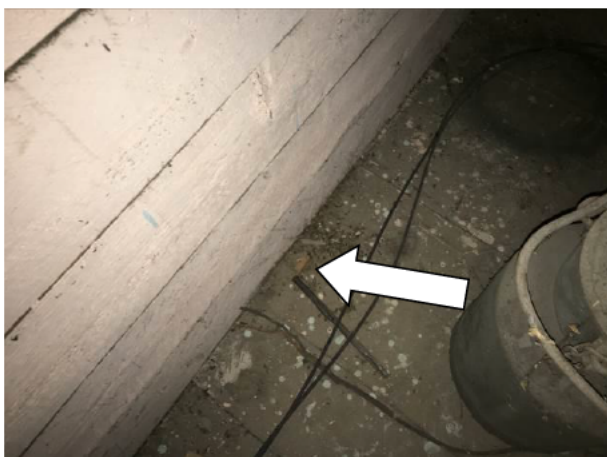
Photograph 5: Showing the accumulation of droppings – primarily rat and mouse with individual droppings characteristic of brown long-eared bat – at the western end of the loft space. The confirmed bat dropping was identified suspended in a cobweb immediately above this.

A small number of individual droppings were noted in the western edge of the loft space – these are largely rat and mouse though a dropping caught in a spider's web above was sent for DNA analysis and was confirmed as brown long-eared bat (see Appendix 1). The droppings were not fresh, but are likely to be from the 2023 active season. As a precautionary assessment, it is likely that at least 5-6 droppings within this location are brown long-eared bat based on this analysis, indicating an occasional day- or night-roost. However the location of the droppings is below a gap in the timber clad component of the loft and it is possible that the droppings identified may be from a larger roost concealed at the ridge, from which just a small number of dropping have fallen to a visible location and are thus apparent. For this reason, further surveys would be required to characterise the roost based on these limitations on inspection, assessment and interpretation.

The identification of bat droppings within the loft space confirm that brown long-eared bats have accessed the roof space.

- A static bat detector should be deployed in the loft space to determine use of the void over a period of several weeks in June. As brown long-eared bats have quiet echolocation, this approach is not comprehensive and must be deployed alongside emergence surveys but may provide valuable additional evidence upon which to base the assessment;
- A minimum of two Presence/Absence Surveys (PAS) should be undertaken to observe the building at dusk/dawn and watch for bats emerging from, or returning to, roost sites from the roof. The layout of the building would only permit this to be undertaken from the southern aspect.
- An additional inspection of the loft space in Magnolia Cottage should be undertaken, to ensure that remodelling works affecting the party wall in the loft space of Camelia Cottage do not impact upon roosting features.

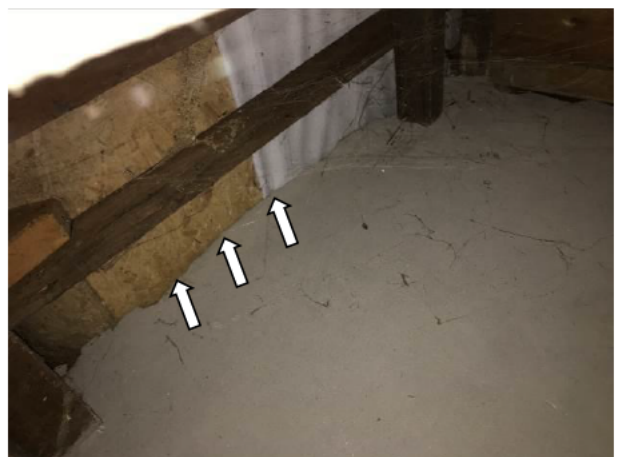
Photograph 6: Showing the concrete wall between Camelia and Magnolia Cottages with minor gaps at the top which a bat could potentially use to access between the loft spaces.

Camelia Cottage's loft and the loft spaces of the neighbouring properties on both sides. These appeared to be generally well-sealed with no direct fly-through access for bats, though minor gaps over the concrete block wall connecting to Magnolia Cottage may occur.
