PRELIMINARY ROOST ASSESSMENT (PRA)

CONSERVATORY ON OLD POST OFFICE, BRYHER, ISLES OF SCILLY

Our reference: 23-8-1

Report date: 10th September 2023

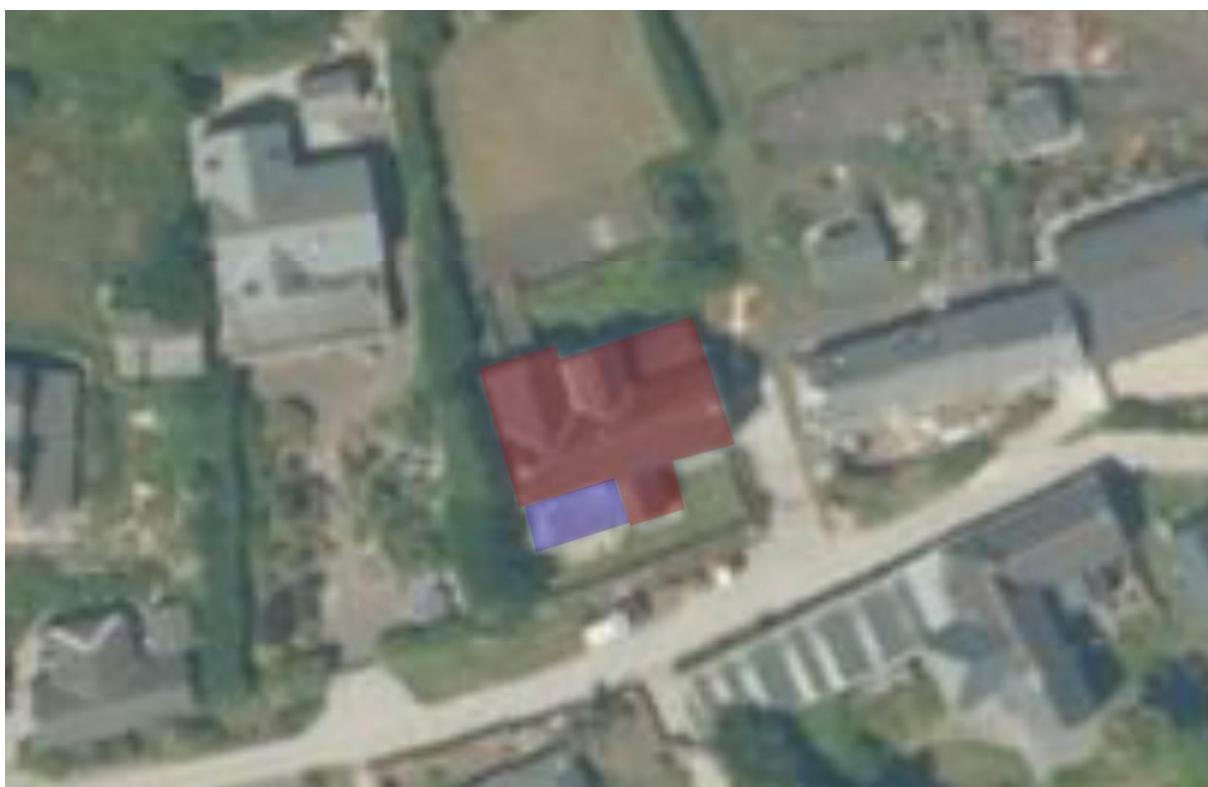
Map 02 – Showing the main residential property indicated with the red wash – the conservatory is shown in the blue wash.

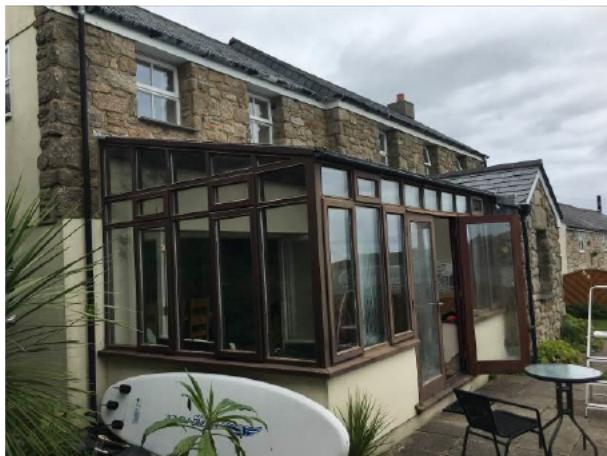
Photograph 1: Showing the conservatory attached to the main house.

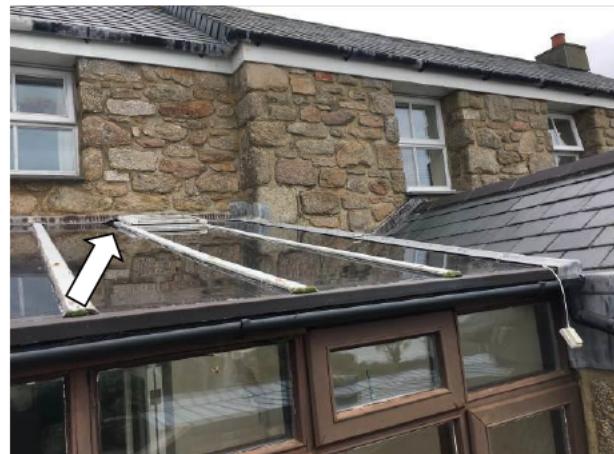
The join between the conservatory roof and the adjacent residential property on both the northern and eastern aspects are lined with flashing – these are predominantly well sealed but in locations where minor gaps could be seen, they were lapping glass and could therefore be inspected from the interior of the conservatory. No evidence of use by roosting bats was identified and the features are considered to be of negligible potential.

Photograph 2: Showing the roof of the conservatory – the flashing at the junction with the house can be seen with very minor gaps indicated.

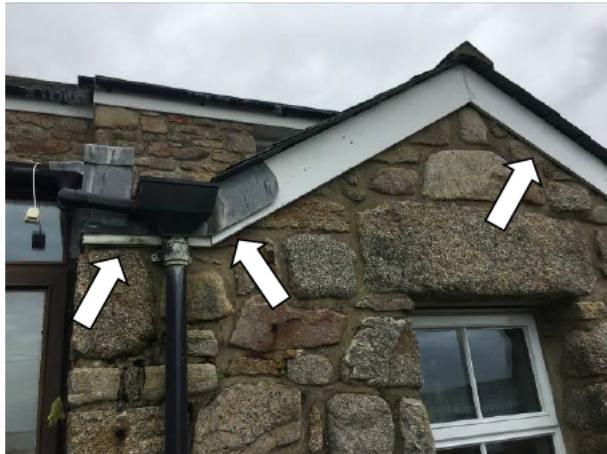
Suitable features for use by roosting bats were identified associated with gaps behind fascias both on the main two-storey building to the north, and the gable of the single-storey building to the east.

Photograph 3: Showing the proximity between the fascias on the gable of the single-storey structure (indicated) and the conservatory to the left.

Care should be taken during works to ensure that these structures are not disturbed, obstructed, or damaged. This involves careful design of scaffolding installation (if required) and may include a contractor briefing to ensure that those working on the project understand the requirement. Other measures such as a temporary sign, tape or physical barrier should be installed if deemed necessary.

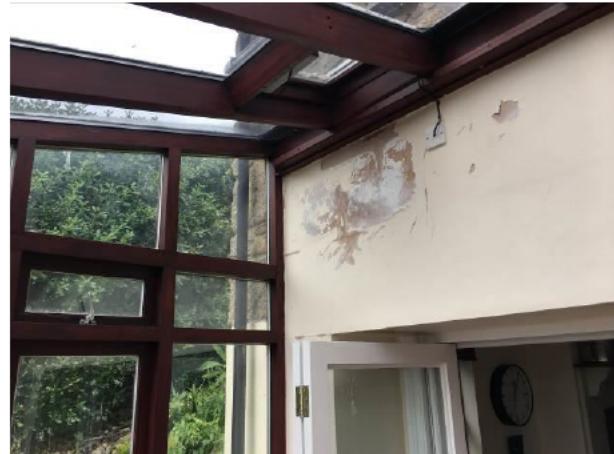
The conservatory structure itself does not offer any roosting potential, and by its nature it creates a light, airy internal space.

Photograph 4: Showing the light, airy interior of the conservatory.

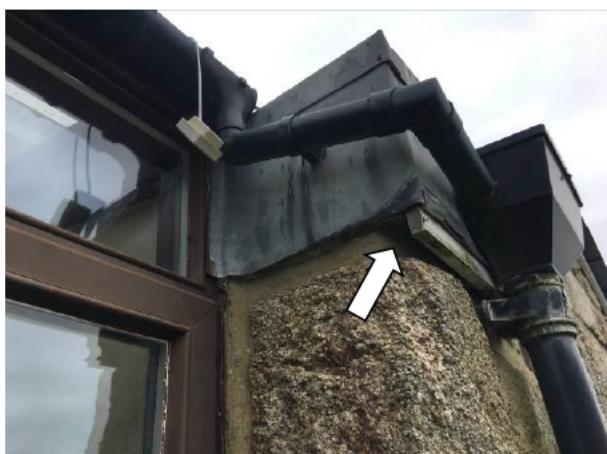
Photograph 5: Showing the gaps in the adjacent fascia and flashing on the single-storey aspect of the building.
