PRELIMINARY ROOST ASSESSMENT (PRA)

GREYSTONES, ST MARY'S, ISLES OF SCILLY

Client: Clive Humphrey

Report date: 15th December 2023

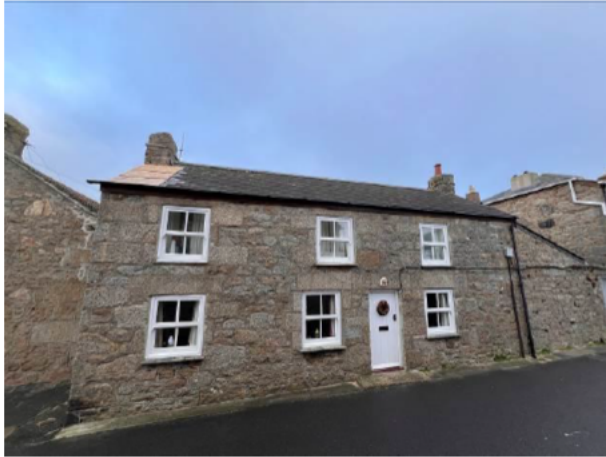
Photograph 1: Showing the property as viewed from the road to the west.

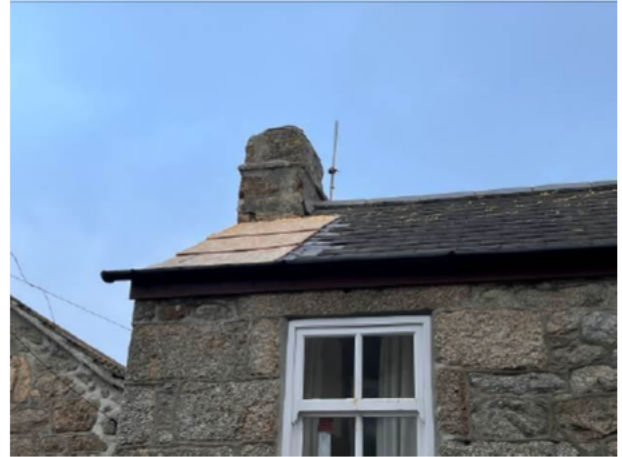
The roof of the property is dry-laid slate tile which is tightly fitted for the most part; however there is a missing section on the northern end which was damaged during a storm in late October 2023. Tiles are missing below the chimney on this aspect and a temporary repair has been made with chipboard and expanding foam. This is the only location where gaps are present beneath tiles but the recent nature of the incident would preclude all but opportunistic use of the feature by bats. The ridge tiles are tightly fitted with no gaps noted. The chimneys are well sealed at the junction with the roof tiles.

Photograph 2: Showing roof with the temporary repair to the damaged section below the northernmost chimney

The tiles immediately around the area of damage are lifted or accessible in places. In the highly unlikely event of bats finding roosting opportunities associated with this feature over the winter of 2023/4, care should be taken when removing the proximate tiles.

Tiles should be lifted away carefully by hand in such a way that, in the unlikely event of a bat being present beneath, they are not crushed or injured as a result of the action. The underside of tiles should be checked before the tile is set aside.

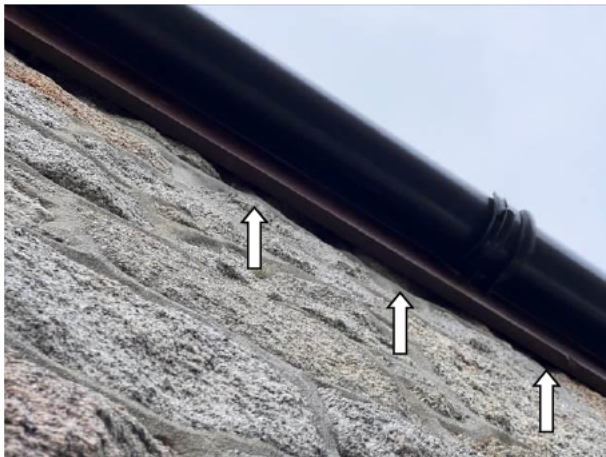
There is a fascia board running along the eaves with guttering attached – there are minor gaps behind this board where the straight plane of the wood is present alongside the irregular surface of the granite. The gaps were fully inspected with a torch and close-focussing binoculars and no bats were present at the time of survey.

There are features of **low potential** for use by roosting bats which could be indirectly affected by uncontrolled works – these are the fascia and drop tiles, although an inspection at the time of survey did not identify any evidence of occupation.

Photograph 3: Showing the fascia board with intermittent gaps behind.

The roof replacement works can approach, but must not impact upon or obstruct, these features in order for the assessment and working methodology outlined in this report to be valid.

Care should be taken during works to ensure that these structures are not disturbed, obstructed, or damaged. This involves careful design of scaffolding installation and may include a contractor briefing to ensure that those working on the roof understand the requirement. Other measures such as a temporary sign, tape or physical barrier should be installed if deemed necessary.

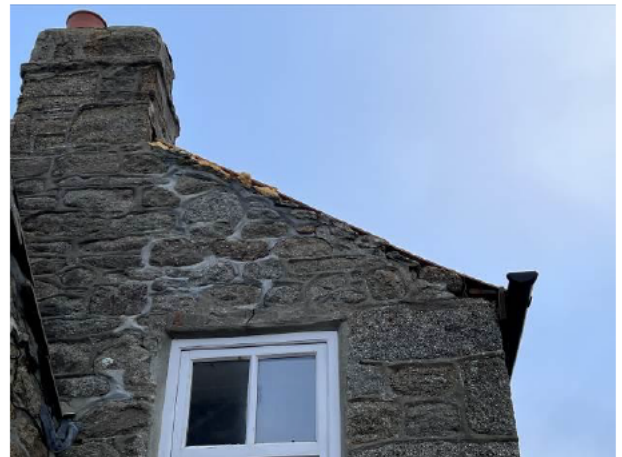
Drop tiles are present on the southern gable – these appear to have minor superficial gaps behind. The tiles are absent on the northern gable adjacent to the temporary repair.

Photograph 4: Showing the northern gable with the expanding foam associated with the temporary roof repair visible above the verge.

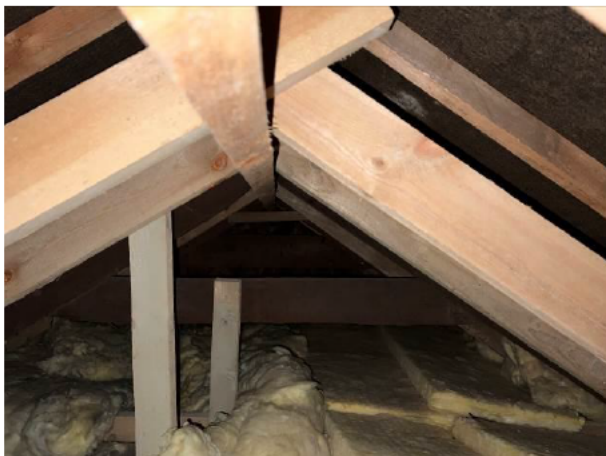
Internally, the loft space is situated above the cross-beam of the A-frame timbers which support the roof. A more modern ridge and rafter structure overlies original timbers but no gaps between loft timbers were noted. The underfelting is comprehensive and in good condition, aside from the damaged section on the northern end. Access for internal inspection was limited by the small dimensions of the space, intervening timbers and the use of the loft for routine storage. However inspection from the access hatch did not identify any droppings or other signs of bats.

Photograph 5: Showing the interior of the loft space
