DESIGN AND ACCESS STATEMENT

PROJECT: Signal Rock Stables, St Martins, TR25 0QL
DOC. NO: 236/4.01_DAS
DATE: 26th September 2023

Prepared by Koha Architects Ltd

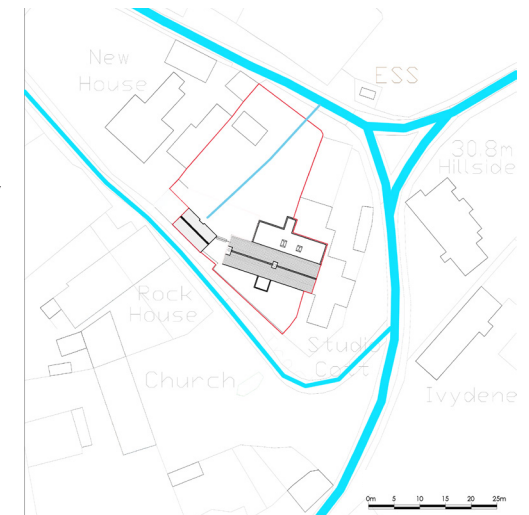
Figure: 06 Map of Signal Rock Showing Main Access Routes

As with most of the Scilly Isles, the predominant mode of transportation is pedestrian. As seen in figure: 06, the property is situated between the main access road and a small concrete track. Access to the beach, from the property is down the main road south, while access to Signal Rock Stables is via the rear garden of signal rock, accessed from a gateway onto the main road.

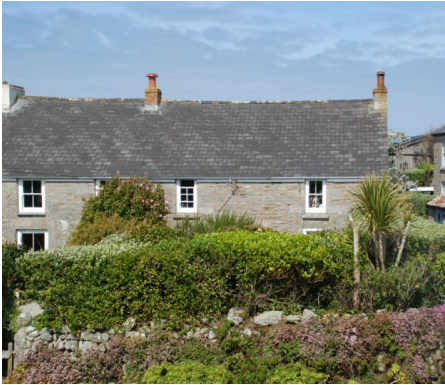
Figure: 08 Rock House

Built in c.1822, Rock House is a Traditional double fronted granite cottage, sporting, sliding sash windows, opened beamed ceilings and a large granite inglenook fireplace (figure: 08). This was first given a Grade II listing on the 14-Dec-1992 (List Entry Number: 1141208).

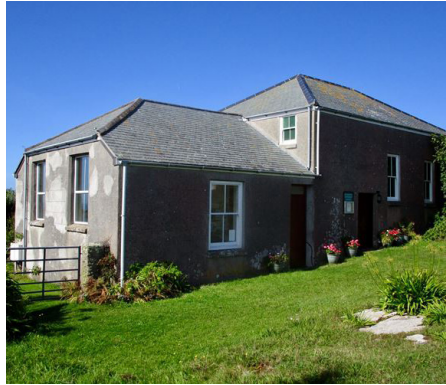
Figure: 09 Methodist Church

Built in c.1845 to serve its neighbouring property around Signal Rock. The Methodist Church is of a Stucco blocked out as ashlar over granite rubble construction, with a hipped scantle slate roof (figure: 09). This was first given a Grade II listing on the 14-Dec-1992 (List Entry Number: 1218371).

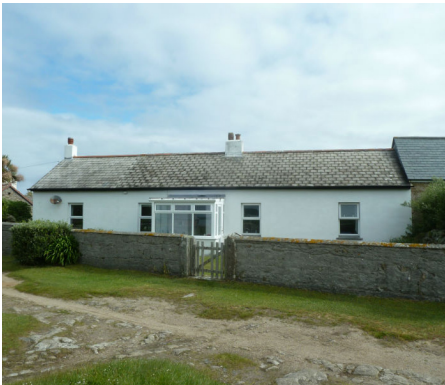
Figure: 10 Signal Rock House

Originally a two-storey granite cottage, similar to Rock House and estimated to be built around the same period, Signal Rock has had extensive modifications, alterations and extensions over its lifespan, to turn it into the large bungalow it is today (figure: 10).

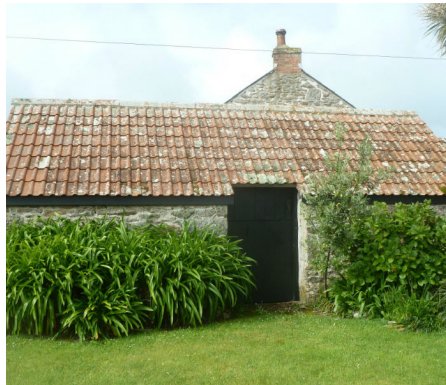
Figure: 11 Signal Rock Stables

Estimated to be built within the same period as the cluster of buildings, Signal Rock Stables was built as an out building to serve Signal Rock. Currently used to store domestic goods for the property owner. This is believed to be of the same purpose as the previous occupant for at least 20 years. (figure: 11).

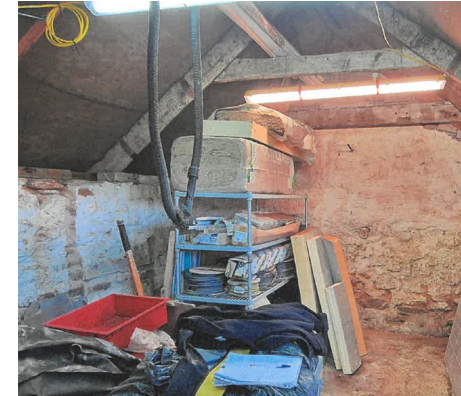
Figure: 12 Internal View Of The Roof Structure Of The Barn.

"It is fair to conclude that the roof coverings and supporting roof timbers are waterproof and in a sound condition."

(Figure: 12)

The Stables has been already connected to electricity via Signal Rock, which currently is being used for the purpose of spacial lighting, and a double socket located within the outbuilding (figure 12).

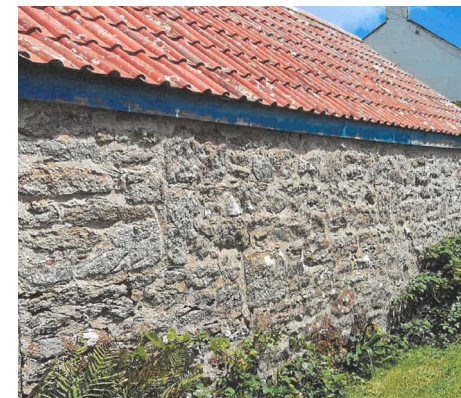
Figure: 13 External View Of Barn Wall Build-up.

"It is fair to conclude that the walls are in a sound structural condition. As stated there is no excessive bulging or cracking and no viable sign of any subsidence." *(Figure: 13)*

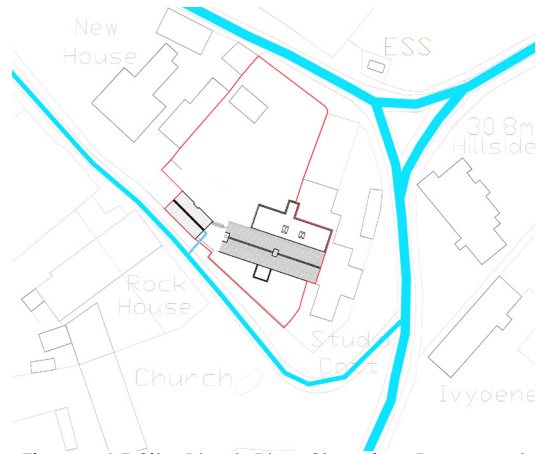
Figure: 15 Site Block Plan Showing Proposed Access Routes.

A small section on the boundary is proposed to be demolished to make provision of a pedestrian access gate. This gate will service the converted Stables, providing dedicated access, as well as distancing it from Signal Rock, reducing the chance of staff movements disturbing the occupier of the main house. Furthermore, the relocation of the gate also reduces the journey time to the beach (work location), allowing for a more efficient use of time.

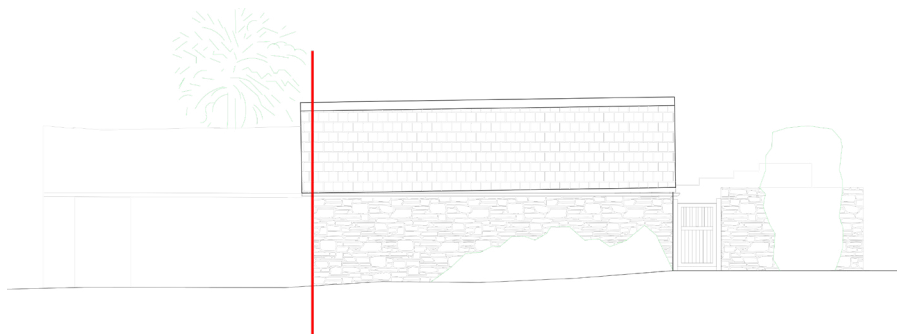
Figure: 16 Proposed Street Elevation Showing Access Gate

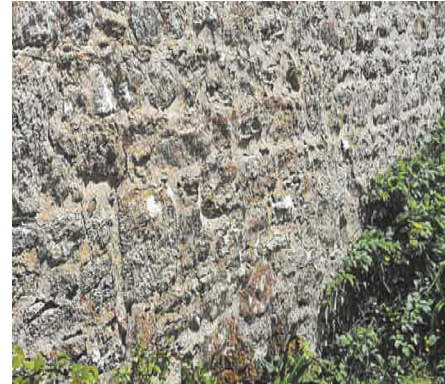
Figure: 17 Natural Stone Walls

- Walls: Natural Stone as existing
- Roof: Concrete Tiles as existing
- Guttering: Black uPVC to match adjoining barn conversion
- Glazed Door: uPVC/glass
- Windows: uPVC/glass (some with composite panel below window)
- Roof-lights: Velux in grey.

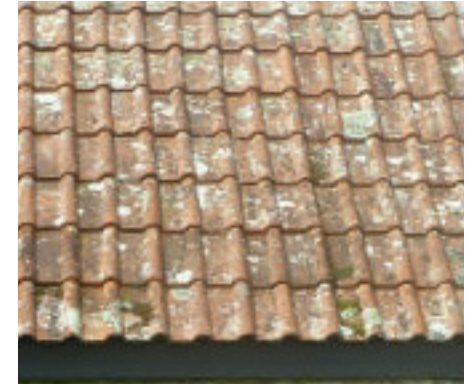
Figure: 18 Concrete Tiled Roof

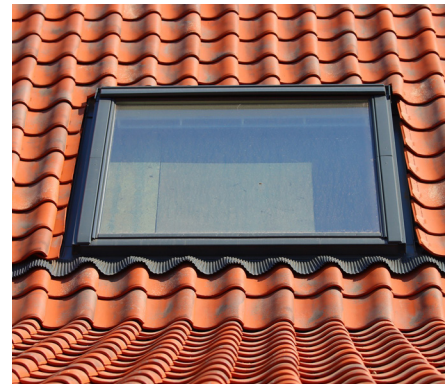
Figure: 19 Vellux Roof-lights
