BAT PRESENCE/ABSENCE SURVEYS (PAS)

SIGNAL ROCK STABLE BLOCK HIGHER TOWN, ST MARTIN'S, ISLES OF SCILLY

Report date: 23rd July 2023

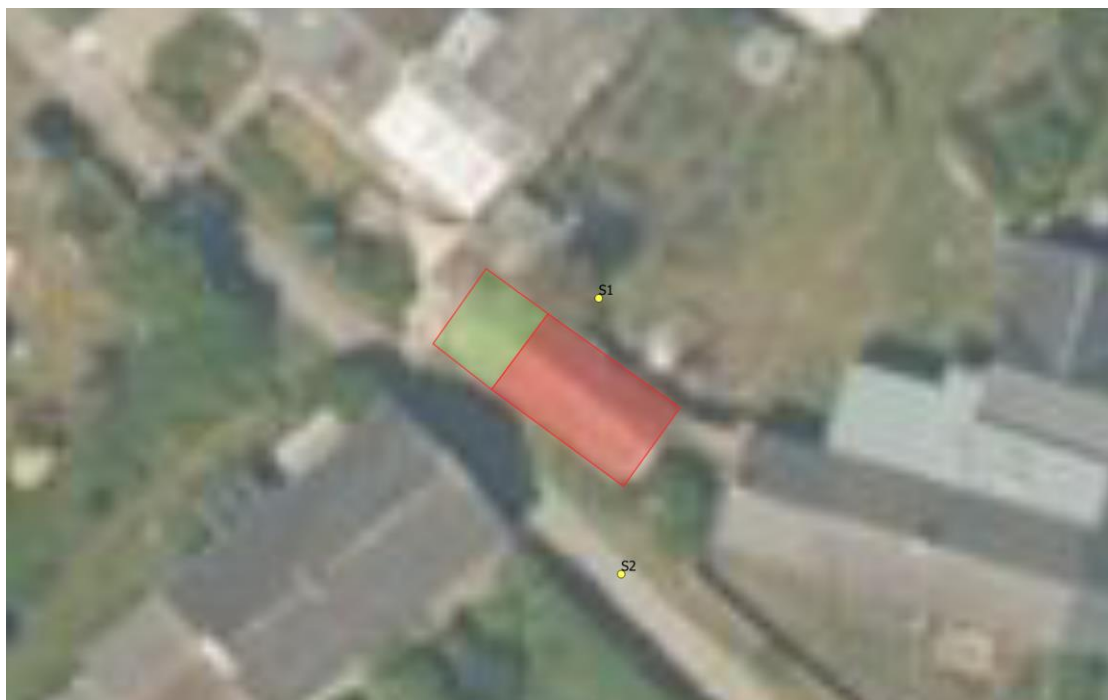
Map 01 – showing surveyor positions around the building.

In order to ensure that the different elements of the building were surveyed comprehensively in line with the Best Practice Guidance, a total of two surveyor positions were identified. These are identified in Map 01 below.

The emergence survey did not identify any emergence activity associated either with either the stable block or the offsite outbuilding attached on the north-western aspect.

The surveyor in Position S2 recorded regular foraging in lane to the south of the site from 22:03 until the end of the survey. The surveyor in position S2 recorded only occasional, brief bat passes towards the end of the survey.
