## **Bat Survey Report**

Bottom Annexe, Old Grimsby, Tresco, Isles of Scilly

15<sup>th</sup> August 2023

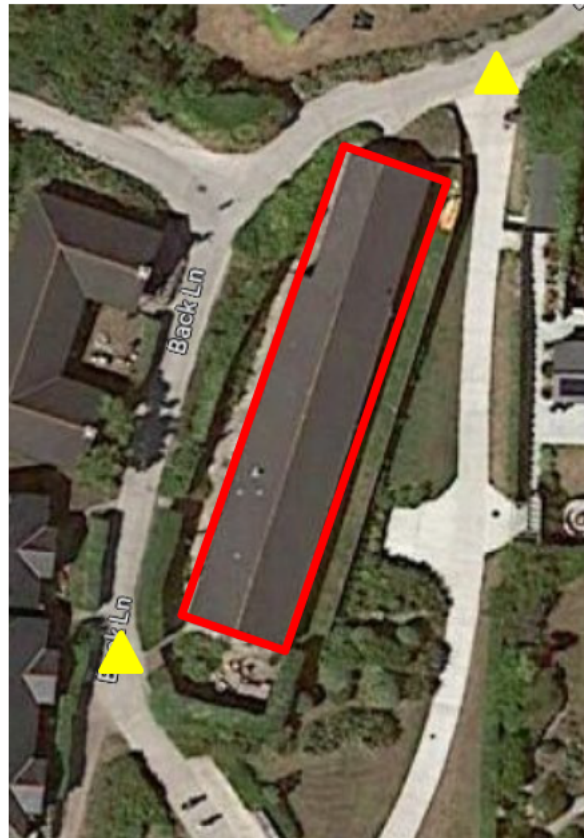
Figure 1: Emergence survey – surveyor locations. Bottom Annexe is outlined in red. Yellow triangles show surveyor locations.

Emergence surveys of the building were undertaken on 18<sup>th</sup> May and 22<sup>nd</sup> June 2023. An emergence survey involves an ecologist(s) counting the number of bats emerging from the building at dusk or dawn for a period of at least 1.75 hrs. The surveyor(s) records the calls of any bats that emerge using a bat detector and recording equipment; this enables identification of the species present and the location of bat access points. Two ecologists were required to cover all elevations of the building. Surveyor locations are shown in Fig. 1 (below).

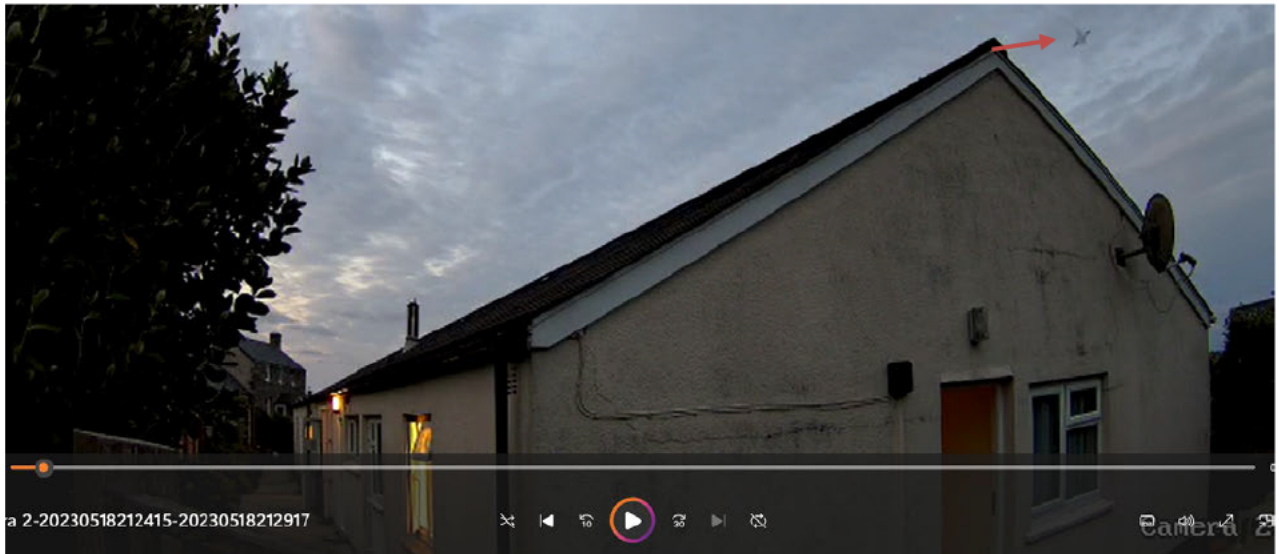
Figure 2: Still image taken from the infra-red video footage used by surveyor 1 (Lucy Wright – south elevation) during the first emergence survey on 18<sup>th</sup> May 2023. Emerging pipistrelle bat recorded on the top right of the photograph (red arrow)

The reolink camera and infrared illuminator were mounted on tripods. The Reolink RLC-811A CCTV cameras are widely and successfully used to record bats emerging from buildings. The fields of view of each camera during the first emergence survey are shown in Fig. 2 and Fig.3 below.

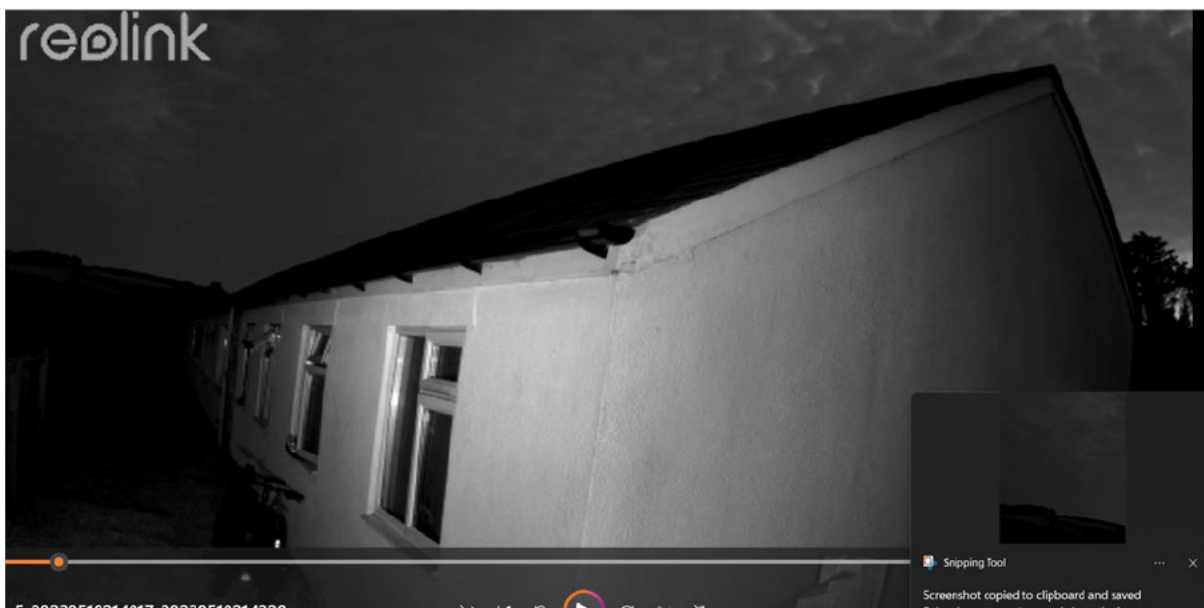
Figure 3: Still image taken from the infra-red video footage during the latter part of the survey (Chloe Balmer – north elevation) on 18<sup>th</sup> May 2023.

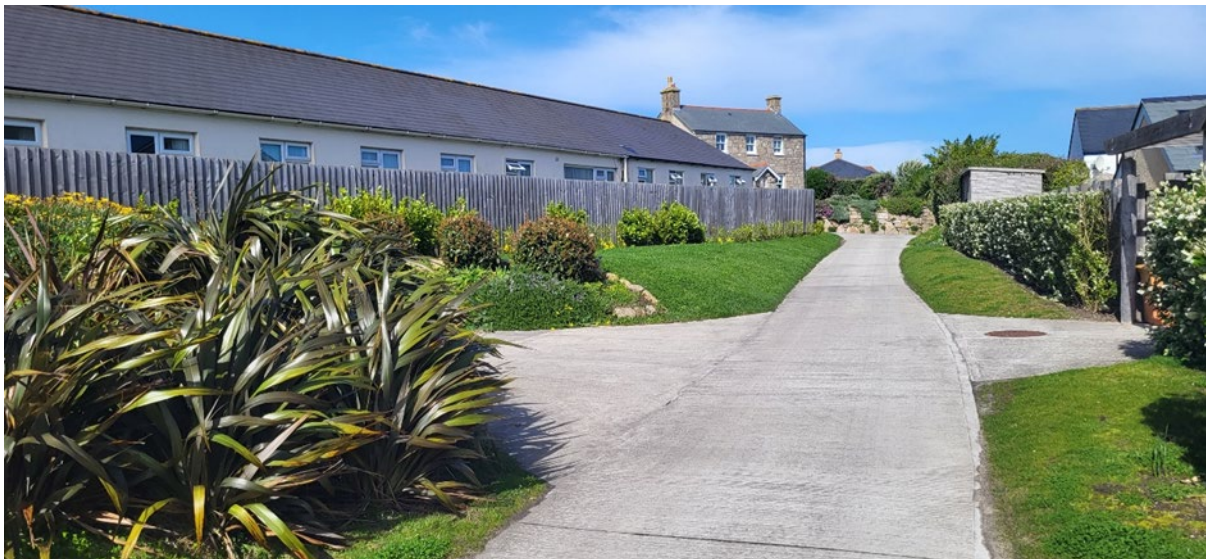
Bottom Annexe is a single storey building of rendered concrete block wall construction, with slate effect roof tiles and concrete ridge tiles (Figure 4: east elevation, Figure 5: west elevation, Figure 6: north elevation, Figure 7: south elevation). The roof is pitched with one flue and two vents on the west elevation. Three roof slates were identified on the west elevation as being slightly raised which may provide access for bats into the interior of the roof. Timber fascia boards are present all around the building with some small gaps on the west elevation. The gable end of the north elevation has a fascia board at the top of the wall of the gable end. There are very small gaps behind this fascia board which may provide crevices for bats and allow bats access into the interior. The fascia board on the east elevation appears to be completely tight and the roof structure appears tight in the most part with no obvious access points or gaps that could be utilised by crevice dwelling bats. However, there are replacement roof slates that may provide an access point for bats on the east elevation.

Figure 4: View of the east elevation of Bottom Annexe

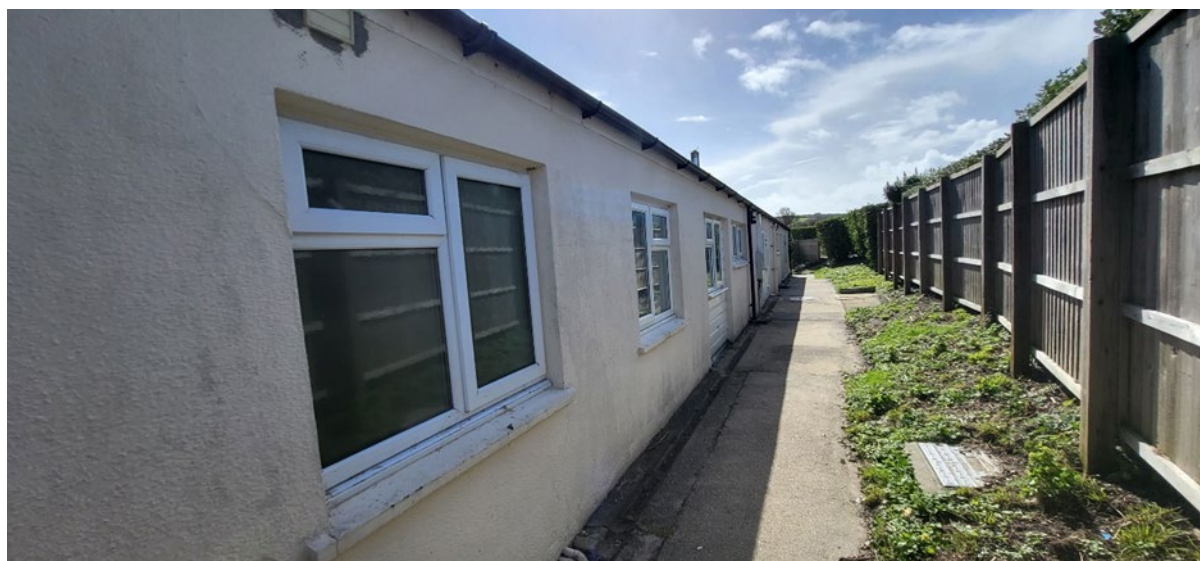
Figure 5: View of the west elevation of Bottom Annexe

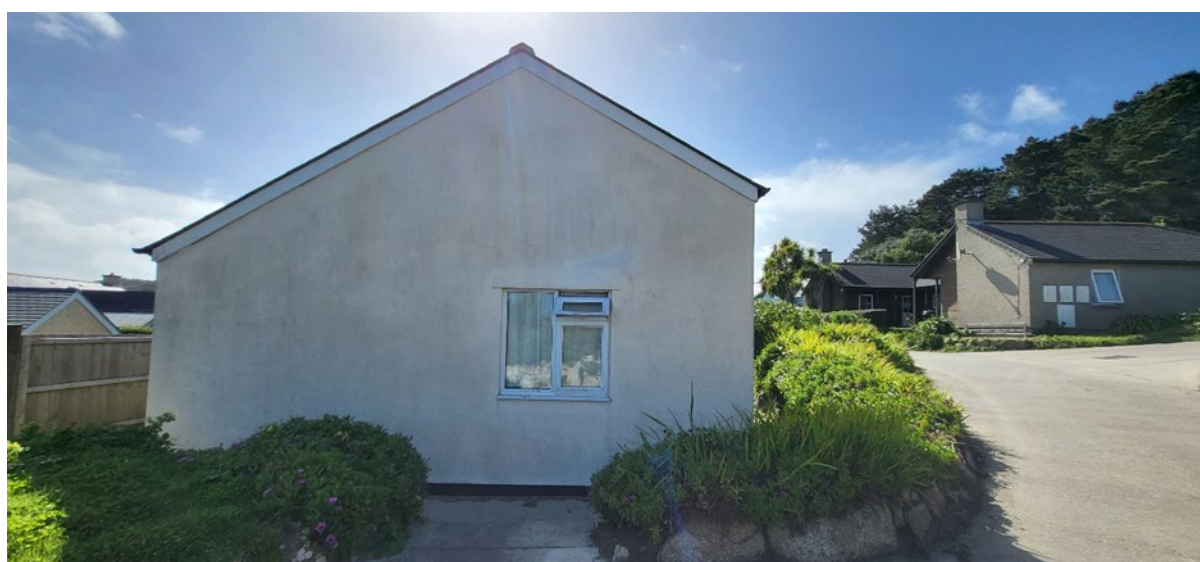
Figure 6: View of the north elevation of Bottom Annexe

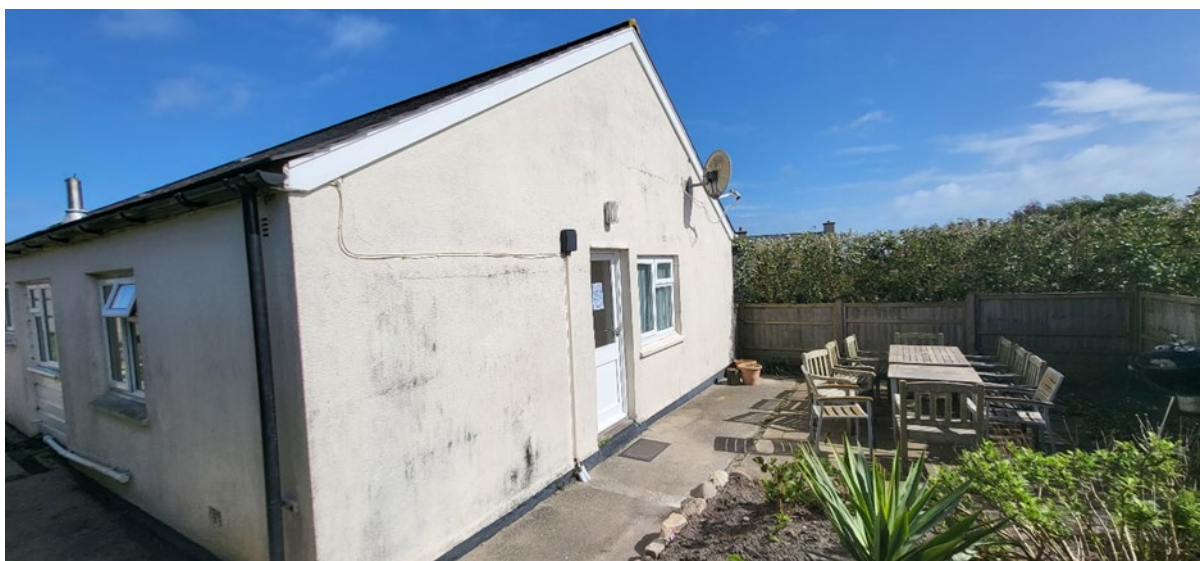
Figure 7: View of the south elevation of Bottom Annexe

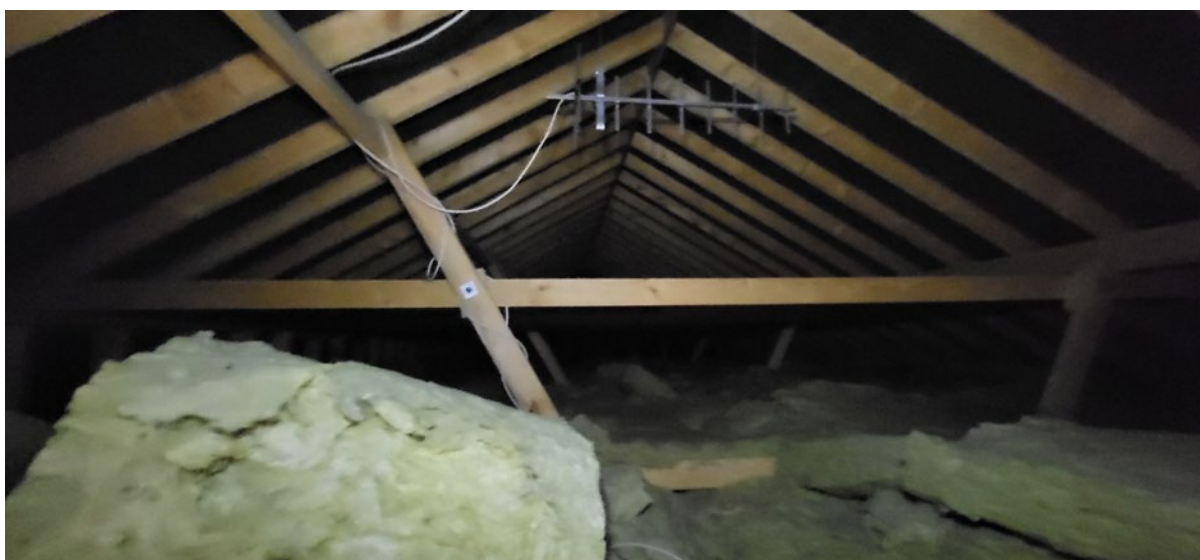
Roof void 3: This section of roof void has the same timber structure as roof voids 1 and 2 but has been lined with bitumen roofing felt (Figure 8). This roof void is much cooler than voids 1 and 2. The floor of the void also has piles of old roofing insulation and was un-boarded, so the inspection was made from the hatch. Several apparent bat droppings c. 3 droppings were identified close to the hatch entrance (Figure 9).

Figure 8: Interior of roof void 3

- If bats will be allowed to access the roof space of the proposed replacement building, then bitumen type 1F roofing felt must be used to line the replacement roof; this is because modern synthetic membranes are harmful to bats and their use will not be permitted by Natural England.
- No exterior lighting will be installed close to the temporary or permanent bat roost features or new access points.
- Building contractors will be briefed prior to commencement of site works. Contractors will be notified about the presence of bats within the building and informed that if a bat/s is/are uncovered during works, then work must stop immediately (as soon as it is safe to do so) and advice sought from the licensed bat ecologist/s (Plan for Ecology Ltd, 01326 218839).

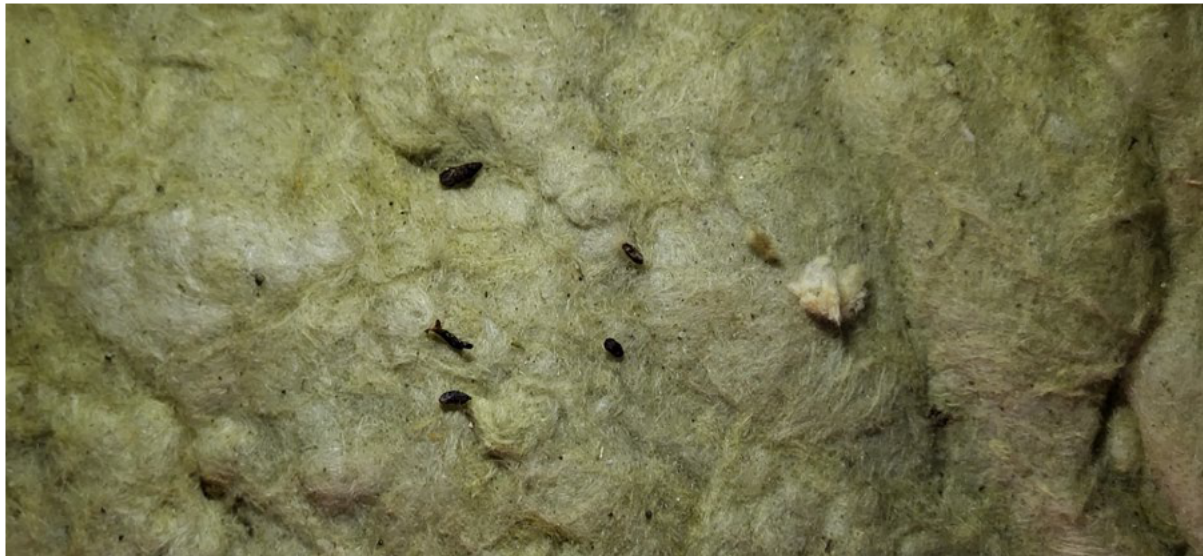
Figure 9: Droppings on roofing insulation of roof void 3

DNA analysis of a sample of droppings collected from Bottom Annexe to determine species was described as lesser white toothed shrew (*Crocidura suaveolens*). The lesser white toothed shrew is primarily insectivorous, the same as bats, and their droppings can be mistaken for bat droppings as they are similar in appearance and crumble when touched due to the presence of insect remains.

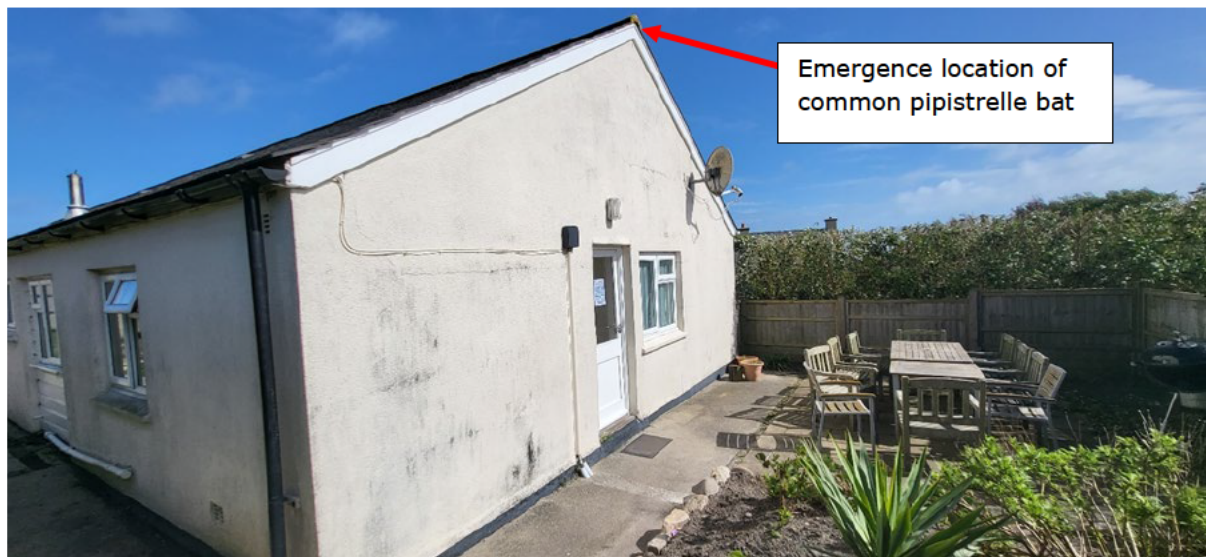
During the first emergence survey on the 18<sup>th</sup> May 2023, one common pipistrelle bat was recorded emerging from the beneath the ridge tile at the gable end on the south elevation.

During the second emergence survey on 22<sup>nd</sup> June 2023, one common pipistrelle bat was recorded emerging from beneath the ridge tile at the gable end on the south elevation.

Figure 10: South elevation of Bottom Annexe. The red arrow indicates the emergence location of the single common pipistrelle bat during both surveys (18<sup>th</sup> May and 22<sup>nd</sup> June 2023)

The survey results show that Bottom Annexe supports a day roost used by an individual common pipistrelle bat. The roost site appears to be beneath the ridge tile on the gable end of the south elevation.

- The common pipistrelle bat day roost located on the south elevation of Bottom Annexe will be lost during the demolition works. Loss of the common pipistrelle bat day roost will be compensated by either installing a bat access (i.e., bat access slate/ tile over bitumen type 1F) to provide bat access to the space between the bitumen membrane and roof tiles, by installing a single raised ridge tile with 50mm x 25mm gap over bitumen type 1F; by installing a timber fascia board with 20 x 50mm gap beneath providing bat access to the

wall top; or by installing a bat box on the exterior of the building. The location/ aspect of the alternative bat roost features will replicate those lost as closely as possible.
