# PERMISSION FOR DEVELOPMENT

**Proposal**: Demolition of existing building and construction of new single storey building

# **Preliminary Bat & Bird Assessment and Adjacent Habitat**

## **Bat Survey Report**

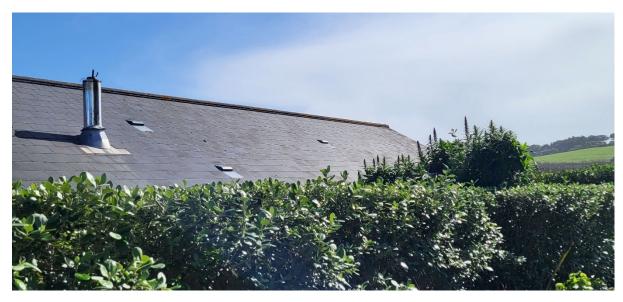
Figure 6: View of the flue and vents on the roof of the west elevation

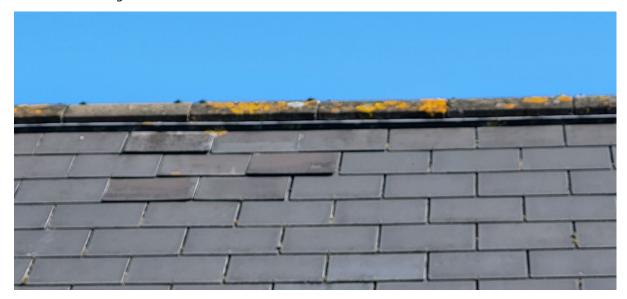
Figure 7: Raised roof slates on the west elevation of Bottom Annexe

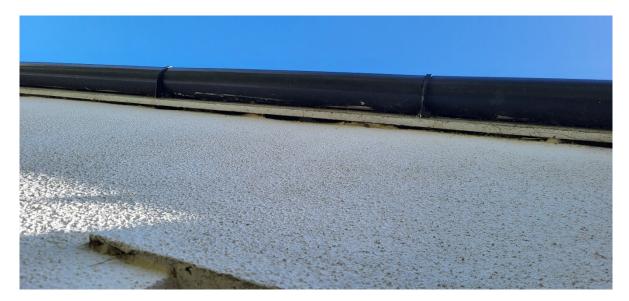
Figure 8: Gaps behind the fascia boards on the west elevation

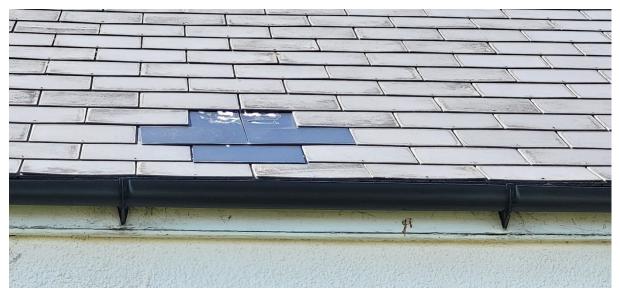
Figure 9: Replacement roof slates on the east elevation that may provide an access point for bats

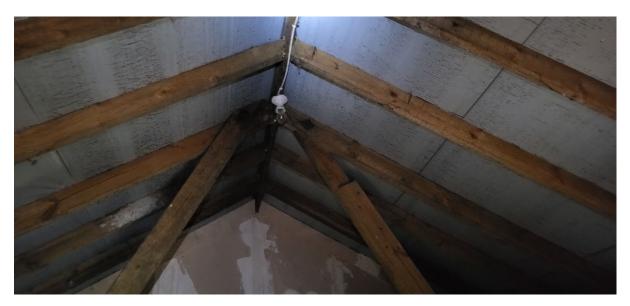
Roof void 1: The roof space is hot and dark with a timber roof structure lined with an impermeable plastic liner (Figure 10). The floor of the roof void is covered in old piles of roofing insulation. The hot water tank is housed here. This void is un-boarded so the inspection was made from the hatch. No droppings were observed from the survey point.

Figure 10: Roof structure of roof voids 1 and 2. Impermeable plastic liner and timber frame

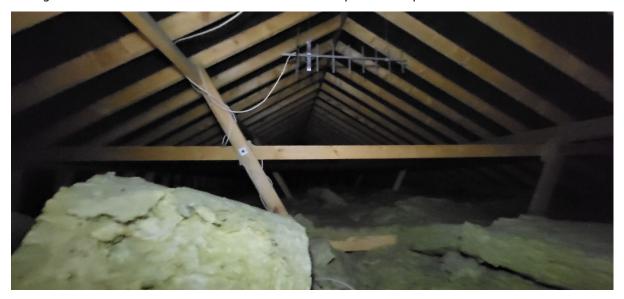
Roof void 3: This section of roof void has the same timber structure as roof voids 1 and 2 but has been lined with bitumen roofing felt (Figure 11). This roof void is much cooler than voids 1 and 2. The floor of the void also has piles of old roofing insulation and was un-boarded so the inspection was made from the hatch. Several bat droppings c. 3 droppings were identified close to the hatch entrance (Figure 12).

Figure 11: Roof structure of void 3. Bitumen roofing felt and timber frame

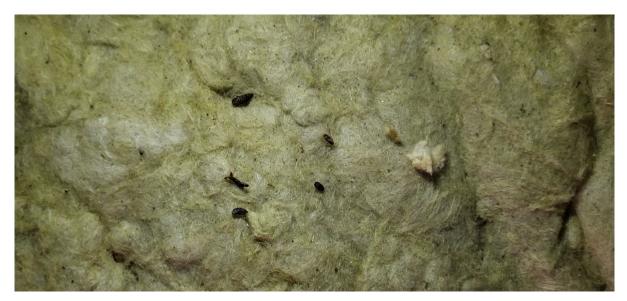
Figure 12: Droppings on the roofing felt close to the hatch entrance of roof void 3

Evidence of bats was found in Bottom Annexe in the form of several bat droppings, scattered on the floor of the roof void 3, on top of the roofing insulation, close to the entrance hatch (Map 1). It was not possible to access the whole of roof void 3 or roof voids 1 and 2 during the survey so there may have been further droppings in the inaccessible areas.

The client seeks permission for demolition and re-building of the Bottom Annexe to improve the staff accommodation facilities. Demolition works must be informed with at least two bat emergence or re-entry surveys undertaken between May and September; one of which should be carried out between May and August. A static detector survey between May-September of roof void 3 is also required together with DNA analysis of bat droppings found within this void. The survey information will be required to inform the planning application and subsequent demolition works. The surveys will determine the bat species present, number of individuals, bat access points and timings of usage.

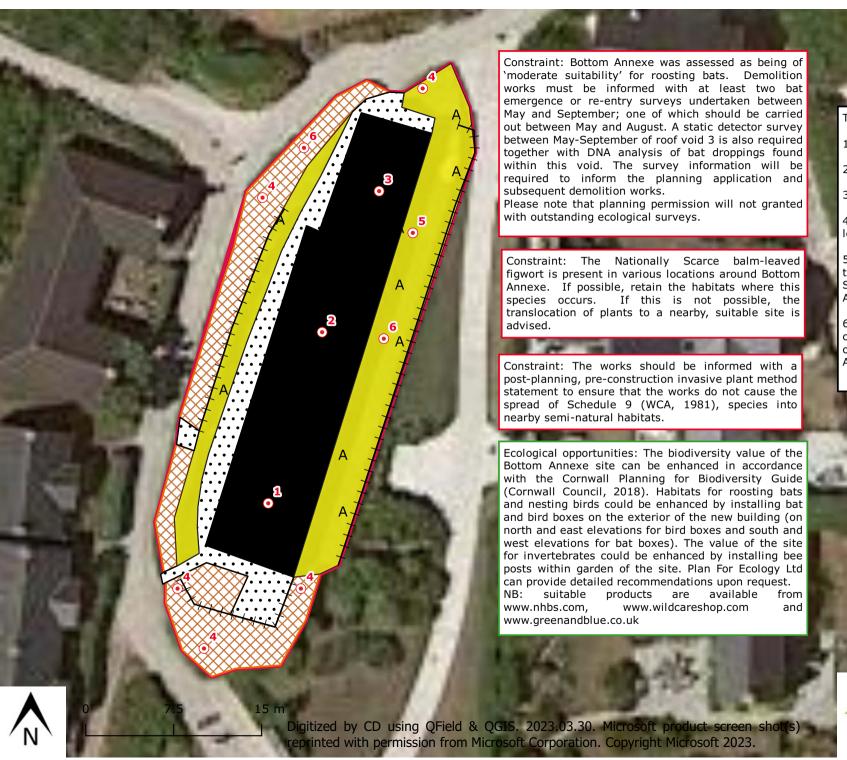
Map 1: Bottom Annexe, Tresco, Bat, Bird and Habitat Survey

- 1. Roof void 1
- 2. Roof void 2
- 3. Roof void 3 (bat droppings found here)
- 4. Location of Nationally Scarce Balm-leaved figwort (Scrophularia scorodonia).
- 5. Location of three cornered leek (Allium triquetrum) (Invasive species listed on Sch. 9 of the Wildlife and Countryside Act, 1981 as amended).
- 6. Location of montbretia (Crocosmia crocosmiiflora) (Invasive species listed on Sch. 9 of the Wildlife and Countryside Act, 1981 as amended).

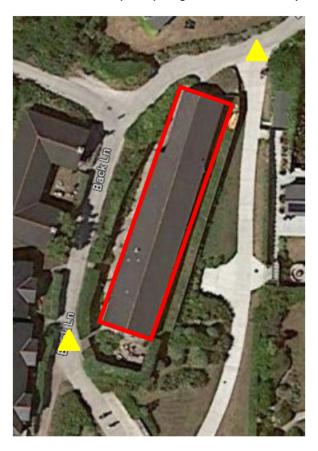
Figure 1: Emergence survey – surveyor locations. Bottom Annexe is outlined in red. Yellow triangles show surveyor locations.

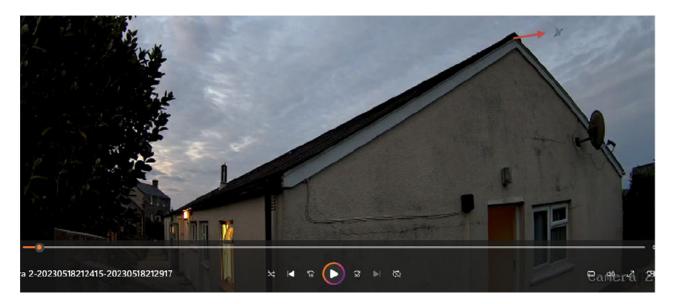
Figure 2: Still image taken from the infra-red video footage used by surveyor 1 (Lucy Wright – south elevation) during the first emergence survey on 18<sup>th</sup> May 2023. Emerging pipistrelle bat recorded on the top right of the photograph (red arrow)

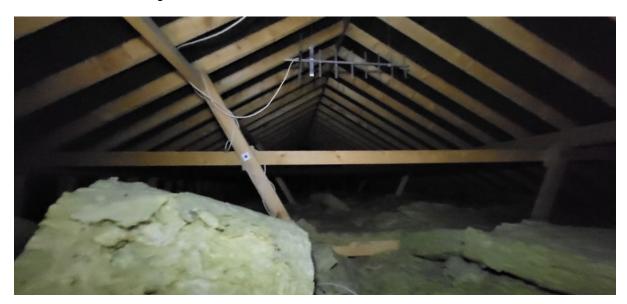
Roof void 3: This section of roof void has the same timber structure as roof voids 1 and 2 but has been lined with bitumen roofing felt (Figure 8). This roof void is much cooler than voids 1 and 2. The floor of the void also has piles of old roofing insulation and was un-boarded, so the inspection was made from the hatch. Several apparent bat droppings c. 3 droppings were identified close to the hatch entrance (Figure 9).

Figure 8: Interior of roof void 3

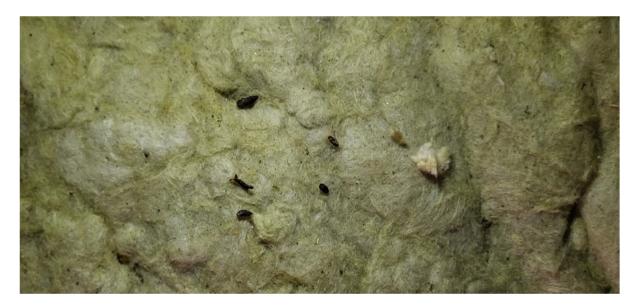
Figure 9: Droppings on roofing insulation of roof void 3

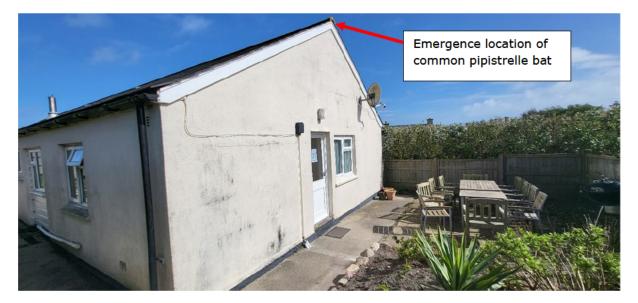
During the first emergence survey on the 18<sup>th</sup> May 2023, one common pipistrelle bat was recorded emerging from the beneath the ridge tile at the gable end on the south elevation.

During the second emergence survey on 22<sup>nd</sup> June 2023, one common pipistrelle bat was recorded emerging from beneath the ridge tile at the gable end on the south elevation.

Figure 10: South elevation of Bottom Annexe. The red arrow indicates the emergence location of the single common pipistrelle bat during both surveys (18<sup>th</sup> May and 22<sup>nd</sup> June 2023)
