Preliminary Bat & Bird Assessment and Adjacent Habitat

Bottom Annexe, Tresco, Isles of Scilly

11th May 2023

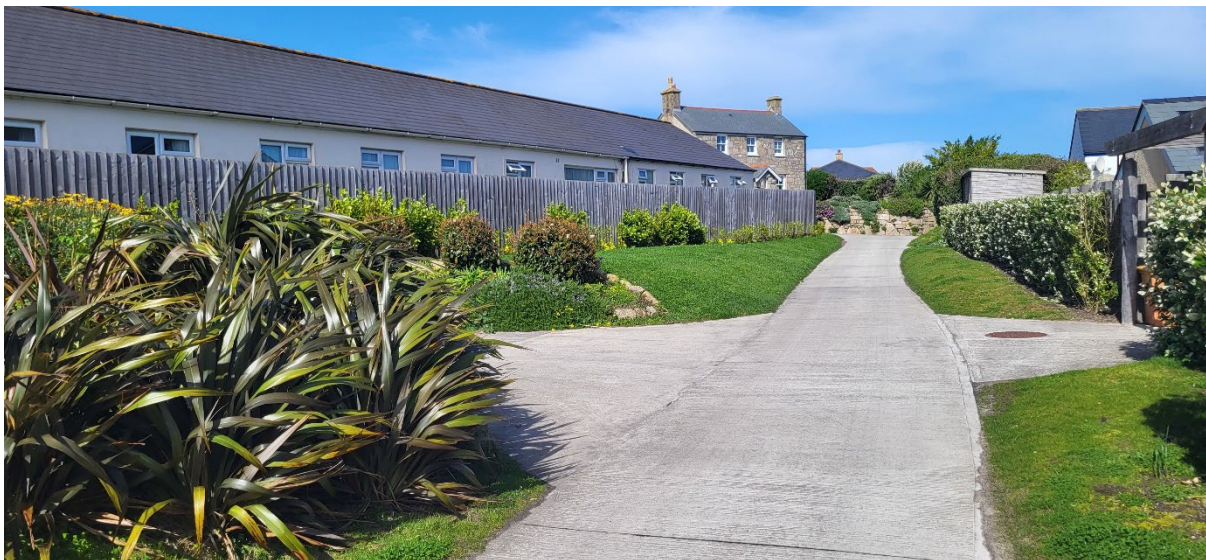
Figure 1: View of the east elevation of Bottom Annexe

The Bottom Annexe is a single storey building of rendered concrete block wall, with slate effect roof tiles and concrete ridge tiles (Figure 1: East elevation, Figures 2 and 3: West elevation, Figure 4: North elevation, Figure 5: South elevation). The roof is pitched with one flue and two vents on the west elevation (Figure 6). Three roof slates were identified on the west elevation as being slightly raised which may be providing access for bats into the interior of the roof (Figure 7). Timber fascia boards are present all around the building with some small gaps on the west elevation (Figure 8). The gable end of the north elevation has a fascia board at the top of the wall of the gable end. There are very small gaps behind this fascia board which may provide crevices for bats and allow bats access into the interior. The fascia board on the east elevation appears to be completely tight and the roof structure appears tight in the most part with no obvious access points or gaps that could be utilised by crevice dwelling bats. However, there are replacement roof slates that may provide an access point for bats on the east elevation (Figure 9).

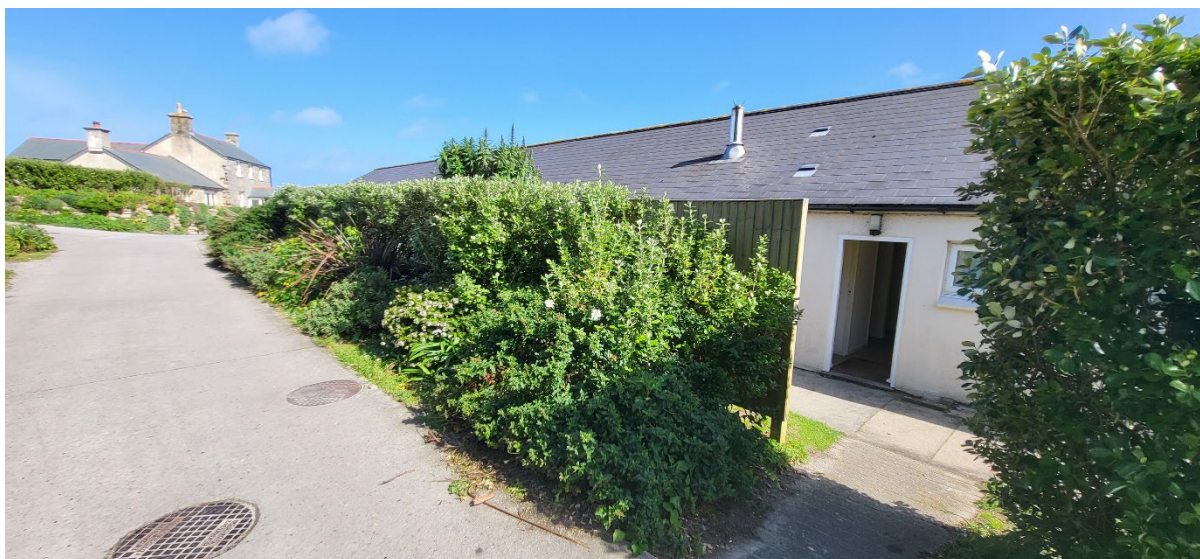
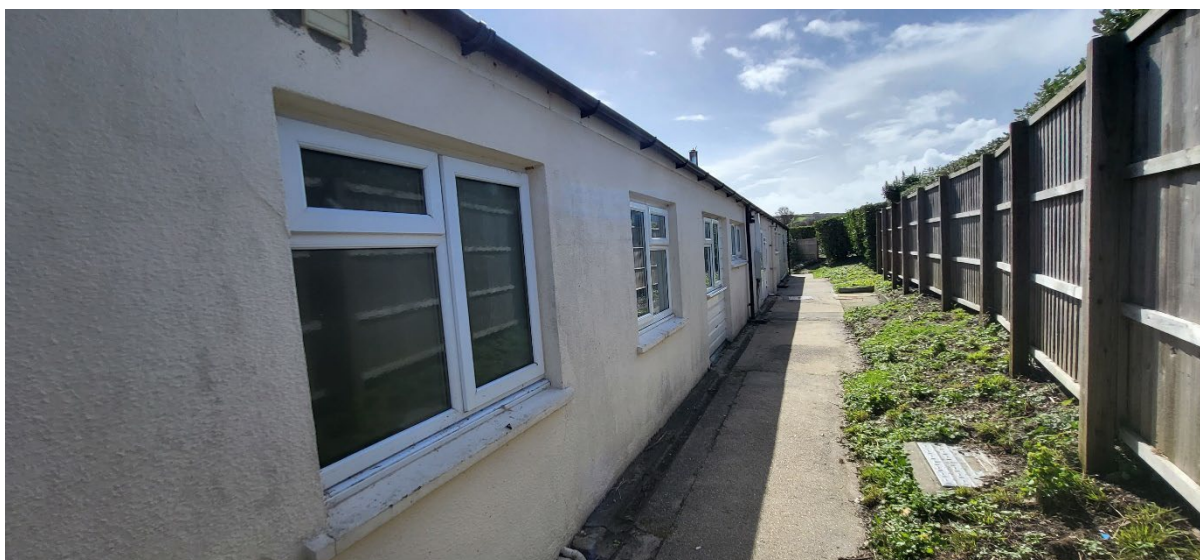
Figure 2: View of the west elevation of Bottom Annexe

Figure 3: View of the west elevation of Bottom Annexe

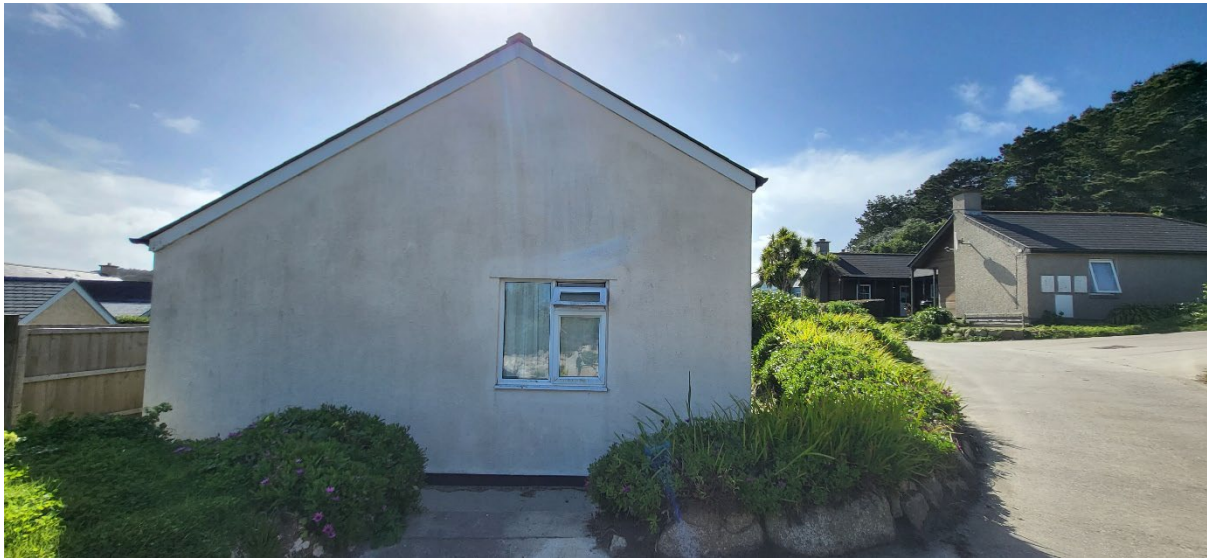
Figure 4: View of the north elevation of Bottom Annexe

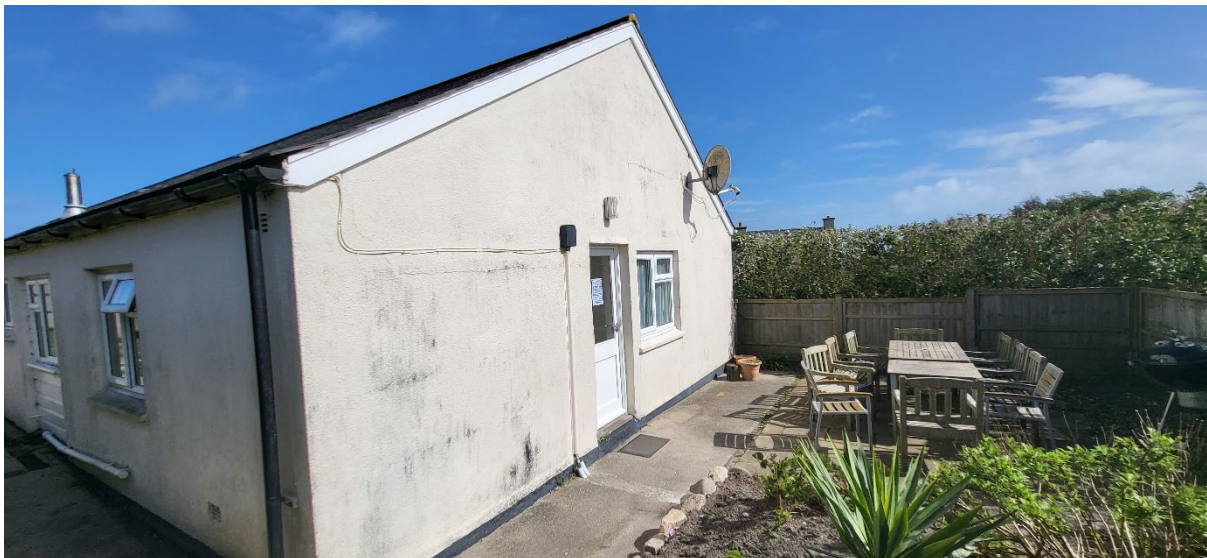
Figure 5: View of the south elevation of Bottom Annexe

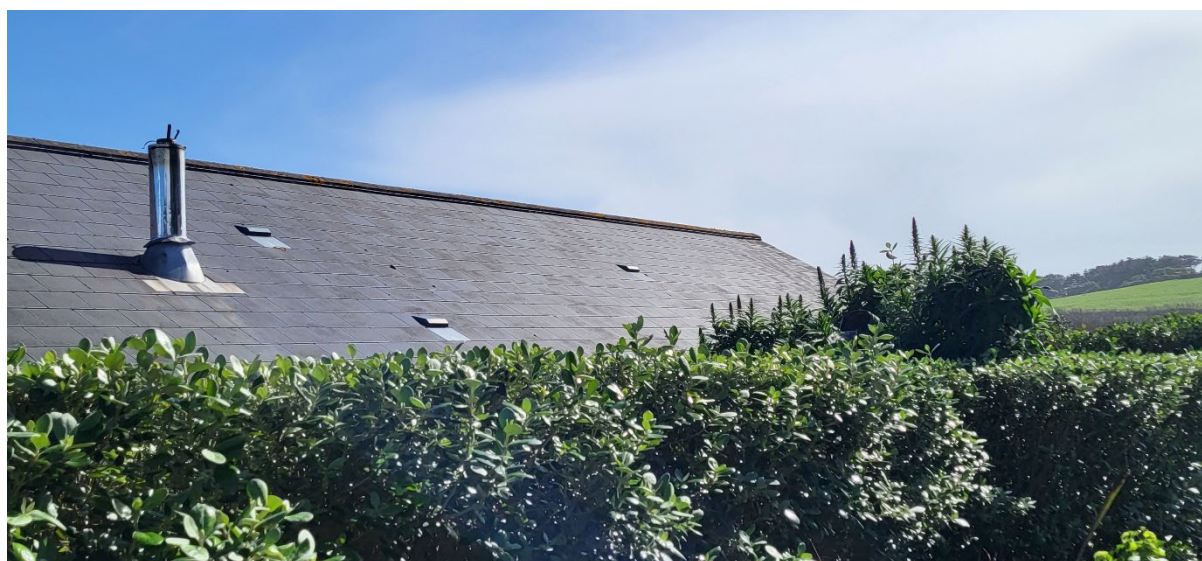
Figure 6: View of the flue and vents on the roof of the west elevation

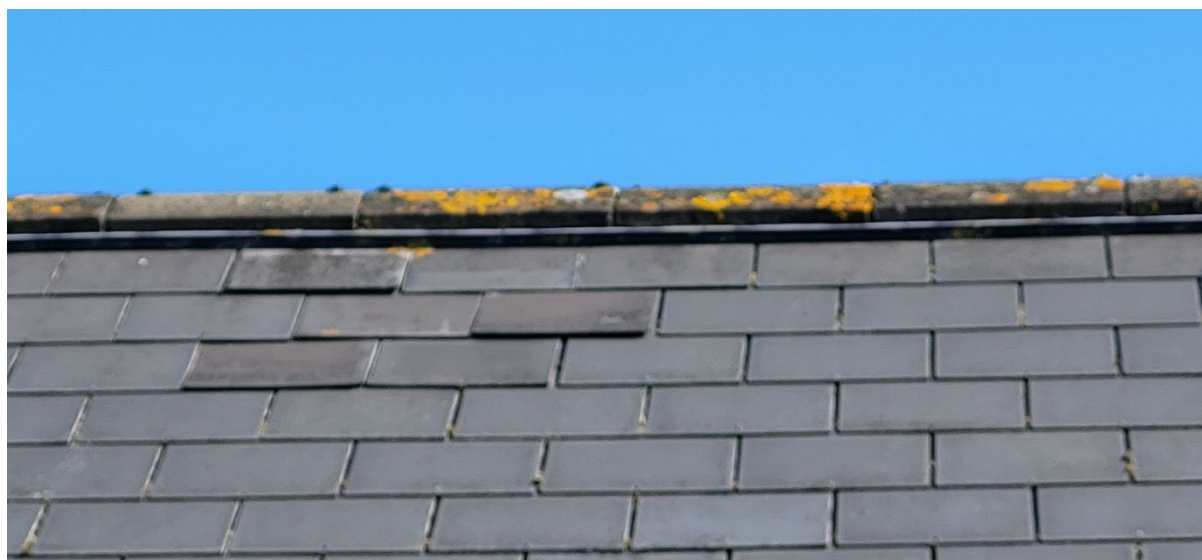
Figure 7: Raised roof slates on the west elevation of Bottom Annexe

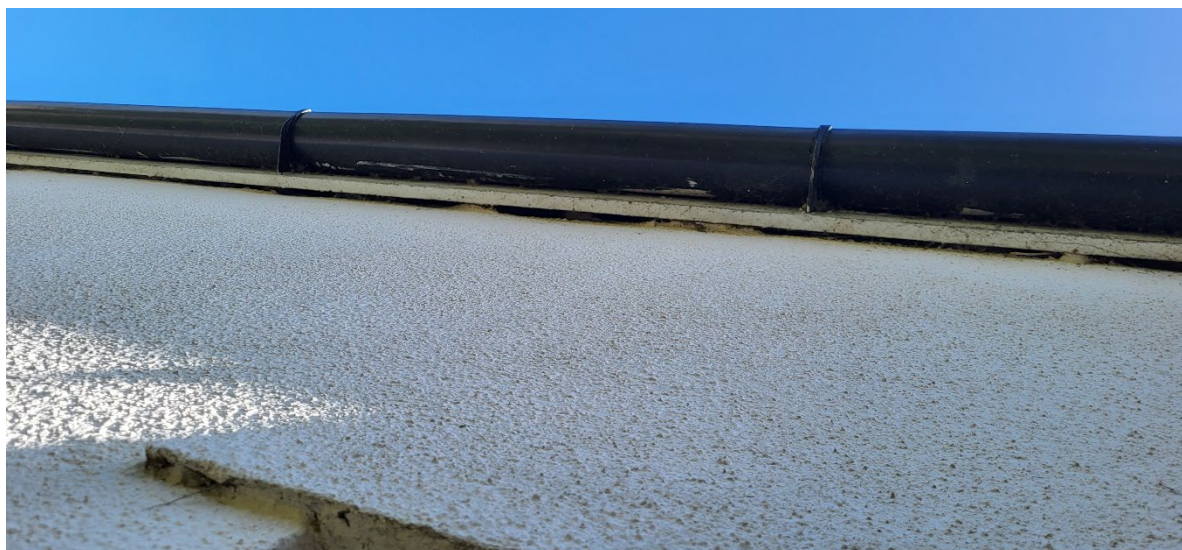
Figure 8: Gaps behind the fascia boards on the west elevation

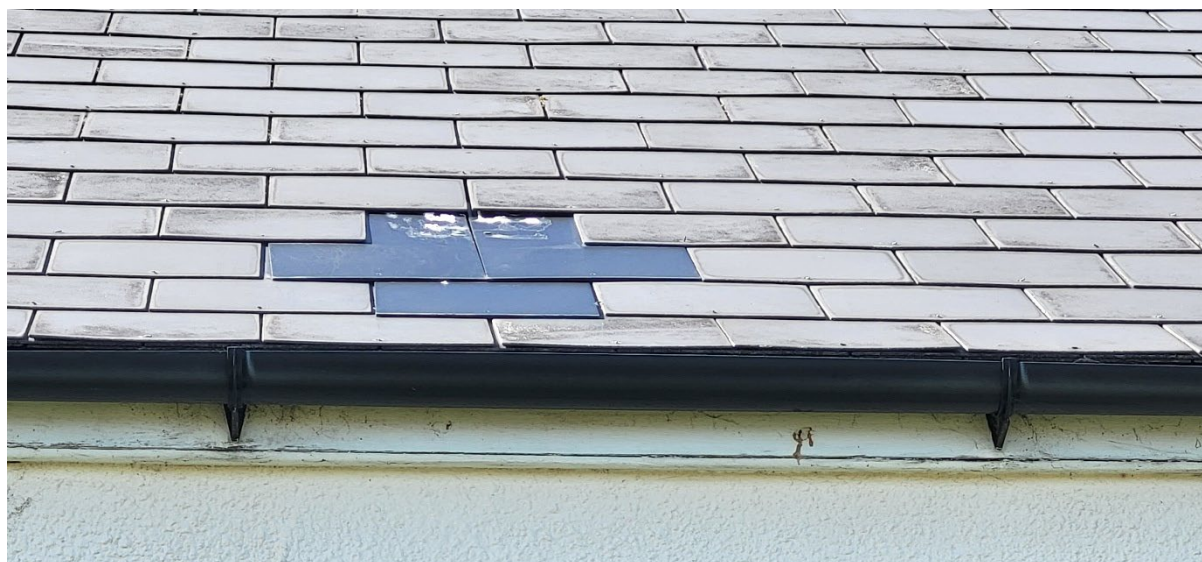
Figure 9: Replacement roof slates on the east elevation that may provide an access point for bats

The client seeks permission for demolition and re-building of the Bottom Annexe to improve the staff accommodation facilities. **Demolition works must be informed with at least two bat emergence or re-entry surveys undertaken between May and September; one of which should be carried out between May and August. A static detector survey between May-September of roof void 3 is also required together with DNA analysis of bat droppings found within this void.** The survey information will be required to inform the planning application and subsequent demolition works. The surveys will determine the bat species present, number of individuals, bat access points and timings of usage.

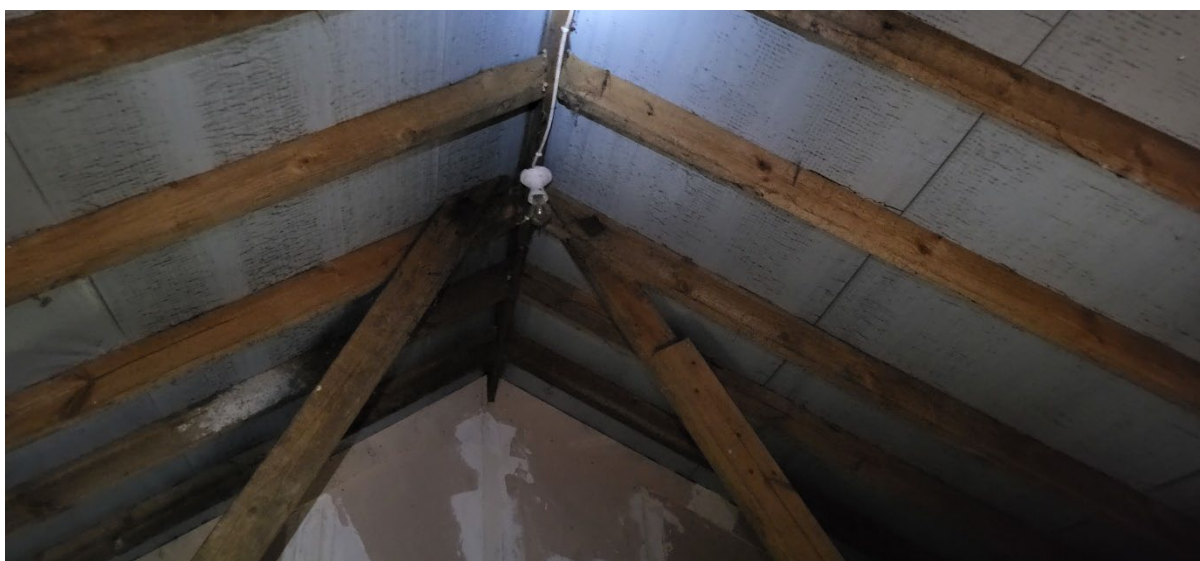
Roof void 1: The roof space is hot and dark with a timber roof structure lined with an impermeable plastic liner (Figure 10). The floor of the roof void is covered in old piles of roofing insulation. The hot water tank is housed here. This void is un-boarded so the inspection was made from the hatch. No droppings were observed from the survey point.

Figure 10: Roof structure of roof voids 1 and 2. Impermeable plastic liner and timber frame

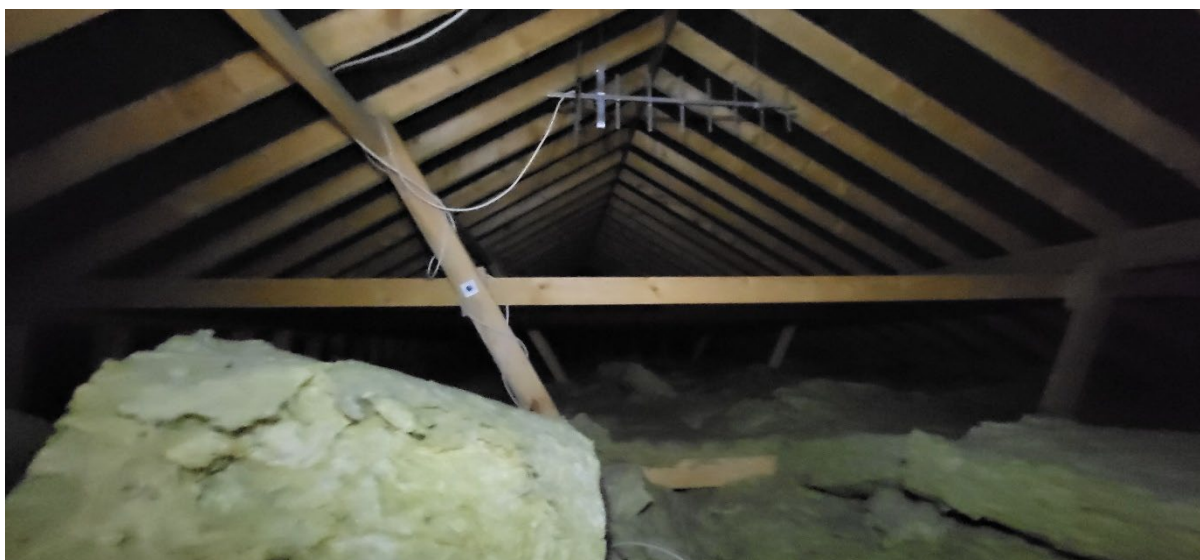
Roof void 3: This section of roof void has the same timber structure as roof voids 1 and 2 but has been lined with bitumen roofing felt (Figure 11). This roof void is much cooler than voids 1 and 2. The floor of the void also has piles of old roofing insulation and was un-boarded so the inspection was made from the hatch. Several bat droppings c. 3 droppings were identified close to the hatch entrance (Figure 12).

Figure 11: Roof structure of void 3. Bitumen roofing felt and timber frame

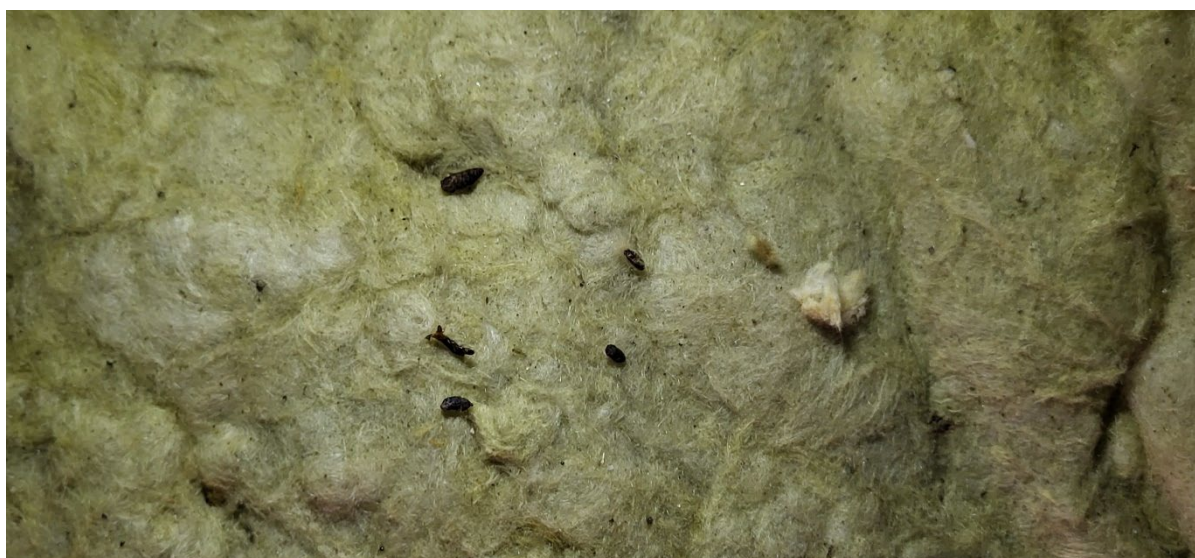
As droppings were identified during the survey and the building supports a number of features that could support roosting bats, the Bottom Annexe was assessed as being of **'moderate suitability'** for supporting roosting bats.

Figure 12: Droppings on the roofing felt close to the hatch entrance of roof void 3

Evidence of bats was found in Bottom Annexe in the form of several bat droppings, scattered on the floor of the roof void 3, on top of the roofing insulation, close to the entrance hatch (Map 1). It was not possible to access the whole of roof void 3 or roof voids 1 and 2 during the survey so there may have been further droppings in the inaccessible areas.

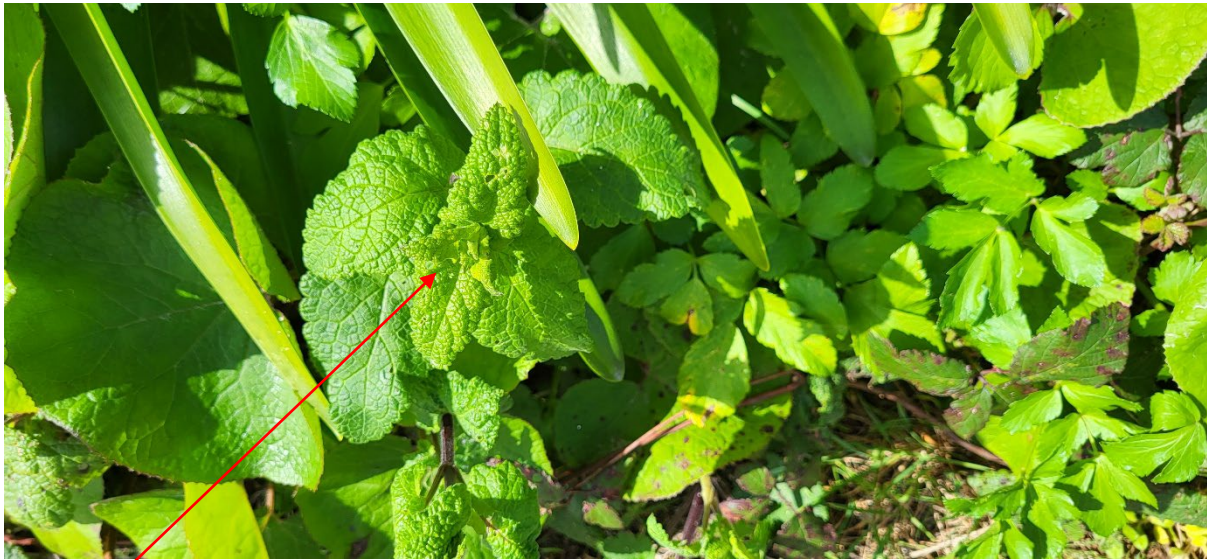
One vascular plant species of ecological importance was identified during the habitat survey. This is balm-leaved figwort (*Scrophularia scorodonia*) which is Nationally Scarce and listed in the Cornwall Red Data Book (Figure 13). The location of this plant can be seen on Map 1 in Appendix 1.

Figure 13: Balm-leaved figwort (*Scrophularia scorondonia*)

The Nationally Scarce balm-leaved figwort is present in various locations around Bottom Annexe. If possible, retain the habitats where this species occurs. If this is not possible, the translocation of plants to a nearby, suitable site is advised.
