PRELIMINARY ROOST ASSESSMENT (PRA)

TRENCH LANE, TR21 0PA (PP-12170819),
OLD TOWN, ST MARY'S, ISLES OF SCILLY

Report date: 1st June 2023

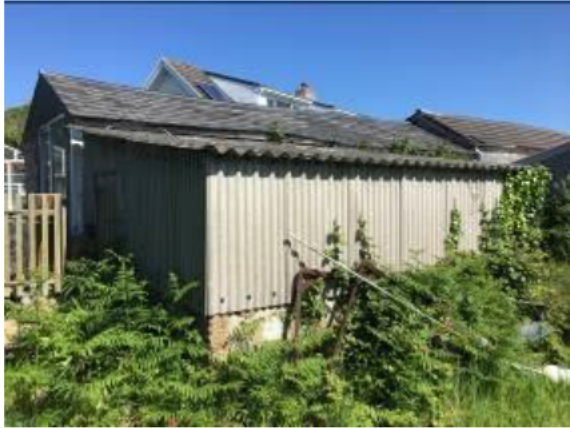
The property is a small, single-storey barn/shed – the lower portion is constructed from granite blocks whilst the upper walls and single-pitch roof comprise corrugated sheet attached to a timber framework. There is a single wooden door and no windows, though translucent sheets ensure that the interior is light during the daytime.

Photograph 1: Showing the northern and western aspects of the building.

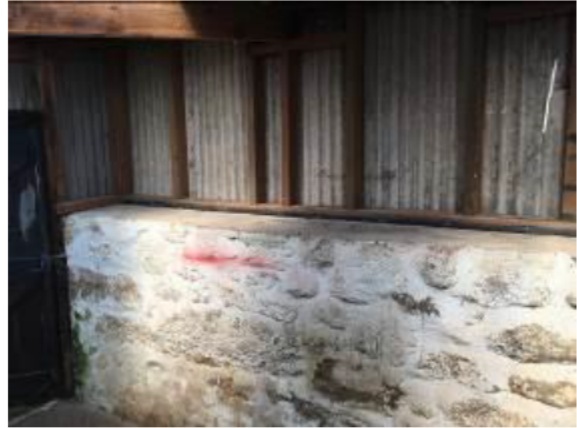
The stonework both internally and externally is well-pointed – no potential gaps or cavities suitable for use by roosting bats were noted.

Photograph 2: Showing the typical internal structure, with the stone-block wall supporting a timber frame with corrugated sheeting attached.

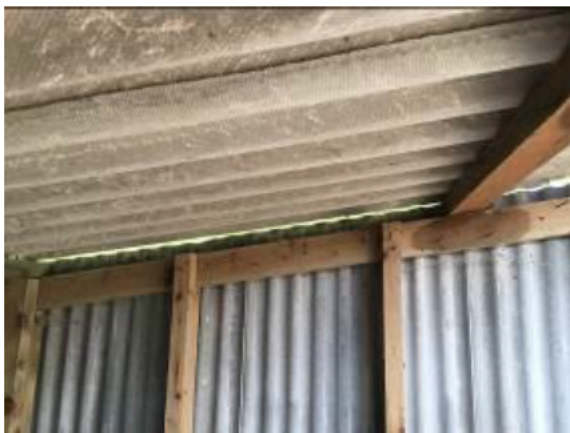
There is no under-boarding or felting on the upper walls or roof – it is constructed of a single-skin with corrugated sheets attached to wooden battens. The size of the intersections between the corrugated sheets and the timbers are not optimal for use by roosting bats, providing no apex cavity, but it is possible that exploratory bats may make opportunistic use of features on a rare basis.

Photograph 3: Showing the upper wall and roof structure.

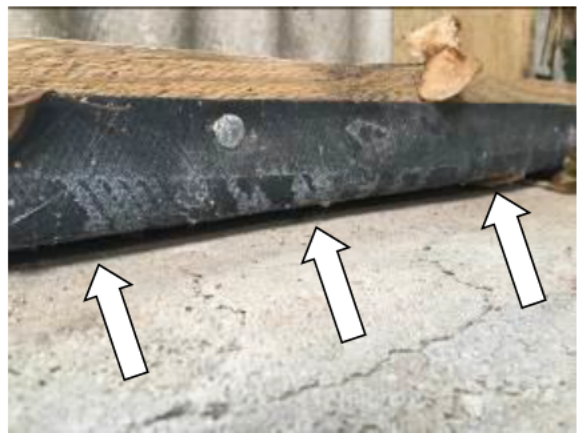
Minor gaps occur where the wooden timber sits atop the stone wall – this was fully inspected and found to be dusty and cobwebbed at the time of survey indicating no recent occupation by bats.

Photograph 4: Showing the minor gap occasionally present between the top of the wall and the timber wall plate.

The gap between the top of the wall and the timber wall-plate should be visually inspected with a torch prior to any works which would seal or otherwise disturb this feature. This can be comprehensively undertaken.

Once it has been confirmed that no bats are present, works to the feature can proceed.

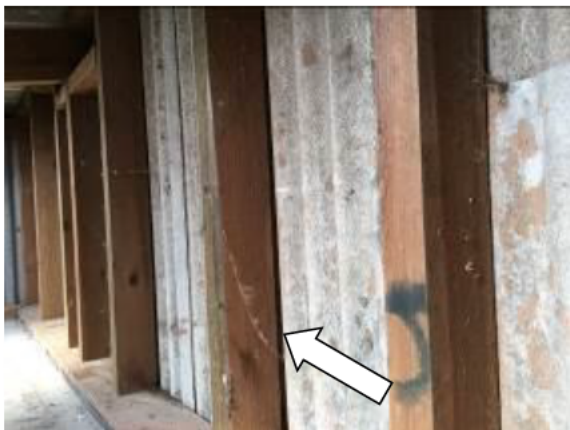
There are minor gaps where corrugated sheets overlap, but these are generally too tightly fitted to allow access to roosting opportunities for bats.

Photograph 5: Showing the internal wall timbers with corrugated sheets directly attached – minor gaps occur behind these.

There are gaps created where the corrugated sheets overlap wall timbers. These can be inspected with a torch prior to works to remove the sheets, or enclosure of the void internally. This can be undertaken comprehensively.

Once it has been confirmed that no bats are present, works to these feature can proceed.
