## BAT PRESENCE/ABSENCE SURVEYS (PAS)

### SELECTED BUILDINGS, ST MARY'S HOSPITAL ST MARY'S, ISLES OF SCILLY

*Report date: 16<sup>th</sup> April 2024*

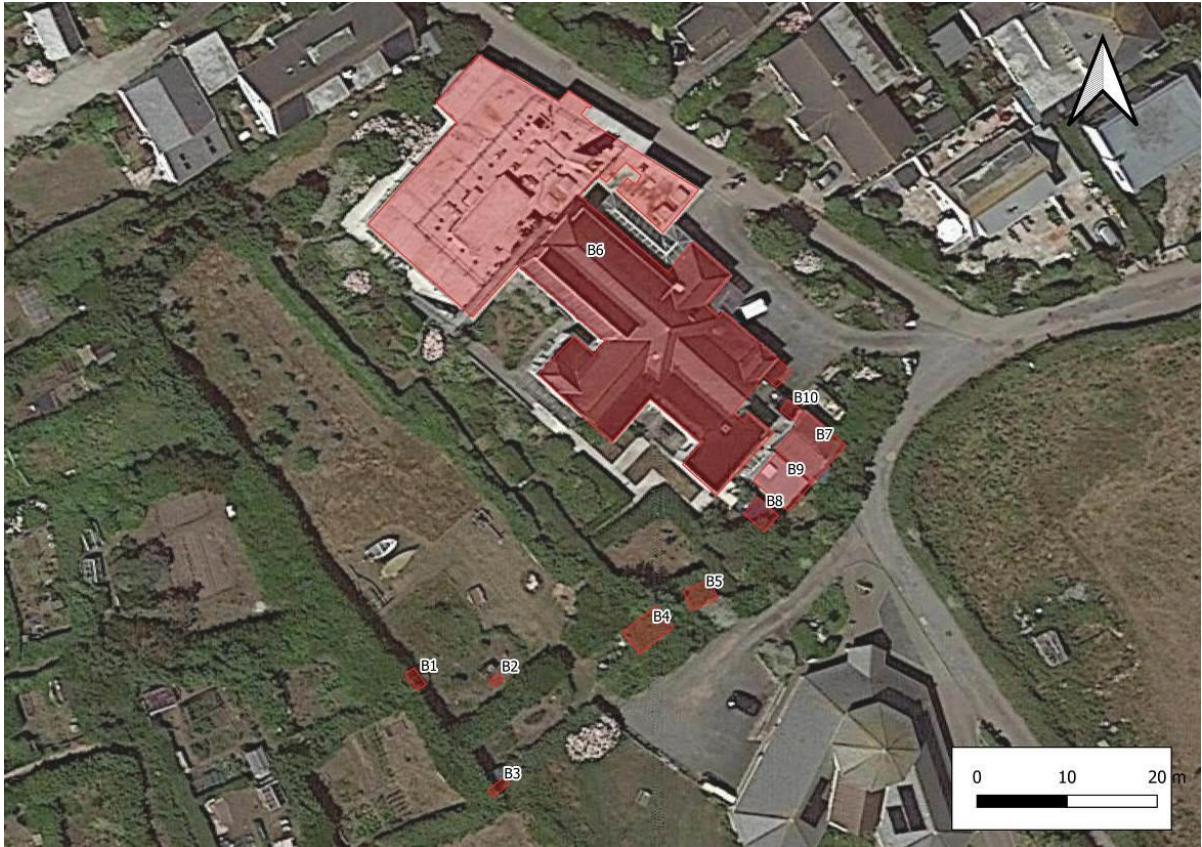
- Buildings B4, B6, B7 and B9 have **Low Potential** to support roosting bats;
- All other buildings have **Negligible Potential** to support roosting bats.

**Map 01** – Showing the different buildings identified as part of the PRA survey and referred to in the report. Map reproduced in accordance with Google’s Fair Use Policy.

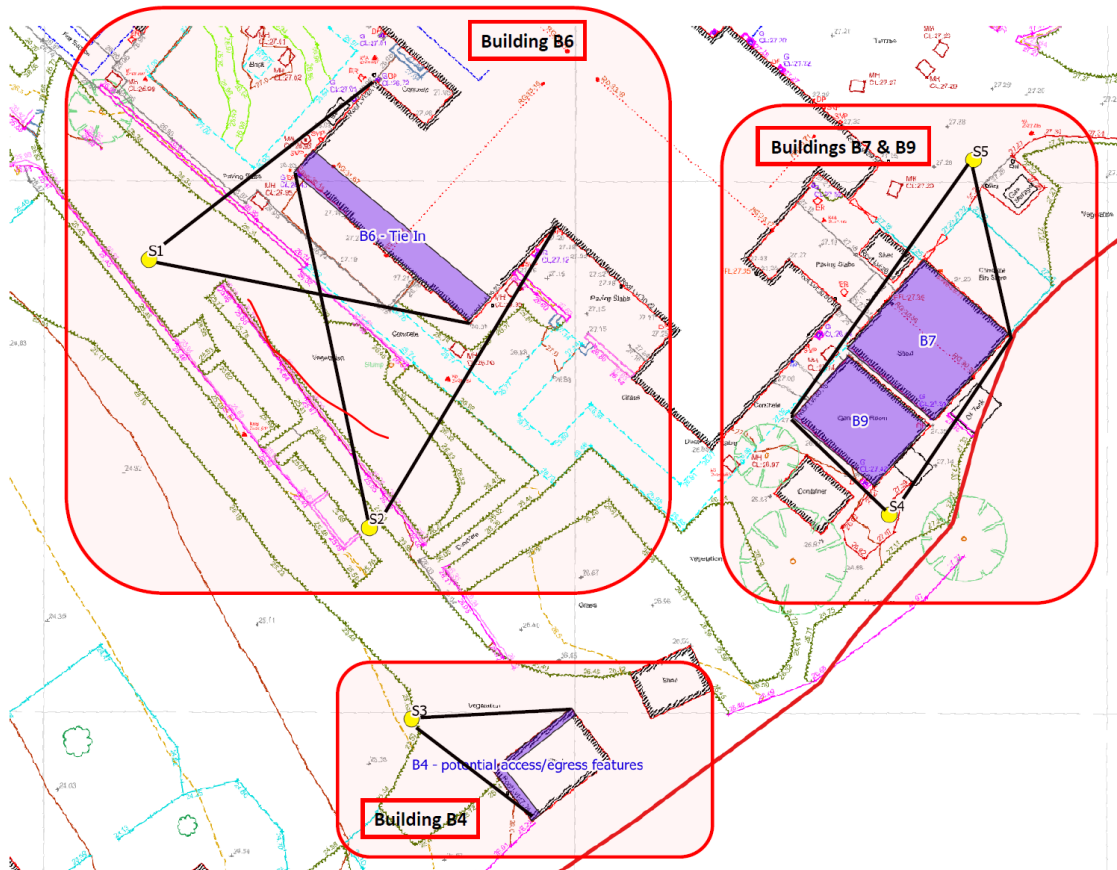
In order to ensure that the different elements of the buildings received a survey effort of a single bat survey for a Low Potential building (in line with the Best Practice Guidance), five surveyor positions were used. These are identified in Map 02 below.

Map 02 – showing surveyor positions around the buildings.

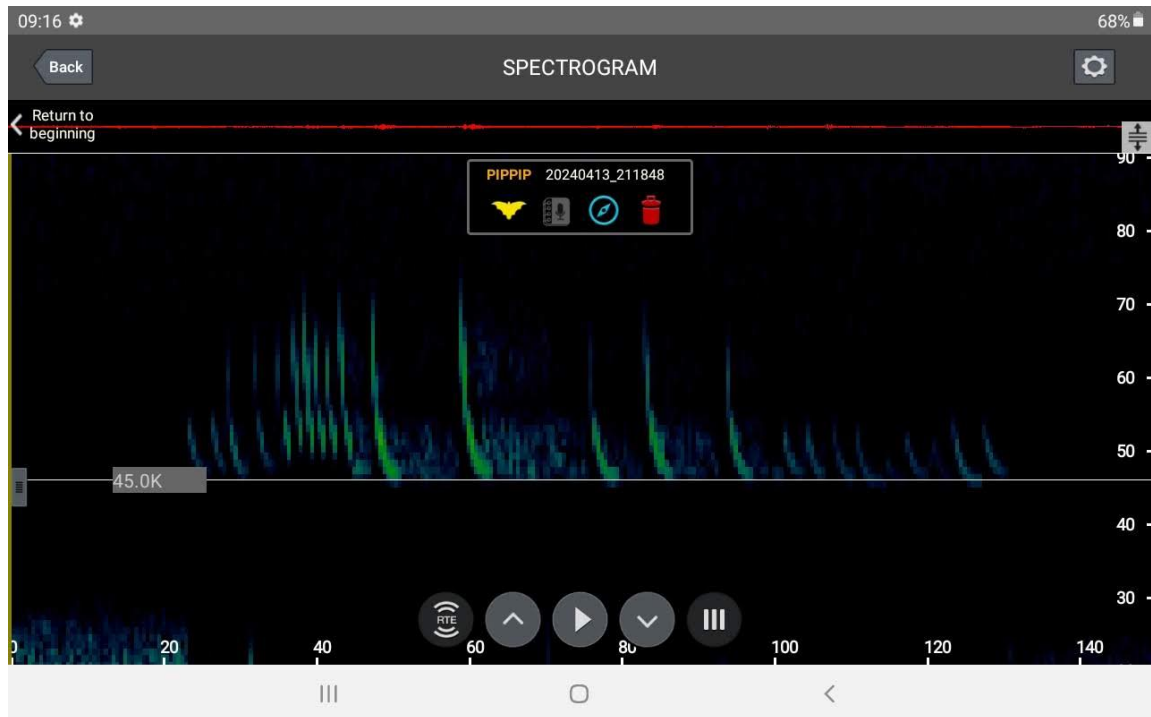
**Sample Sonogram** – showing common pipistrelle pass at 9:18pm by Surveyor S5.

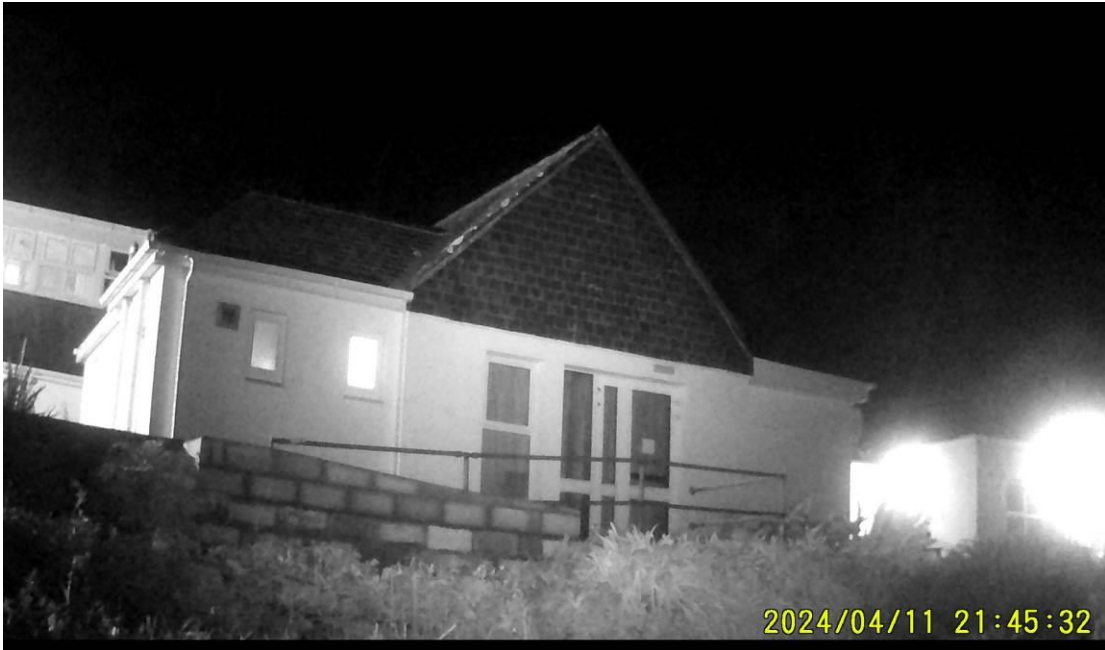
**Surveyor 01** – showing footage from the Nightfox Red on surveyor position S1. The view is predominantly replicated by the surveyor and NVA in position S2.

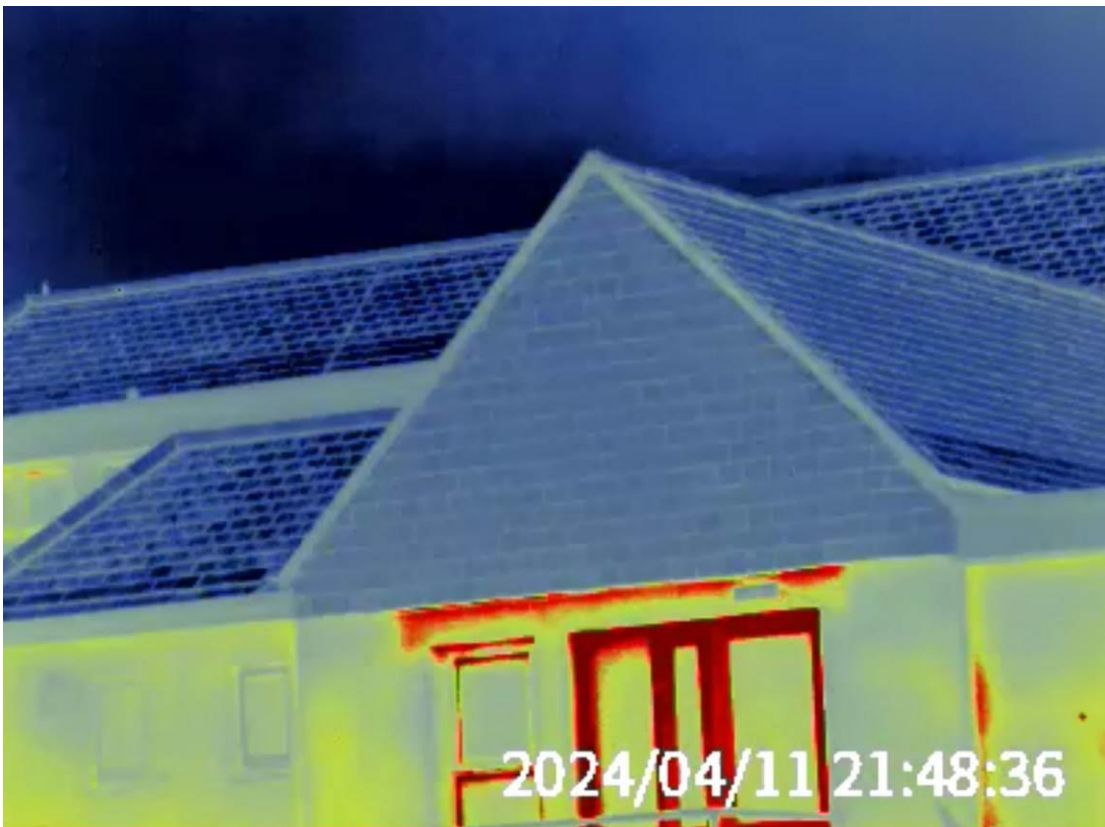
**Surveyor 02** – showing footage from the Track IR35 on surveyor position S2. The view is predominantly replicated by the surveyor and NVA in position S1.

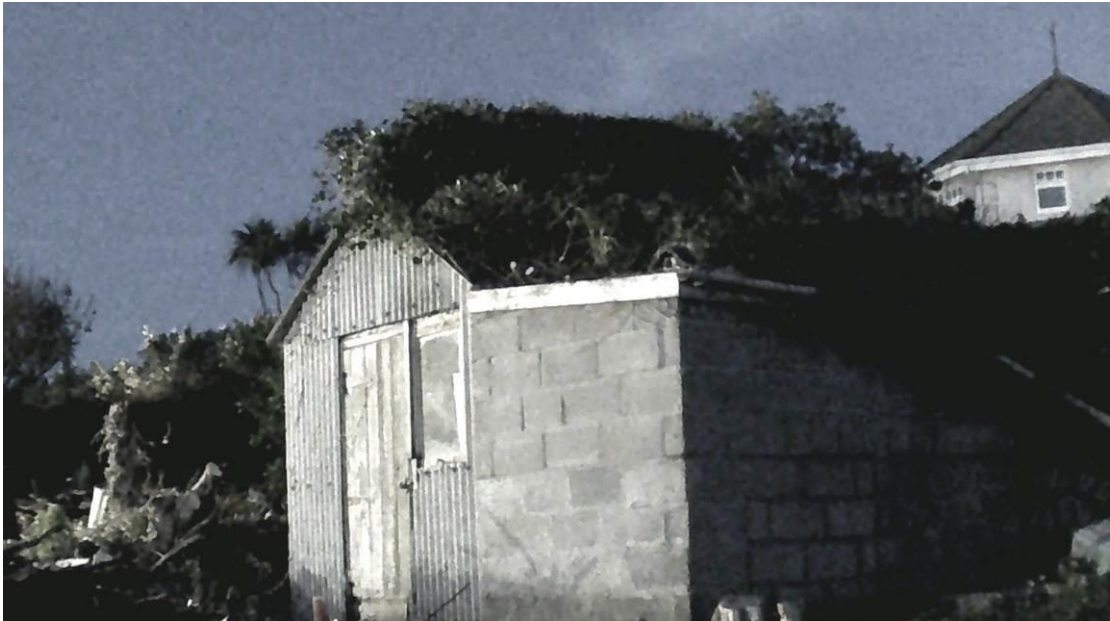
The interference of artificial light sources (associated with hospital security) affected the quality of images around B6, B7 and B9 due to the contrast between artificial and IR light on adjacent aspects – however a careful review of the footage allowed the results to be confirmed. The constraints are given full consideration in the associated screenshots in Appendix 2.

**Surveyor 03** – showing footage from the Nightfox Whisker on surveyor position S3 – note the constraint from artificial light (on the LHS aspect) vs infrared only (on the RHS aspect) – however the surveyor had an excellent, close view of a relatively small area of building and the illumination of key aspects/features was sufficient throughout the period when common pipistrelle and brown long-eared bat (the only two species known to be resident and breeding on the island) would emerge. The result can therefore be confirmed with confidence.

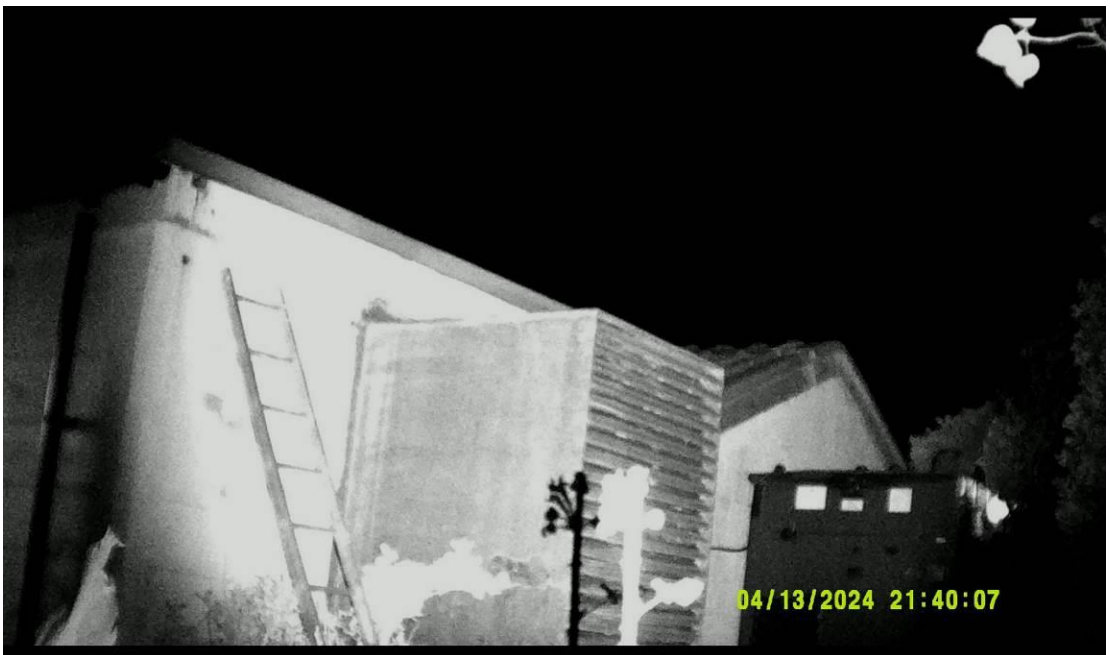
**Surveyor 04** – showing footage from the Nightfox Whisker on surveyor position S4. The FOV restricted full replication of surveyor aspect due to the close proximity of the survey position to the building; focus was therefore on the aspects of the building where Potential Roosting Features (PRFs) were recorded in the PRA. The position however provided optimal conditions for the sureyor with excellent close-range visibility.

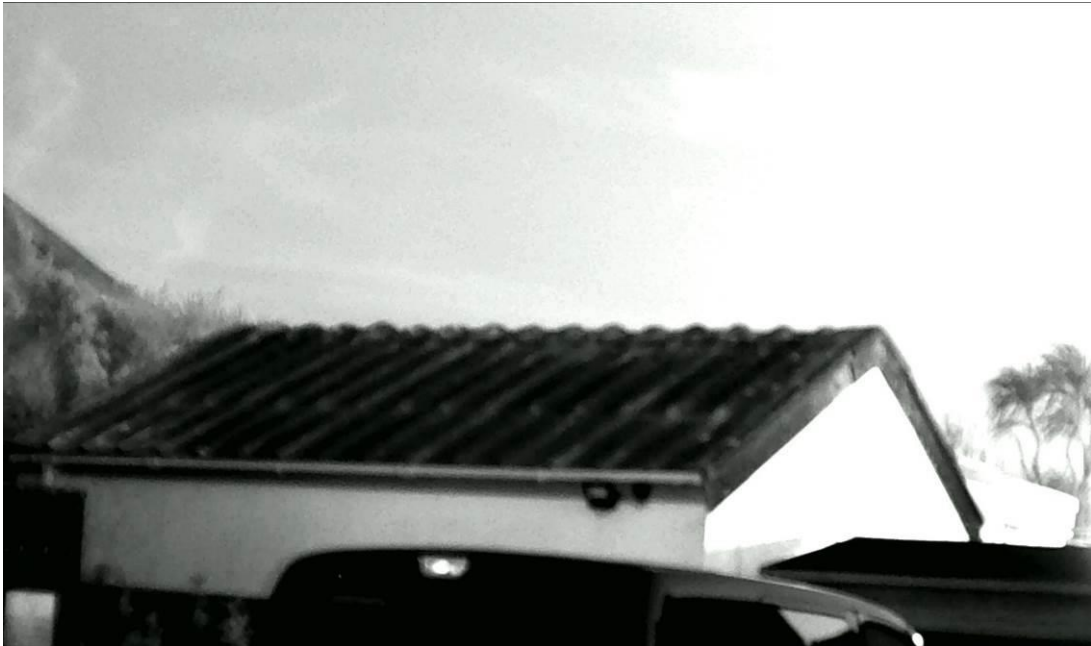
**Surveyor 05** – showing footage from the Nightfox Whisker on surveyor position S5 – note the constraint from artificial light (on the RHS aspect) vs infrared only (on the LHS aspect) – however the surveyor had an excellent, close view of a relatively small area of building and the illumination of key aspects/features was sufficient throughout the period when common pipistrelle and brown long-eared bat (the only two species known to be resident and breeding on the island) would emerge. The level of artificial lighting on the aspects on the RHS from a close proximate outside light (on all night for security purposes) would make it highly unlikely that a bat would roost and emerge from this aspect; therefore the focus of the lighting decisions was on the unlit eaves aspect closest to the camera which is in darkness and lit by IR only in this screenshot. The result can therefore be confirmed with confidence.
