### **PERMISSION FOR DEVELOPMENT**

<b>Application No:</b>	<b>P/24/019/COU</b>	<b>Date Application Registered:</b>	<b>26th March 2024</b>
<b>Applicant:</b>	<b>Mr Adam Peters Latham Park, St Blazey Road, St Blazey, Par, Cornwall, PL24 2HY</b>	<b>Agent:</b>	<b>Angela Warwick Situ8 Planning Consultancy Millham Farm, Lostwithiel, Cornwall, PL22 0JA</b>

**Site address:** Circus Field Church Road Hugh Town St Mary's Isles of Scilly  
**Proposal:** Temporary use of field for construction site welfare facilities and the storage of materials in conjunction with planning ref P/24/006/FUL (AMENDED PLANS).

Integrated Health & Social  
Care Centre, Isles of Scilly  
Temporary Works Yard  
Heritage Impact Assessment

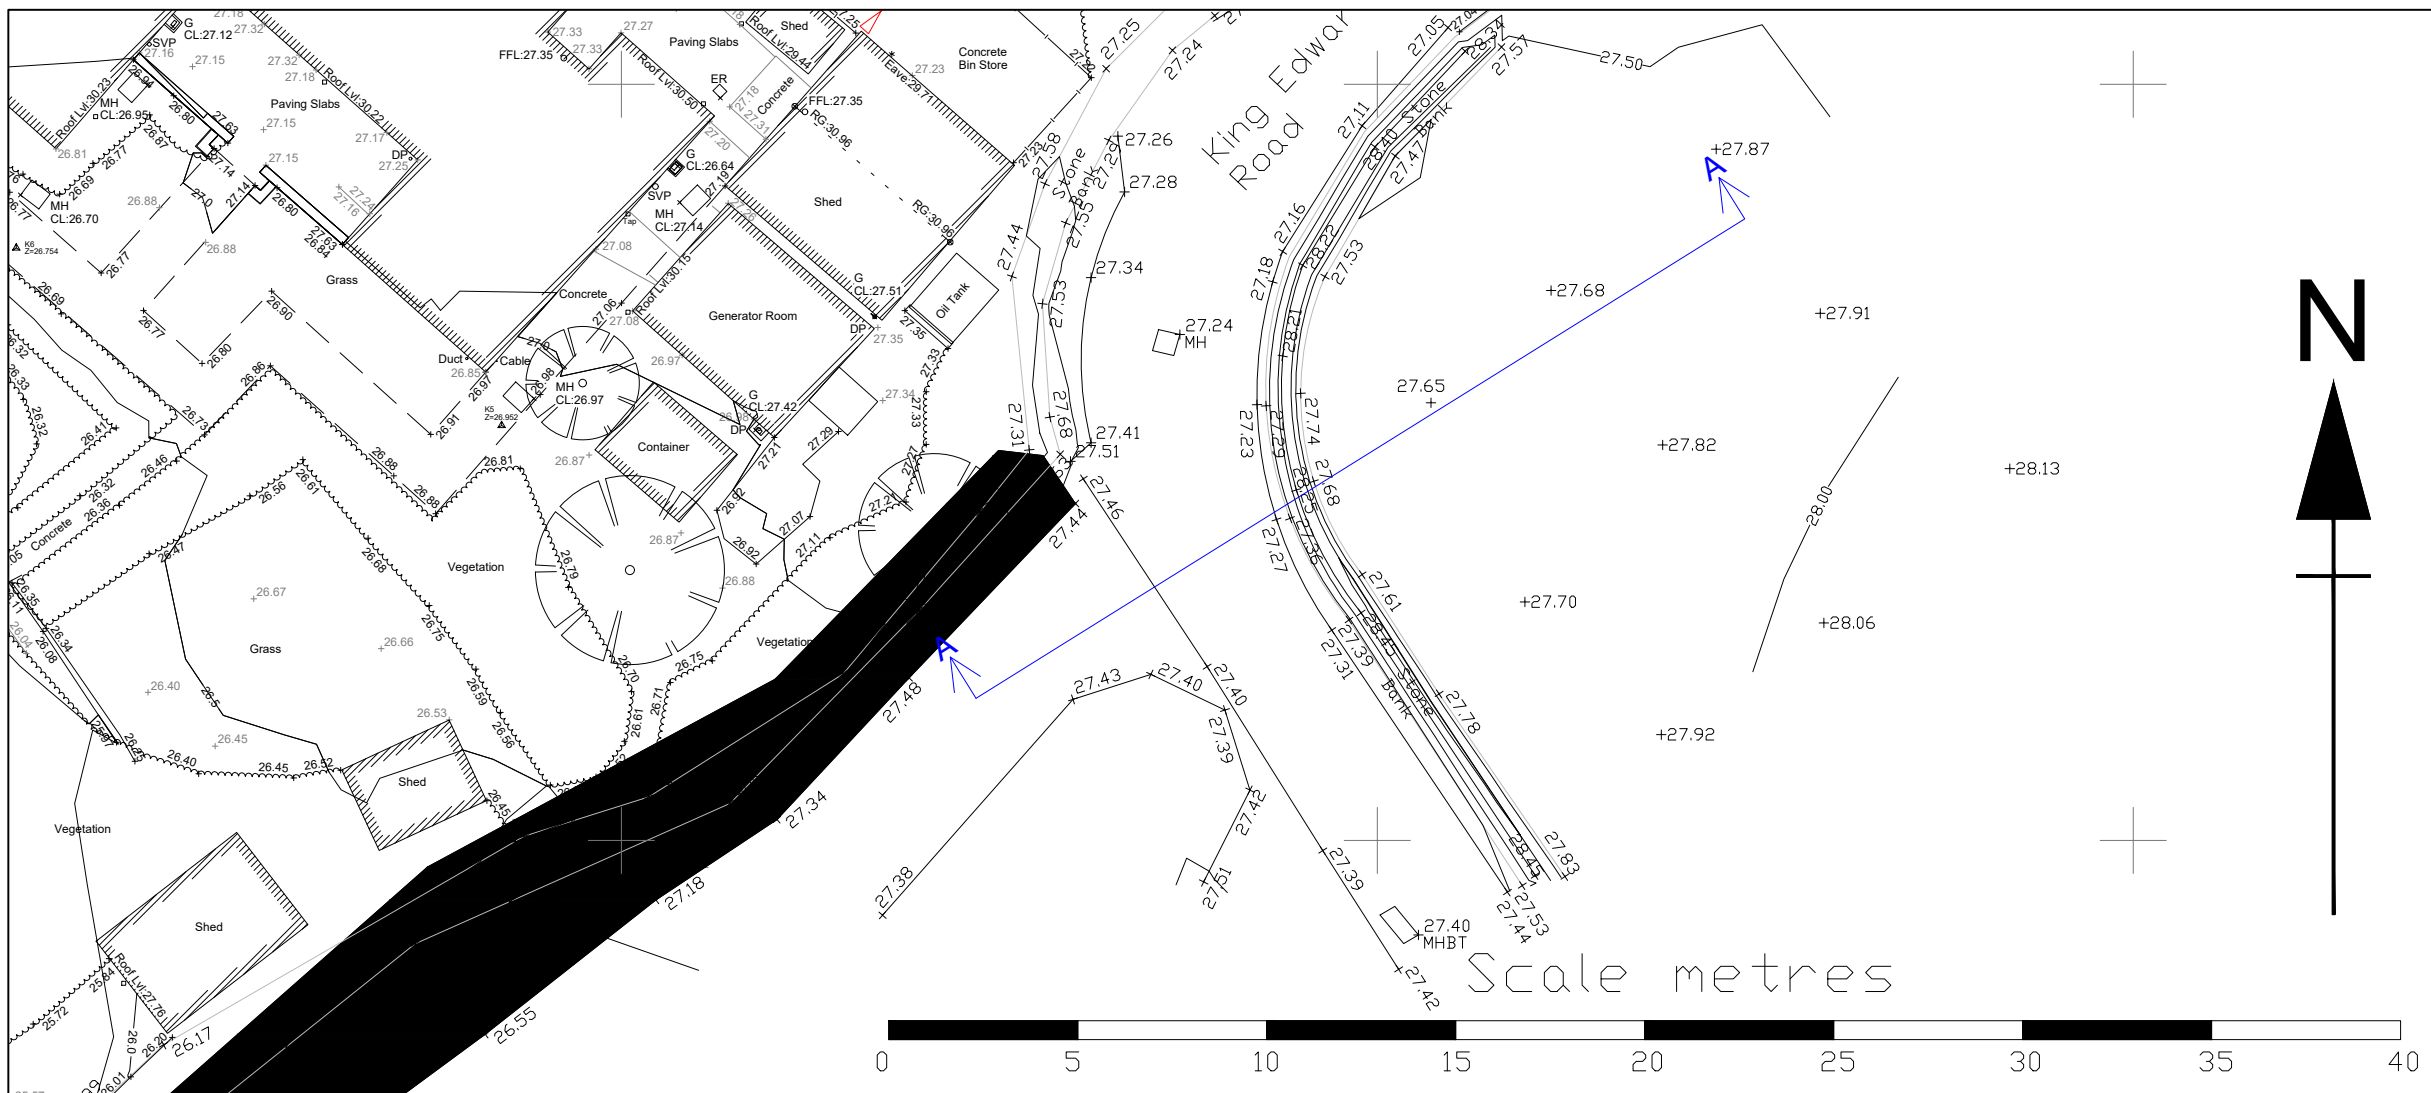
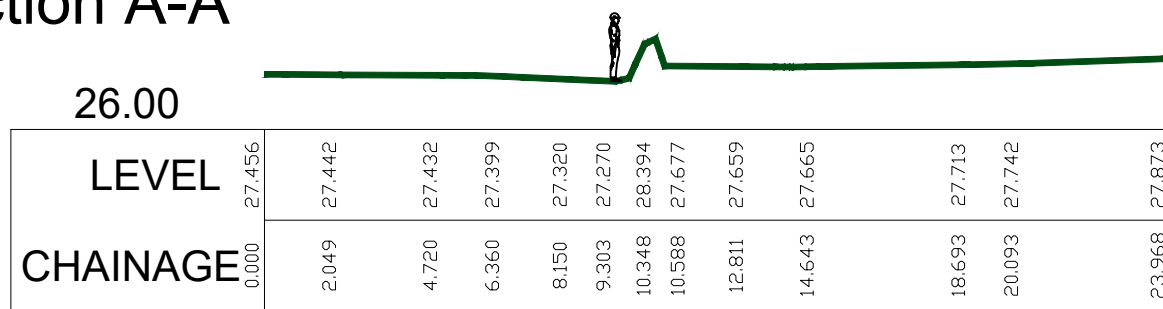
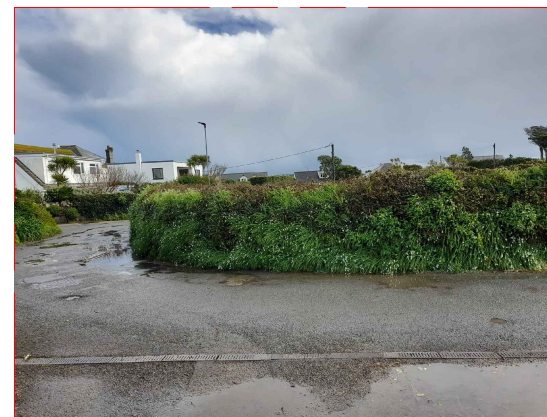
### Existing Section A-A

Horiz. 1:200  
Vert. 1:200

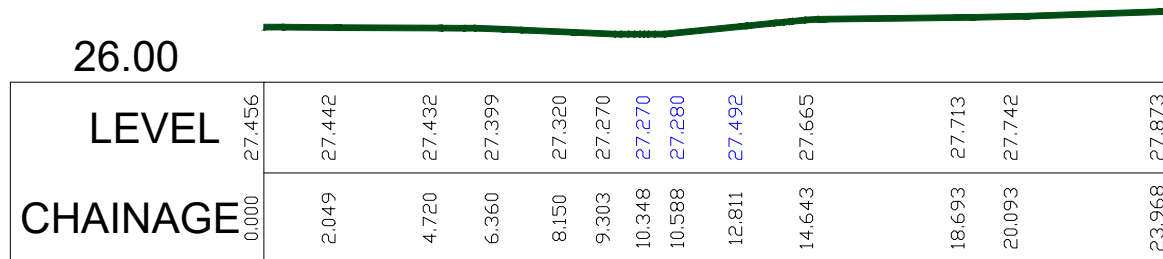
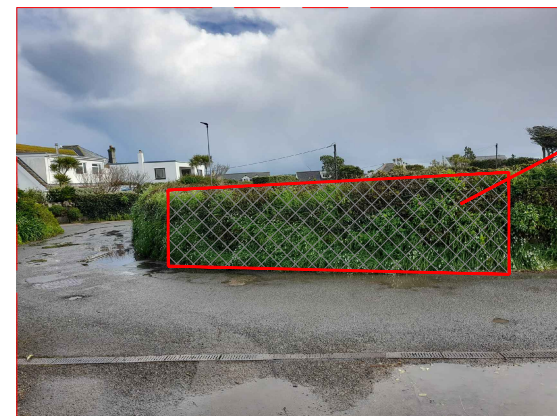
Section of wall to be temporarily removed, set aside and then re-built on completion of the works.

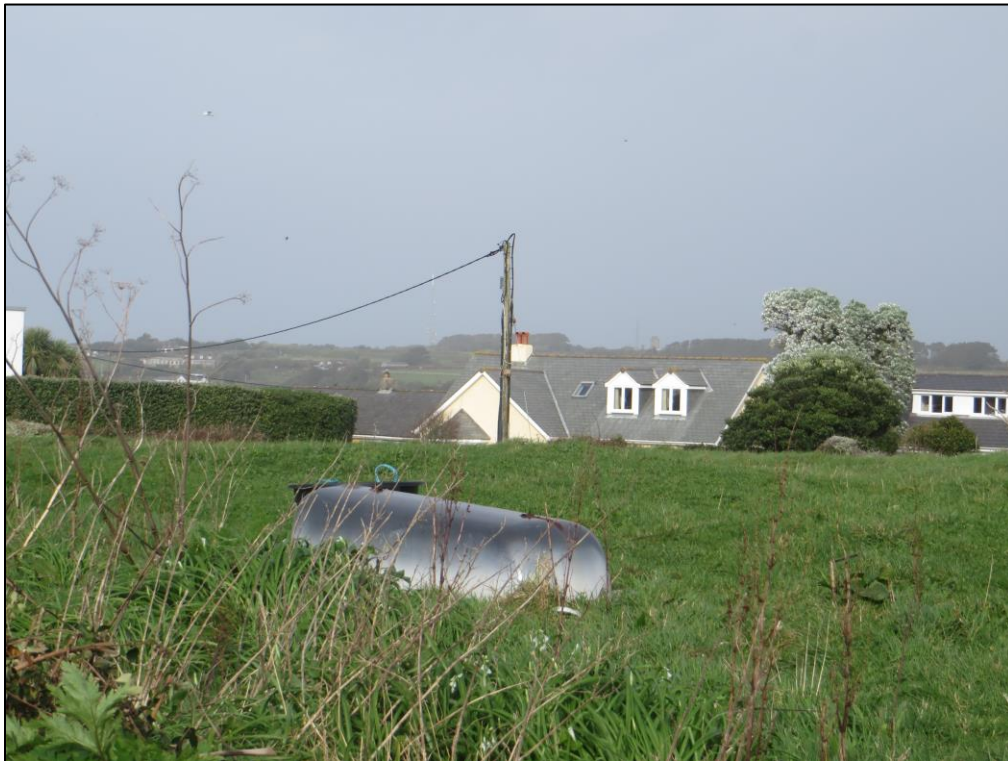
*Figure 4 The scheduled platform cairn in February 2024 (photo: Katharine Sawyer)*

To avoid inadvertent damage to the Scheduled Monument it is recommended that an exclusion zone of 5m should be established around the circumference of the scheduled area of the platform cairn.

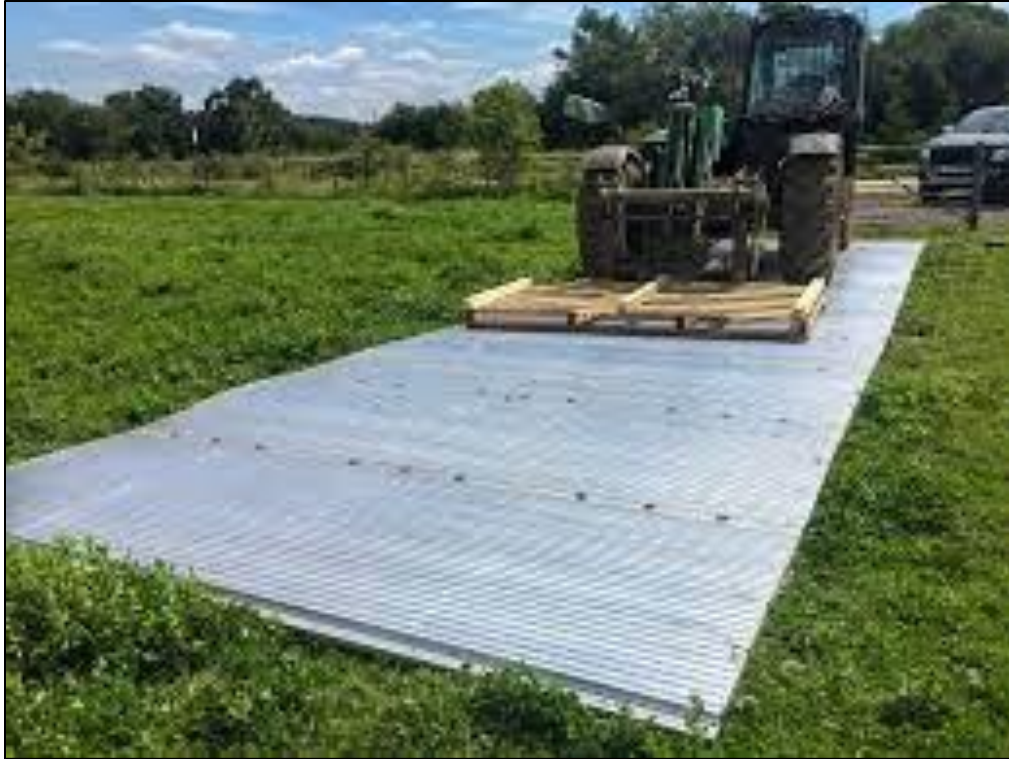
*Figure 11 Example of the type of ground surface matting which will be used..*

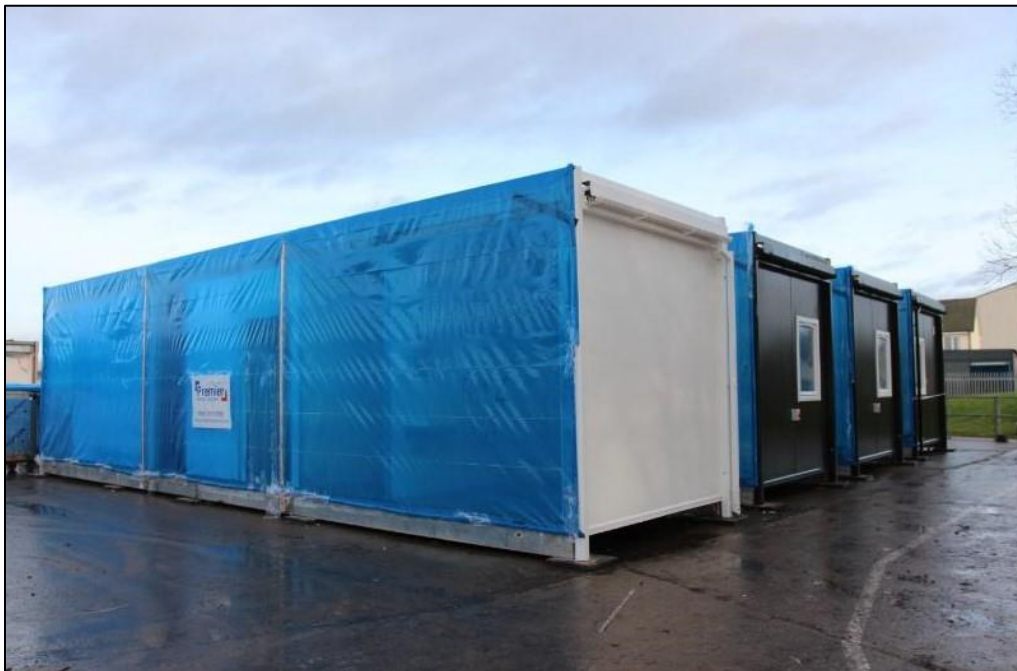
*Figure 12 Example of the type of storage modules which will be used.*

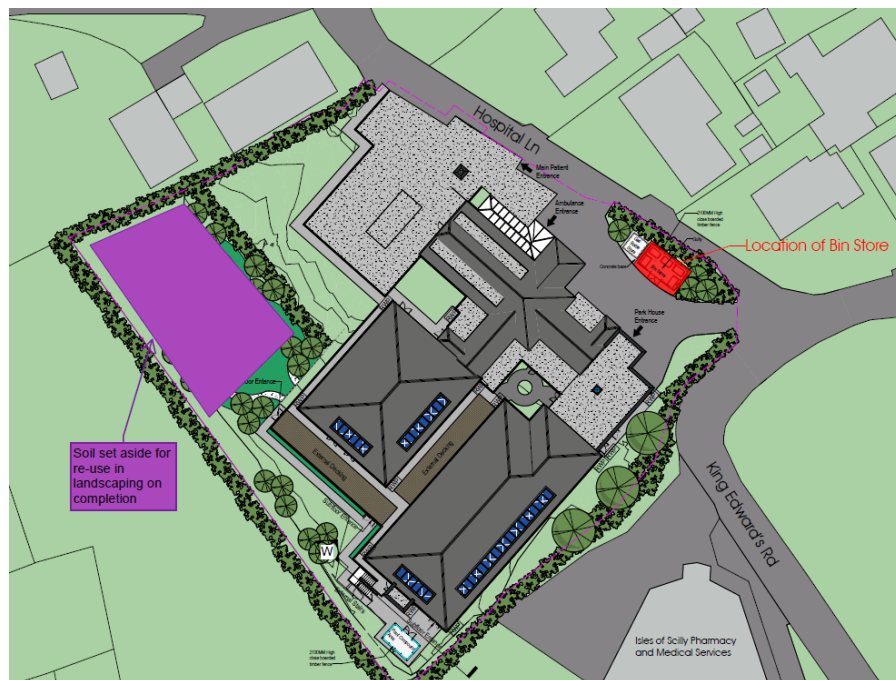
## 7. The storage of excavated spoil

Storage of spoil on Circus Field compound and the hospital site is shown in areas coloured purple on plans below.

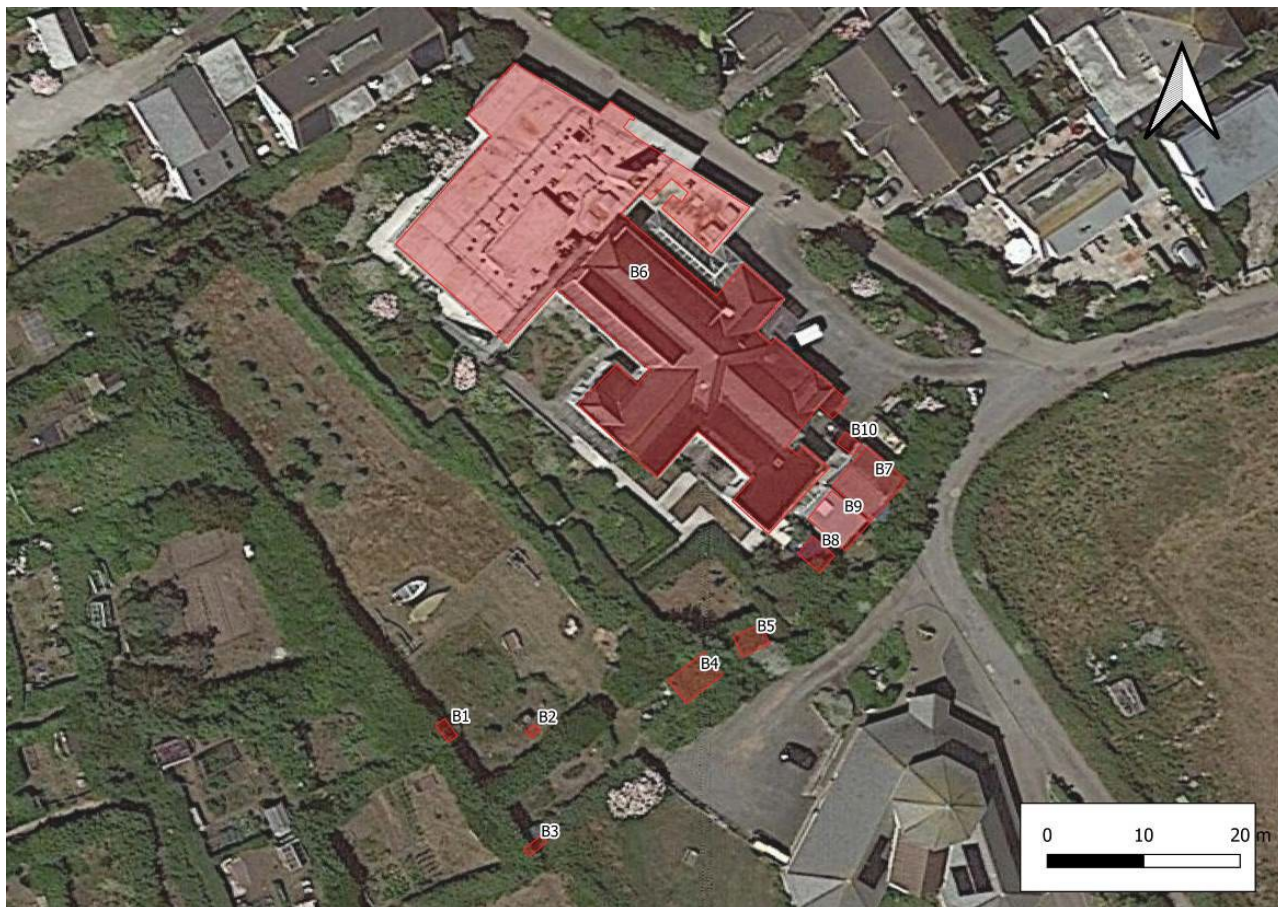
There are a number of buildings due for removal within the Hospital site – these are identified and described in the Ecological Assessment submitted in support of the application and illustrated in the following map.

Any removal of buildings would be subject to pre-commencement inspections for nesting birds and rabbits, to be carried out by the Ecologist. This would include ensuring that rabbits are not present in burrows beneath structures.

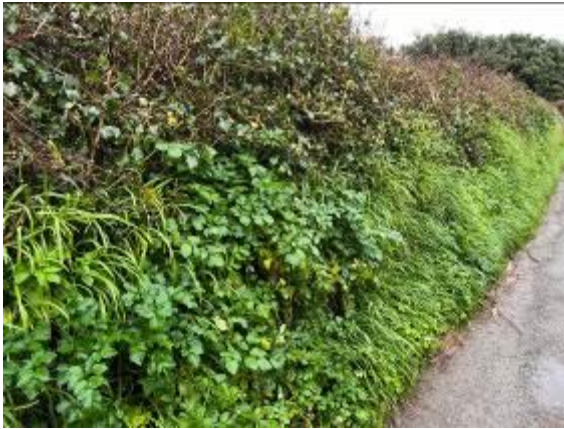
**Photo 01** – Showing the Cornish Hedge on the western boundary with abundant three-cornered leek

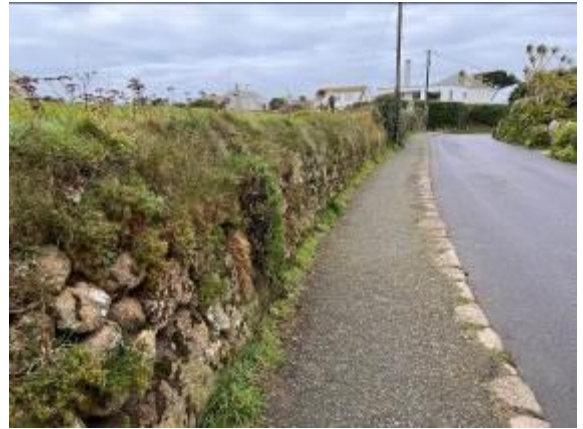
**Photo 02** – Showing the eastern boundary where the Cornish Hedge is level with the Circus Field sward to the west (left) but rises above the offsite pavement to the east (right).

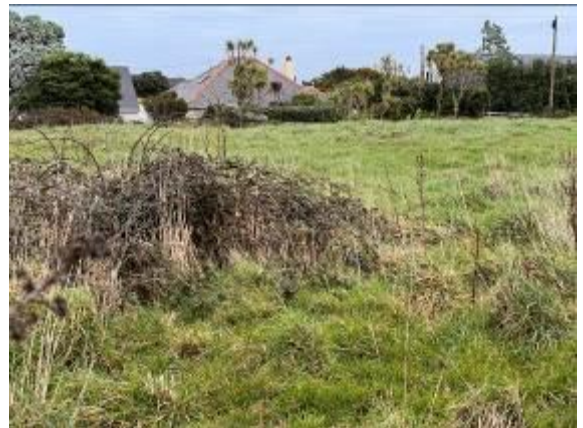
**Photo 04** – Showing the bramble mounds present in the undermanaged western boundary.

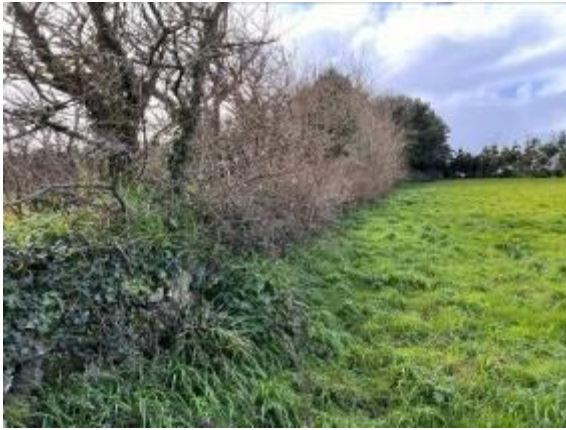
**Photo 07** – Showing the drystone wall and elm trees on the southern boundary.
