## BAT PRESENCE/ABSENCE SURVEYS (PAS)

### PARKSIDE, ST MARY'S, ISLES OF SCILLY

*Report date: 20<sup>th</sup> September 2023*

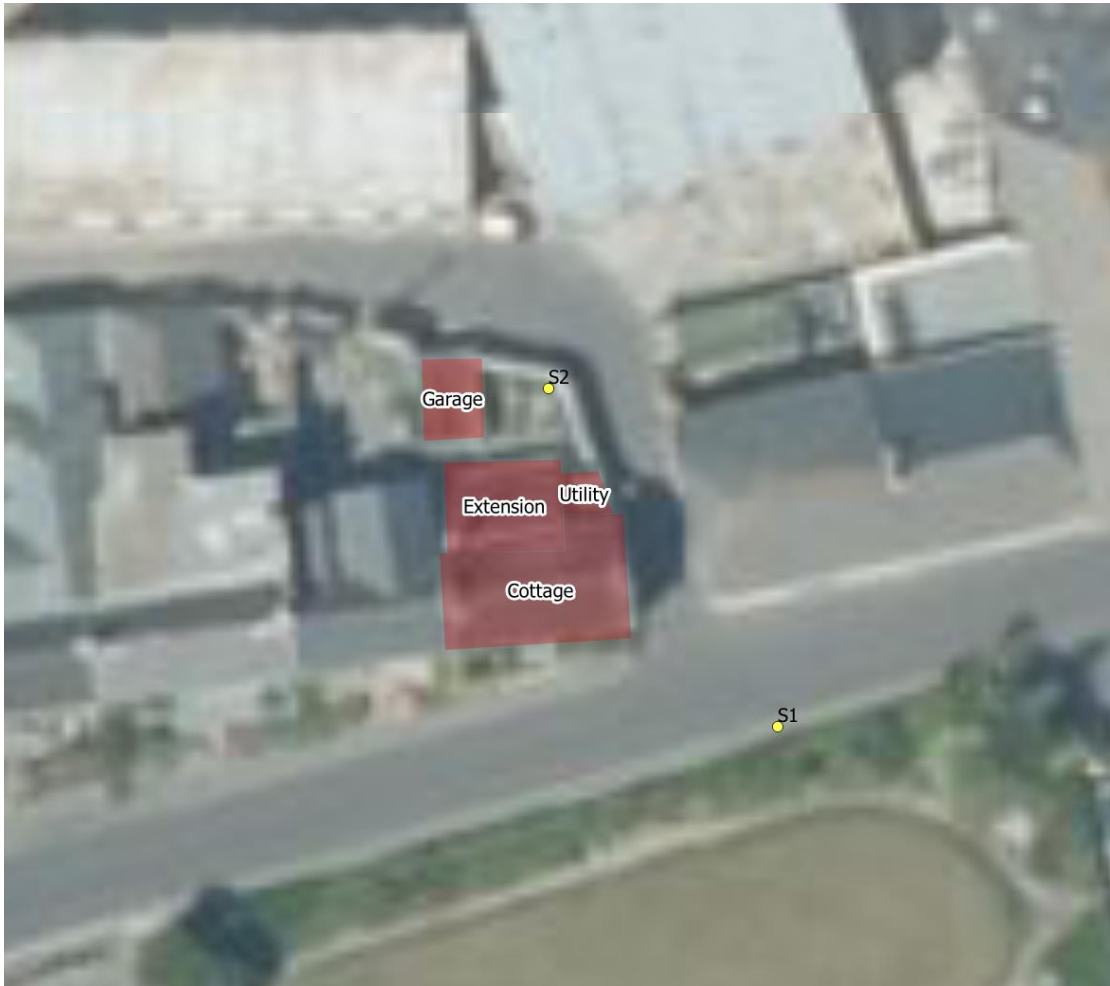
**Map 01** – showing surveyor positions around the building.

In order to ensure that the different elements of the building were surveyed comprehensively in line with the Best Practice Guidance, a total of two surveyor positions were identified. These are identified in Map 01 below.

The surveyor in Position S1 recorded foraging activity by common pipistrelle bats to the south and east of the property from 20:31 until around 20:42. No further activity was recorded after this time. The surveyor in Position S2 recorded the same activity from a different angle but no additional activity was recorded.

The timing and activity recorded was equivalent to that recorded in the initial PAS survey. The surveyor in Position S1 recorded foraging activity by common pipistrelle bats to the south and east of the property from 19:58 until around 20:15. No further activity was recorded after this time. The surveyor in Position S2 recorded the same activity from a different angle but no additional activity was recorded.
