## BAT PRESENCE/ABSENCE SURVEYS (PAS)

### BISHOPS VIEW, ST MARY'S, ISLES OF SCILLY

*Our reference:* 25-6-7

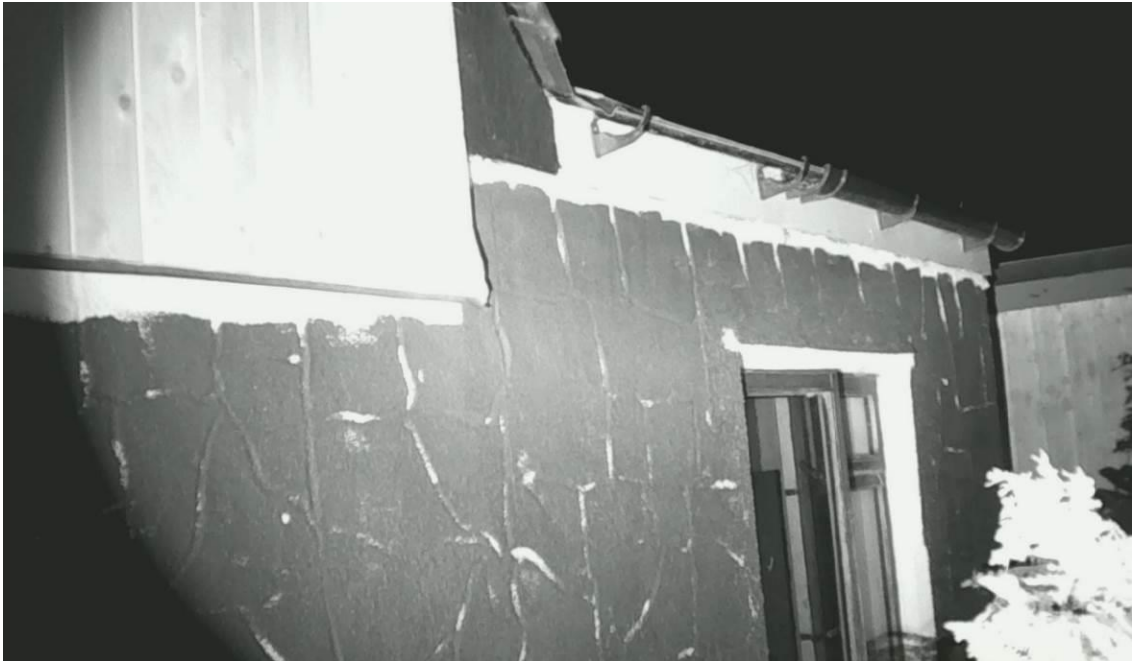
**NVA1** – showing a screenshot from the Nightfox Whisker at position S1.

In order to ensure that the building received a survey effort of a single bat survey for a Low Potential building (in line with the Best Practice Guidance), a single surveyor position with an NVA was deployed immediately adjacent to the fascia feature on the eastern aspect of the building which was identified as the only potential roosting feature or access point for bats during the PRA. This was a feature of limited extent at single-storey height allowing comprehensive and close observation by the surveyor.

The NVA Field of Vision (FOV) covered the areas under survey – see Appendix 2 for example screenshots from the footage.
