**Co-op Food Store,  
Hugh Street, St.Mary's,  
Isles of Scilly**

## **PHASE ONE ENVIRONMENTAL ASSESSMENT REPORT (PRELIMINARY RISK ASSESSMENT)**

Client:  
The Co-operative Group Ltd

| Report | CP25230 CL 001 |

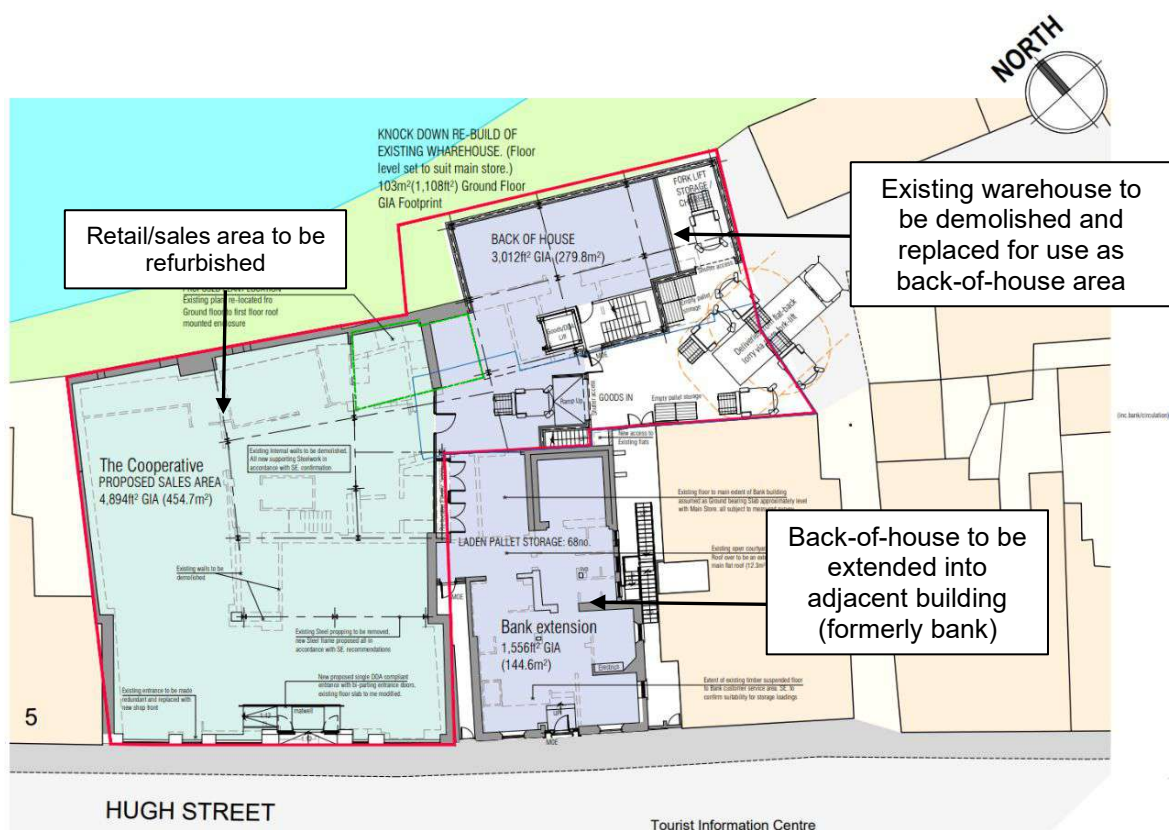
A site plan showing the proposed development plan is provided below.

- Re-furbishing the existing sales / retail area.
- Knock-down and re-build the existing warehouse area to the rear of the site, for continued use as 'back-of-house' area.
- Extend the 'back-of-house' area into the newly acquired adjacent building (formerly a bank).
- Retain first floor flats.

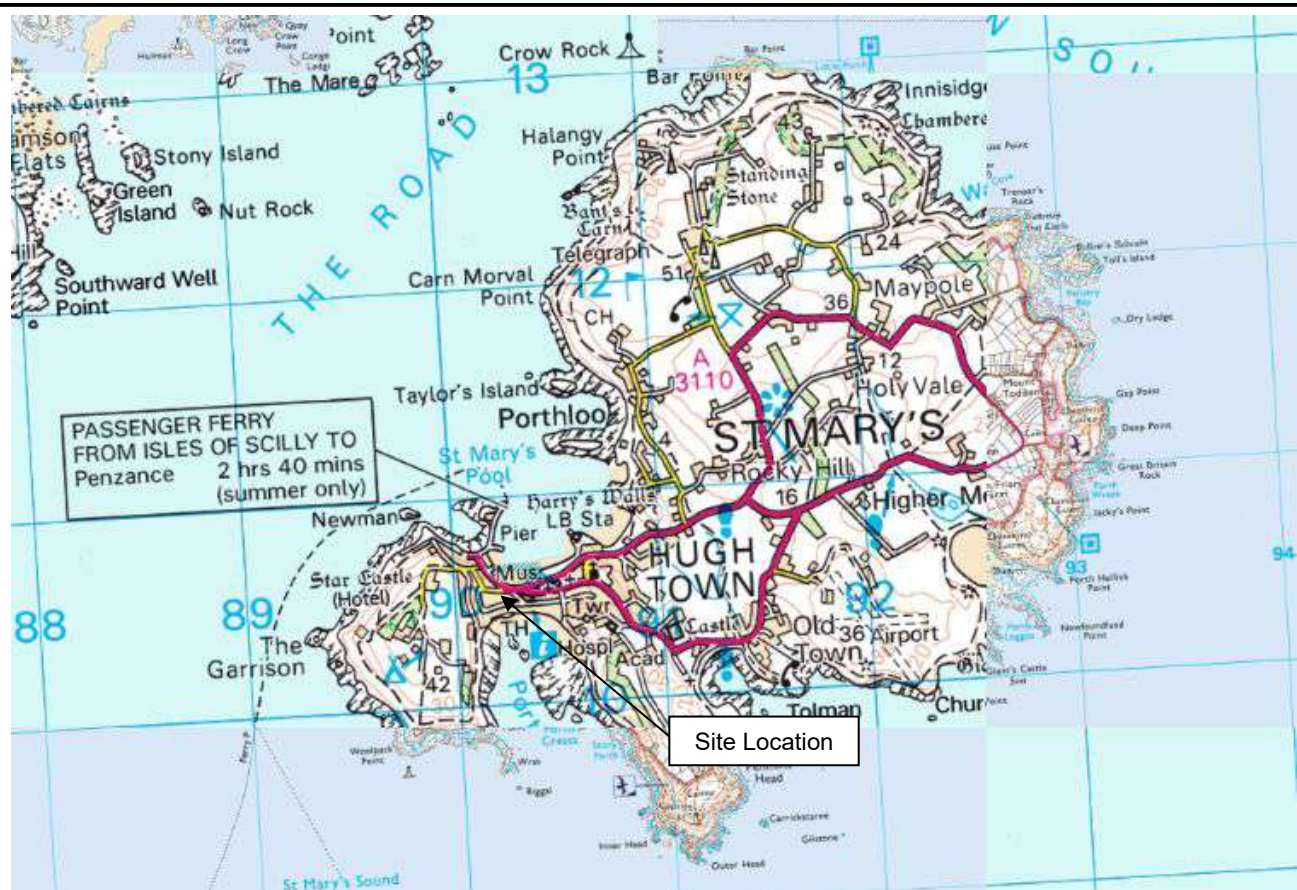
**Figure One: Site Location Map**

| Grid Reference | 90240, 10590 | Location | The site is located on Hugh Street and is located <1 km from Hugh Town centre on St.Marys. An OS map showing the site's location is provided below. |

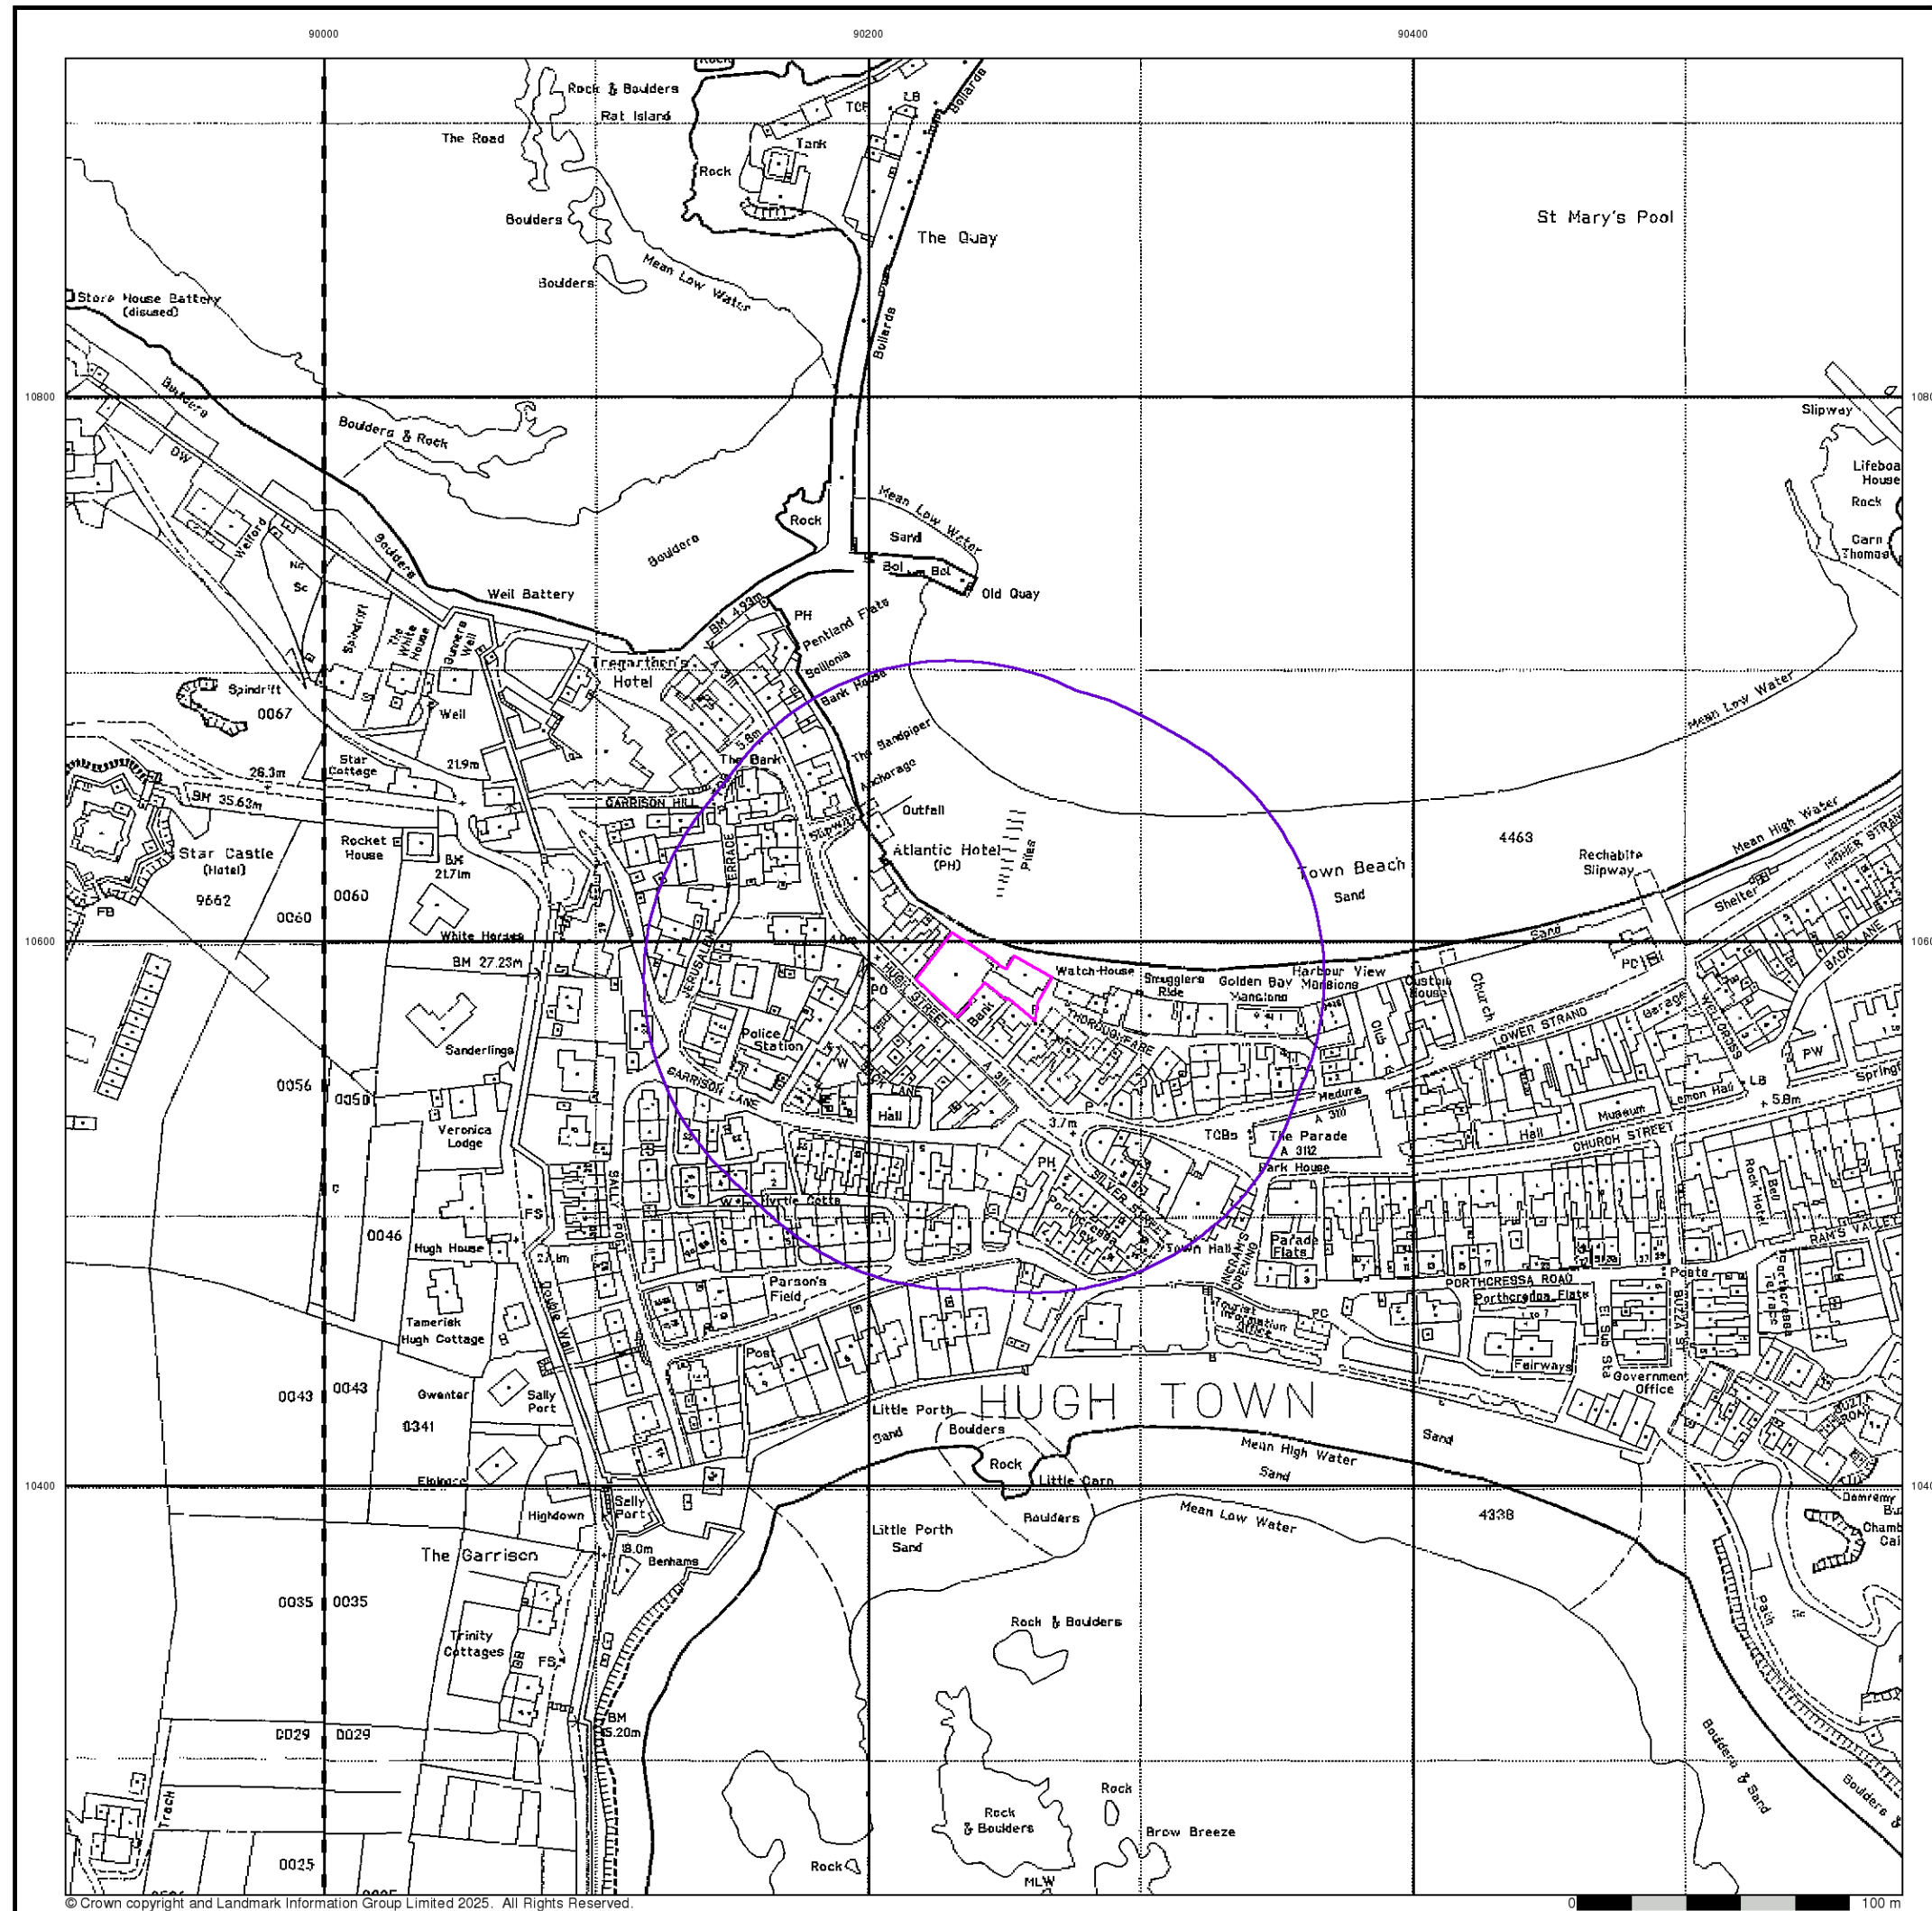
## Ordnance Survey Plan

| Date | Review of Map – Description of Land Use at Site and in the Immediate Surrounding Area | Potentially Contaminative Land-use | |
|---|---|---|---|
| 1980-1981<br>(1:2,500 Scale) | The site is now depicted as one large building to the west and one smaller building to the eastern site boundary.<br><br>A throughfare south of the second building is present. The site is likely to have been for commercial/ retail use given the location and surrounding uses.<br><br>Further development of larger residential properties with large gardens to the west and south-west (~150m to 200m). Small residential development to the east with some commercial uses (~150m). | | |

Published 1980 - 1981
