**Co-op Food Store,  
Hugh Street, St.Mary's,  
Isles of Scilly**

## **PHASE ONE ENVIRONMENTAL ASSESSMENT REPORT (PRELIMINARY RISK ASSESSMENT)**

Report	CP25230 CL 001
Date	January 2025
Page	1

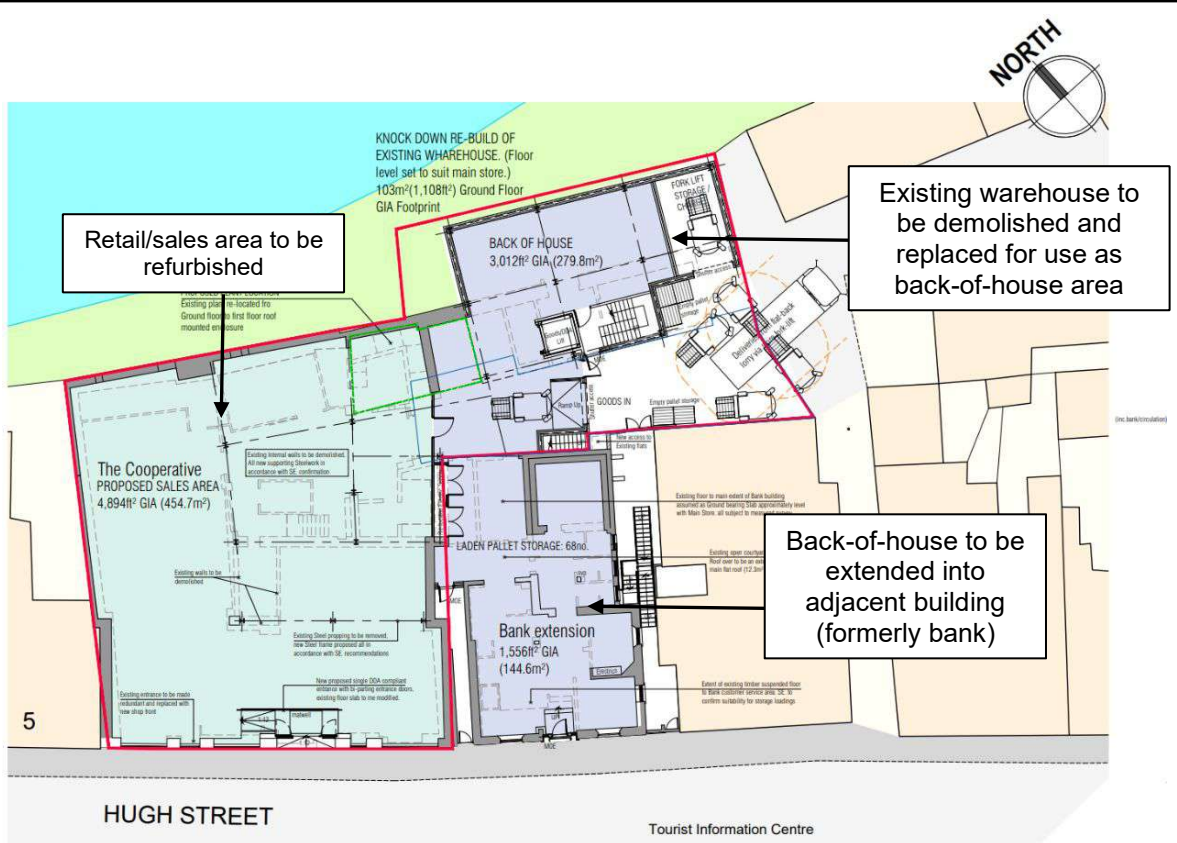
Table One: Proposed Development Plans

A site plan showing the proposed development plan is provided below.

- Re-furbishing the existing sales / retail area.
- Knock-down and re-build the existing warehouse area to the rear of the site,for continued use as 'back-of-house' area.
- Extend the 'back-of-house' area into the newly acquired adjacent building (formerly a bank).
- Retain first floor flats.

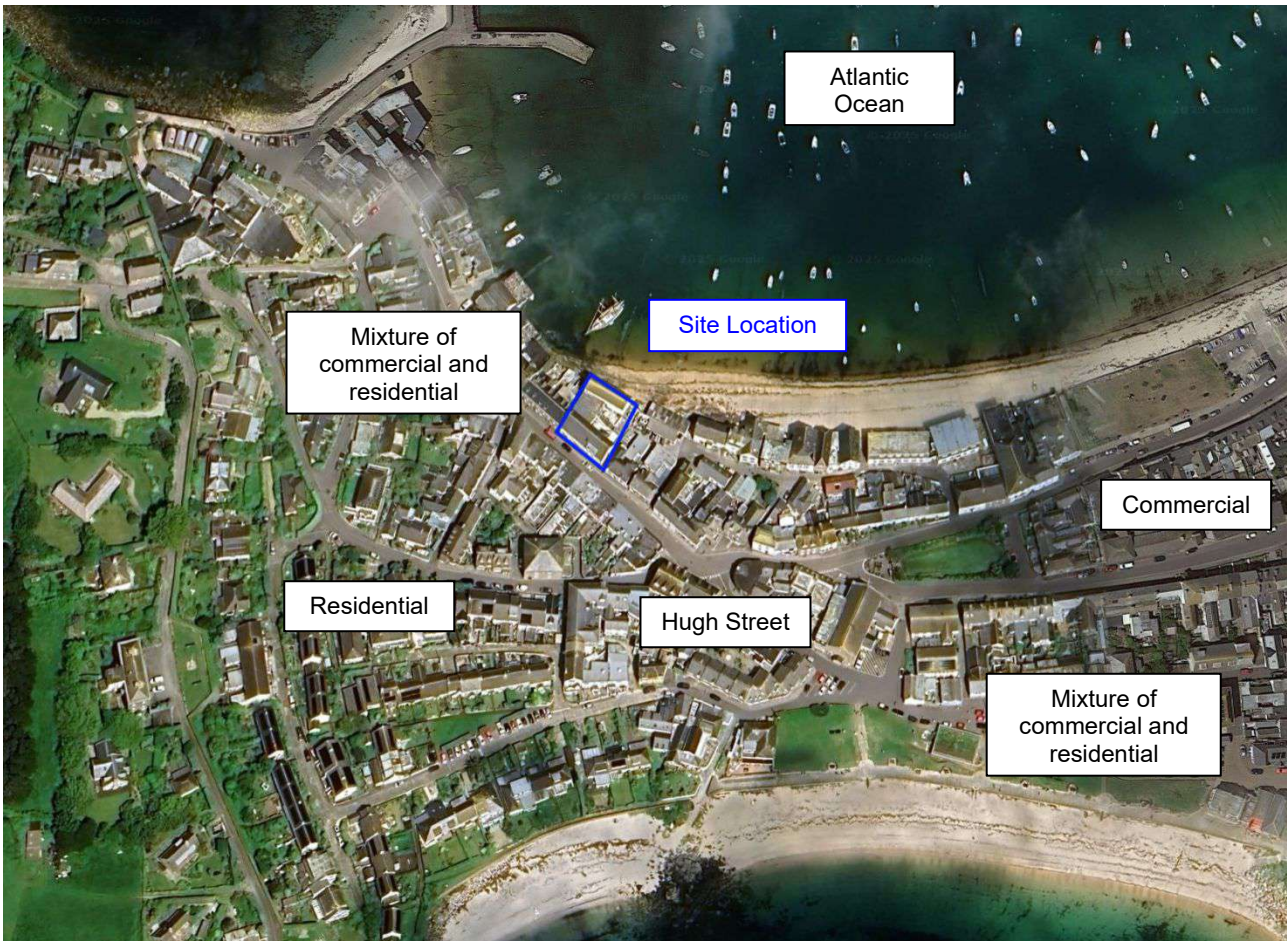
**Figure Two: Aerial Photograph Showing Site and Surrounding Area**

Direction	Details
North	Town Beach on site boundary, sea front <10m. St Mary's Isles of Scilly Terminal (sea port)(~200m).
East	Neighbouring commercial uses including travel agents, retail, and restaurants (<10m) and numerous residential properties (entire properties and/or first floor flats)
South	Hugh Street on site boundary. Beyond are residential properties and accommodation (<5m).
West	Residential properties with gardens (~20m). Large open fields (~200m).
