PLAN FOR ECOLOGY

Bat Survey Report

Site: Borough Farm, Tresco, Isles of Scilly, TR24 0PX

24th July 2025; version 1

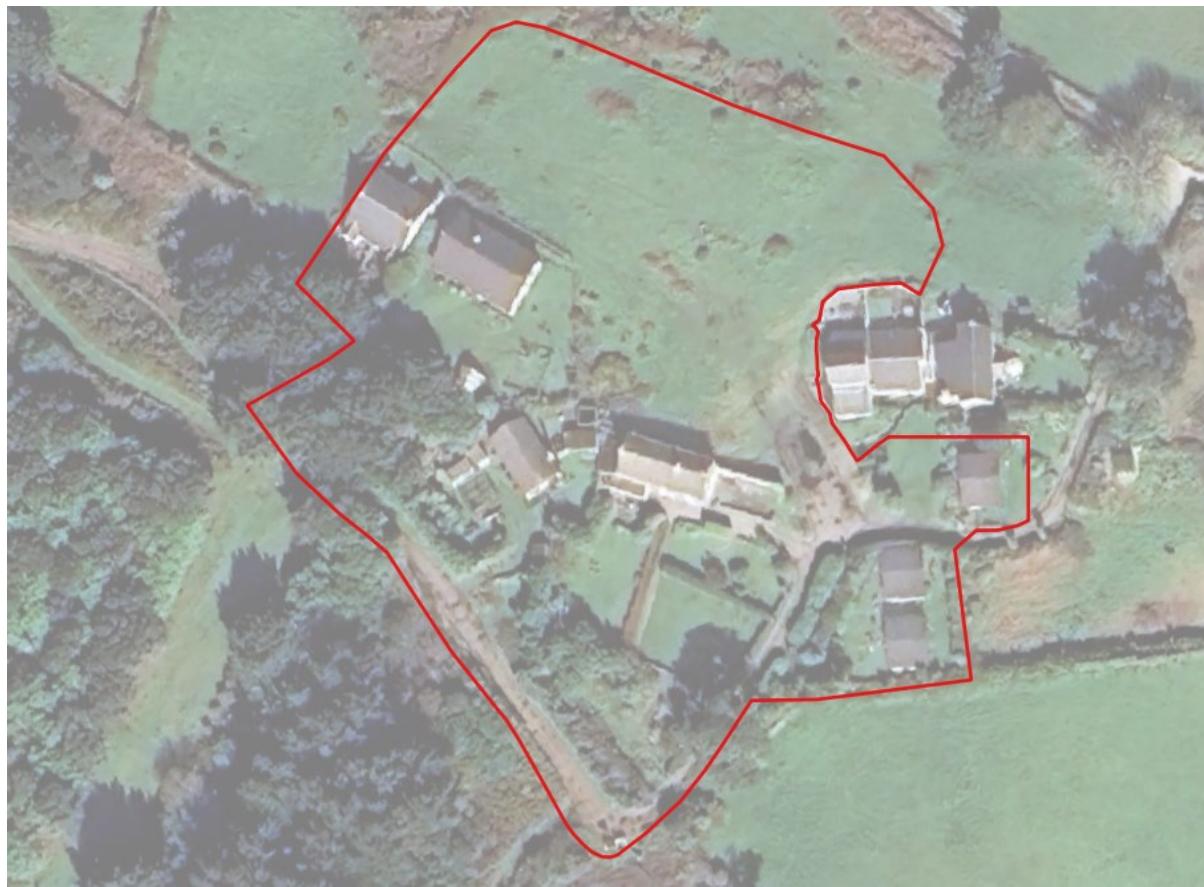
Figure 1. Existing site plan showing buildings present within the red line planning boundary.

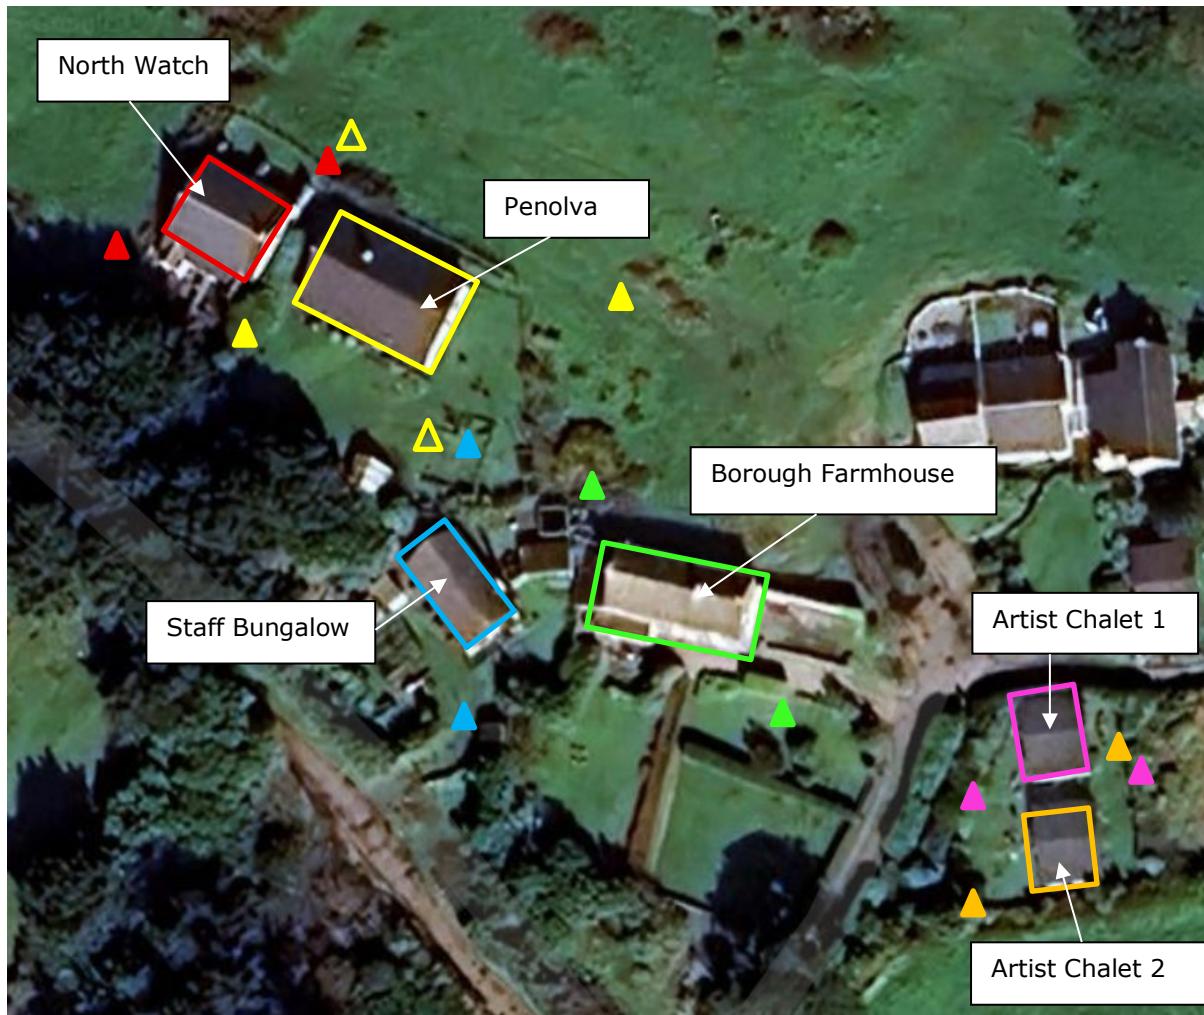
Figure 2: Emergence surveys – aerial view of the site showing the buildings surveyed. Triangles indicate surveyor and/or camera locations during the emergence survey(s) of each building. NB. Unfilled yellow triangles indicate location of surveyors/ cameras on first emergence survey of Penova and filled yellow circles on second emergence survey.

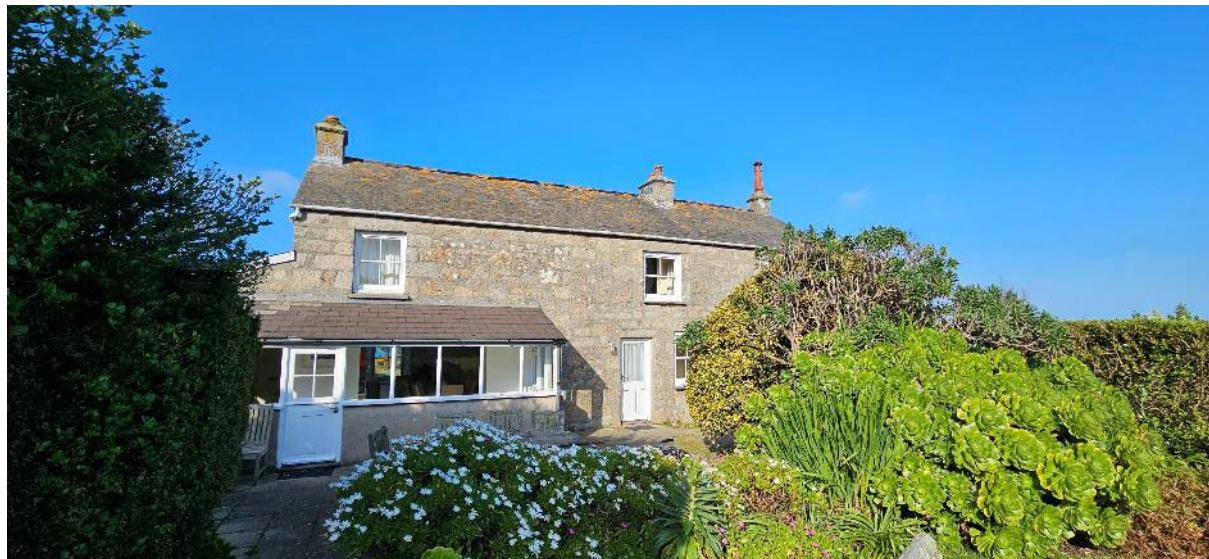
Borough Farmhouse is a two-storey stone farmhouse in use as a holiday rental (Figs. 3-4). The building features a slate tile roof with concrete ridge tiles, one row of slate hanging tiles on the gable ends, three stone chimneys with clay pots, and timber fascia boards, windows and doors. A single storey mono-pitched protection is located on the west gable end, together with a tile roofed, single storey sunroom off the south elevation. Several gaps are present beneath the ridge tiles, notably towards the east gable end of the property. There are also gaps beneath the timber fascia boards and hanging tiles. These features have potential to provide suitable roost sites for bats or access to the roof void interior.

Figure 3: South elevation of Borough Farmhouse.

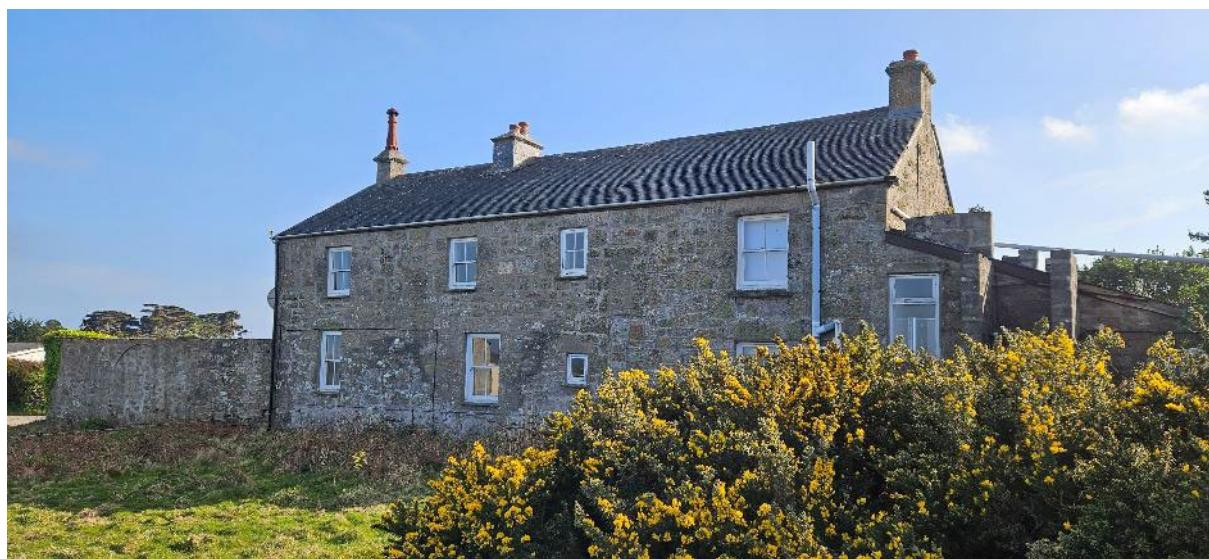
Figure 4: North elevation and west gable end of Borough Farmhouse.

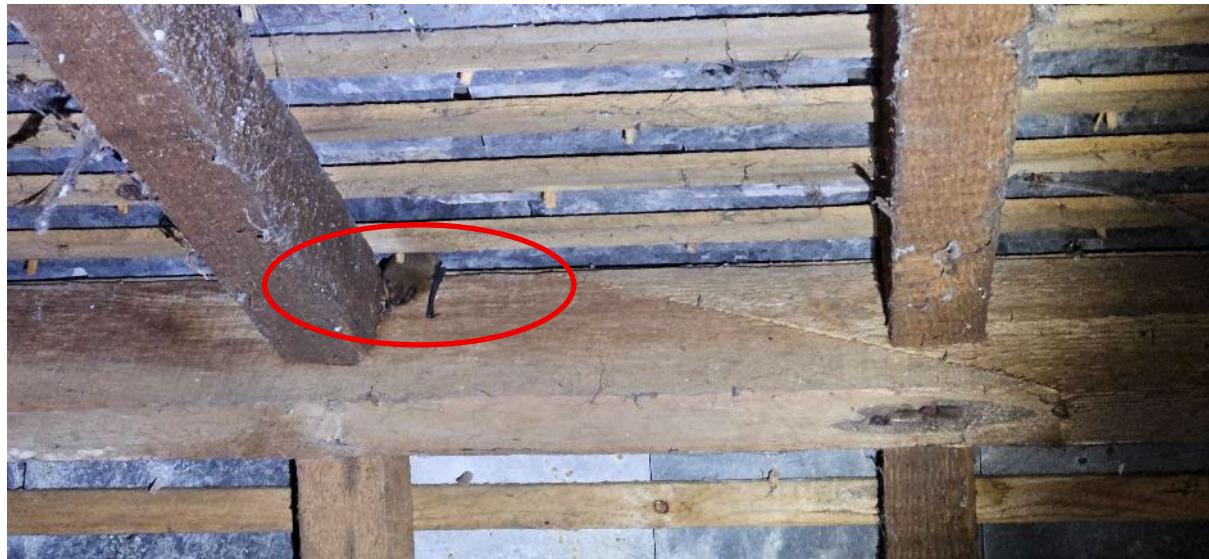
Internally, there are two accessible shallow, unlined roof voids above the first floor; each void measures c. 1.2m x 4m x 4m. Access was limited to the immediate vicinity of the loft hatches due to the shallow pitch of the roof. No bat droppings were found but a single common pipistrelle bat was observed roosting at the ridge within the most easterly roof void (Fig. 5). This bat, observed on a warm, sunny day on 19th March 2025, was very active and quickly moved away from the torch light, suggesting that this bat was day roosting as opposed to hibernating. NB. the roof void in which

the bat was located slopes south and would likely warm up on sunny days, even in winter. Hibernating bats require consistently cool and humid conditions, and the roof void within Borough Farmhouse does not provide these conditions.

Figure 5: Eastern roof void interior of Borough Farmhouse and roosting common pipistrelle bat at ridge (red outline).

Borough Farmhouse is a confirmed bat roost and was assessed as being of '**moderate**' suitability for roosting bats, in line with Collins (2023).

- The three common pipistrelle bat day roosts will be lost. Three alternative roost features must be provided within the replacement buildings. These should comprise a combination of raised ridge tiles/ bat slates over a bat safe membrane; 20mm x 50mm gaps beneath timber fascia boards; and/or bat boxes incorporated into the fabric of the proposed buildings (to be agreed with the client). The alternative roost features should be located as close as possible to the locations of the roosts to be lost.

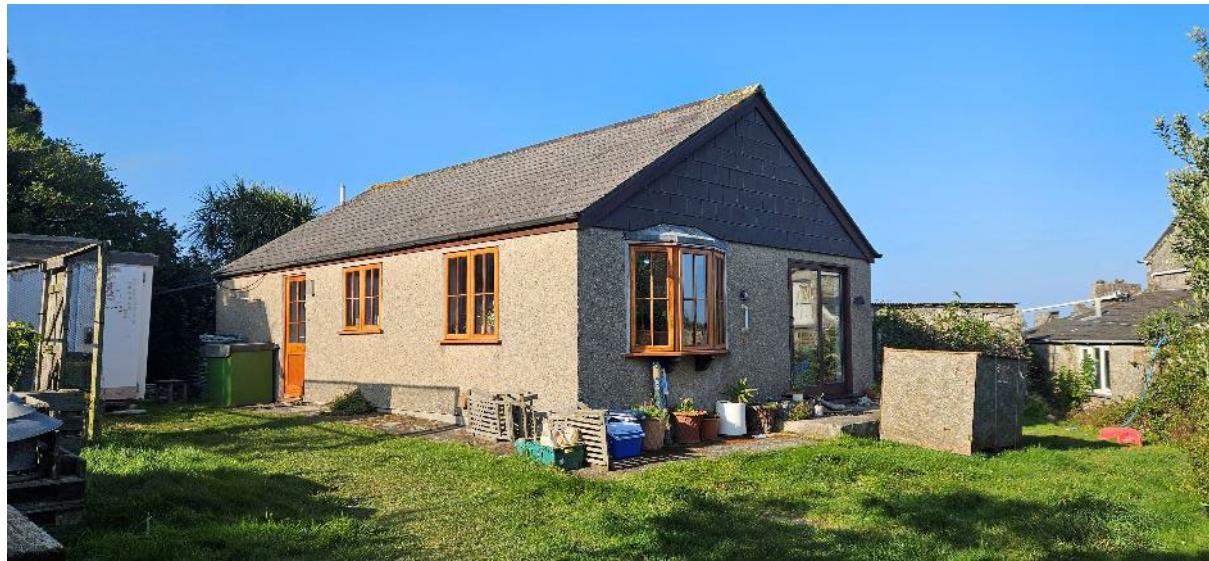
The Staff Bungalow is in full-time occupation as a residential property (Fig. 6). The property is of block construction with a composite tile roof, concrete ridge tiles and a single rendered chimney. The window and door apertures and fascia boards are timber, and the exterior of the property features a pebbledash render and uPVC rainwater goods. The gable ends of the property are clad with hanging composite tiles. There are gaps beneath the hanging tiles, timber fascia boards and potentially beneath ridge tiles around the chimney. These features have potential to provide suitable roost sites for bats or access to the roof void interior.

Internally, the Staff Bungalow features a single large, uncluttered roof void above the ground floor. The void has a traditional timber structure without struts and purlins and is lined with a bitumen membrane.

The Staff Bungalow was assessed as being of '**moderate**' suitability for roosting bats, in line with Collins (2023).

Figure 6: South and east elevations of the Staff Bungalow.

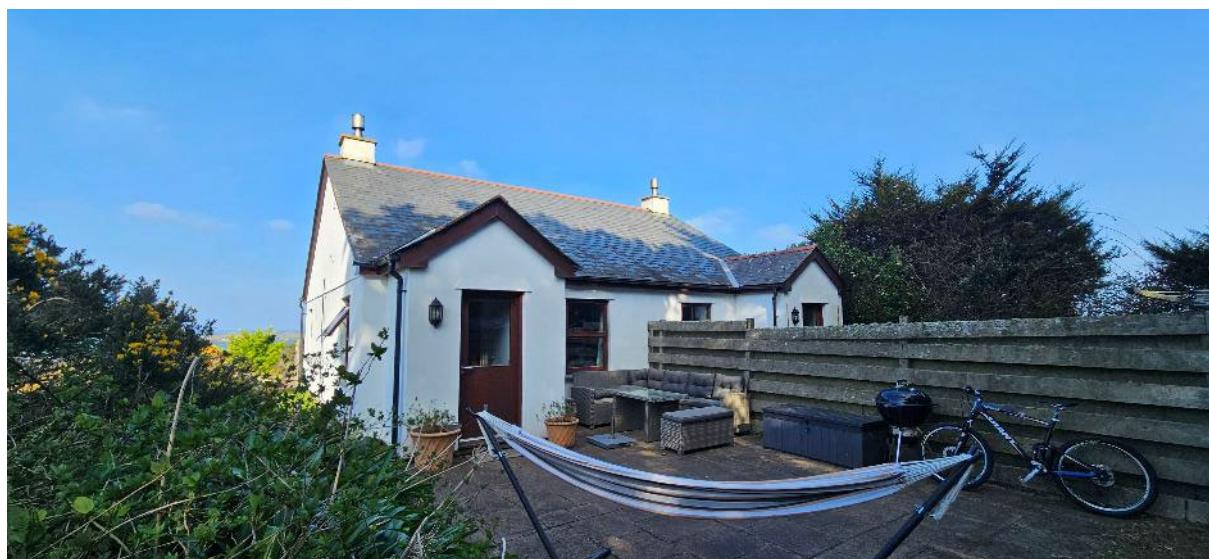
North Watch comprises two semi-detached, residential, single-storey buildings in current use. The combined property features a slate roof with clay ridge tiles and two rendered chimneys (Fig. 7). The fascia boards, soffits, window and door apertures are timber. The property is likely of block construction and is rendered externally. There are gaps beneath three missing roof tiles, beneath the timber fascia boards, occasional gaps where the soffit meets the wall top, and a possible gap at the ridge was noted. These features have potential to provide suitable roost sites for bats or access to the roof void interior. Internally, there is a separate roof void above each property (North Watch 1 & 2). Both voids feature 'W' style crossing roof timbers and a synthetic roof lining and are boarded out for storage.

North Watch 1 and 2 were assessed as being of '**moderate**' suitability for roosting bats in line with Collins (2023).

Figure 7: North Watch 1 (left) and 2 (right) – south and west elevations.

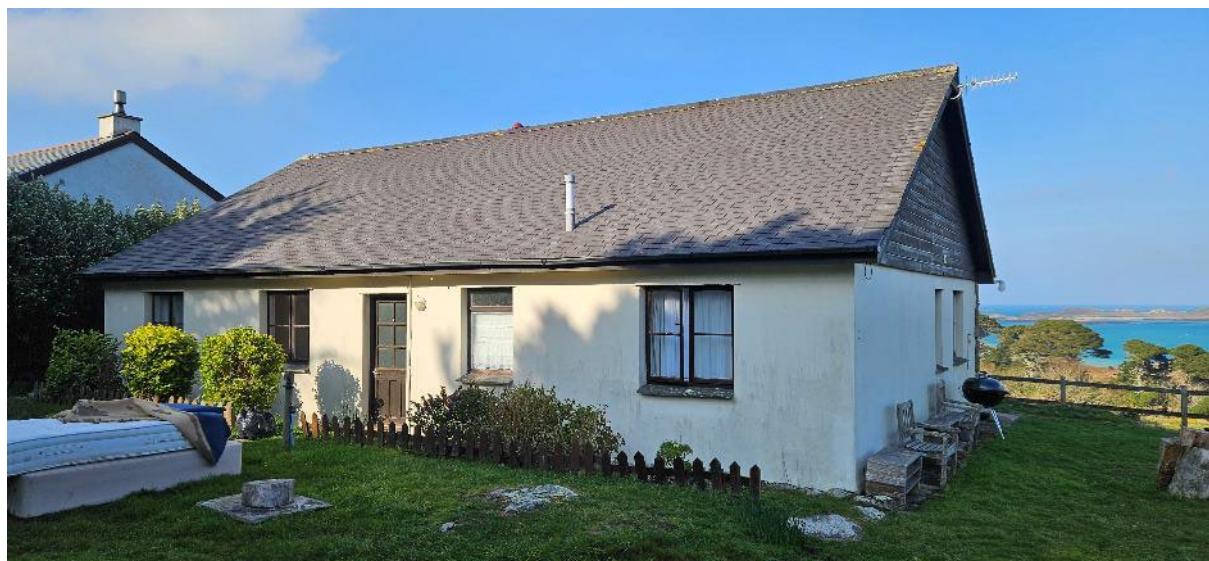
Penolva comprises a single-storey, detached residential property (Figs 8-9). The property features composite roof tiles and concrete ridge tiles, timber fascia boards, soffits, window and door apertures, uPVC rainwater goods and a single rendered chimney. Penolva is likely of block construction and is rendered externally. Timber cladding is present on the gable ends of the property and the exterior of the property is stone-clad on the north elevation. Potential gaps were noted at the ridge, beneath the timber cladding on the gable ends, beneath the timber soffits and at the gable apex. These features have potential to provide suitable roost sites for bats or access to the roof void interior. Internally, the property features a single, large bitumen lined roof void over the ground floor. Light was noted penetrating the void indicating potential access points for bats. The roof void is partially boarded out and in use for storage. Rolled insulation is present between the timber floor joists.

Penolva was assessed as being of '**moderate**' suitability for roosting bats, in line with Collins (2023).

Figure 8: South elevation and east gable end of Penolva showing timber clad gable.

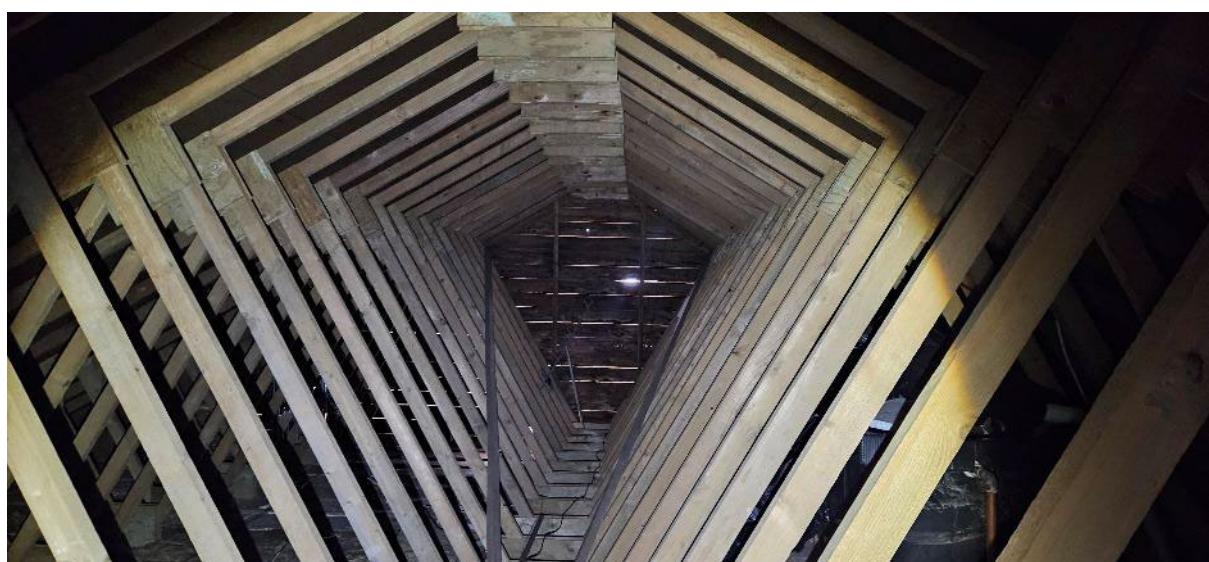
Figure 9: Roof void interior of Penolva.

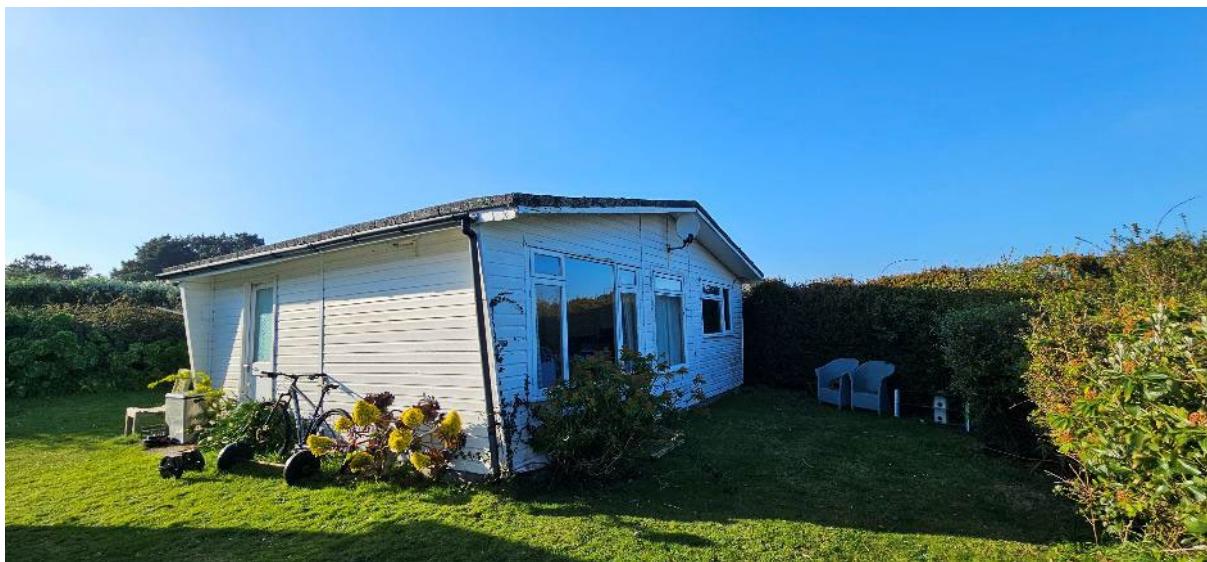
The Artist Chalets comprise two detached chalets of timber construction with timber soffits and fascia boards, a bitumen roof covering and uPVC windows and rainwater goods (Figs 10-11). The chalets have no accessible roof voids internally but there is likely a shallow void above the interior ceilings. Externally, there are 1-2cm gaps beneath the soffit board on the gable ends of each chalet. These features have some limited potential to provide suitable roost sites for bats or access to the roof void interior.

Artist Chalets 1 and 2 were assessed as being of 'low' suitability for roosting bats, in line with Collins (2023). **NB.** Following the first bat emergence survey of Artist Chalet 2, during which a bat was seen to emerge from the building, an additional bat survey was recommended.

Figure 10: Artist Chalet 1.

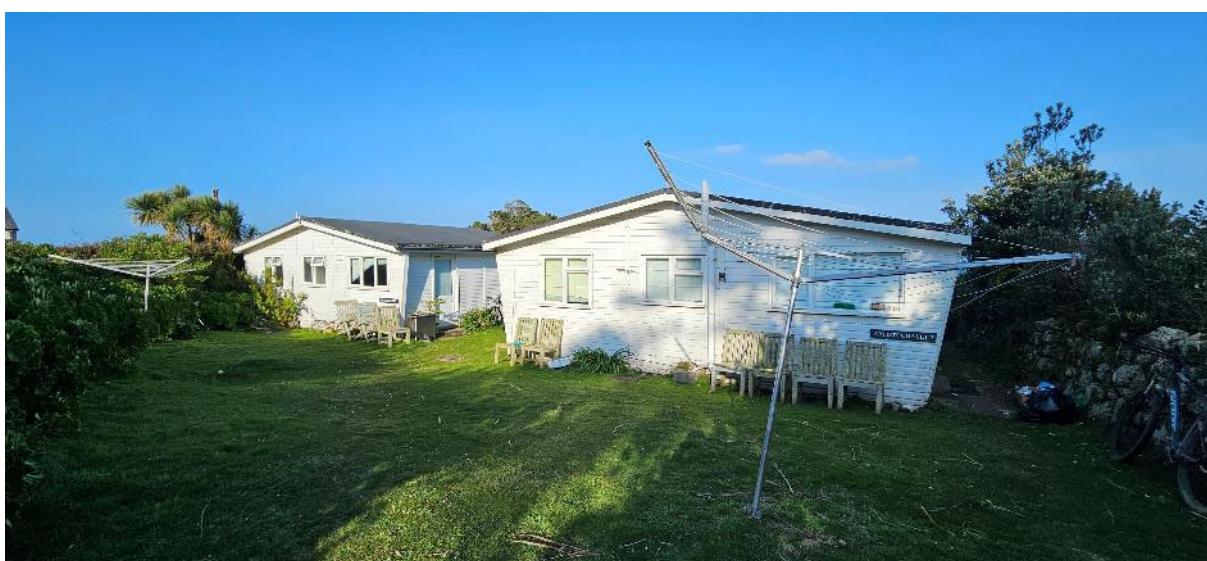
Figure 11: Artist Chalet 2 (right).

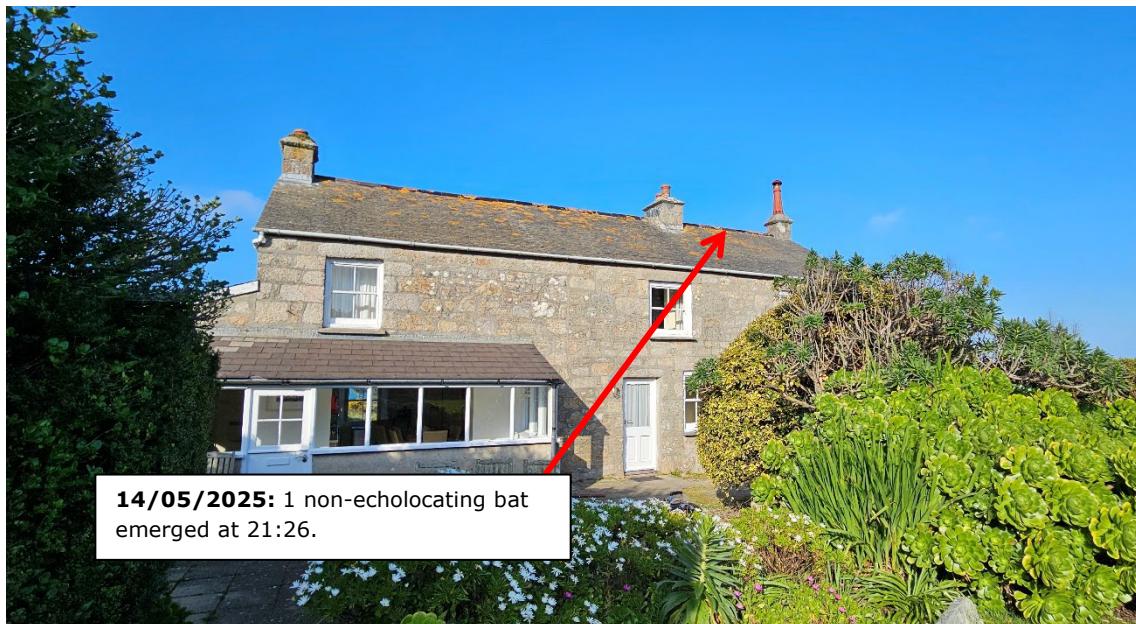
During the first emergence survey on 14th May 2025, one non-echolocating bat was observed to emerge from the roof ridge at the eastern end of the building (Fig. 12). Based on the results of the visual assessment, during which a common pipistrelle bat was seen day roosting below the ridge within the eastern roof void, this bat is assumed to be a common pipistrelle bat.

Figure 12: South elevation of Borough Farmhouse showing bat emergence location.

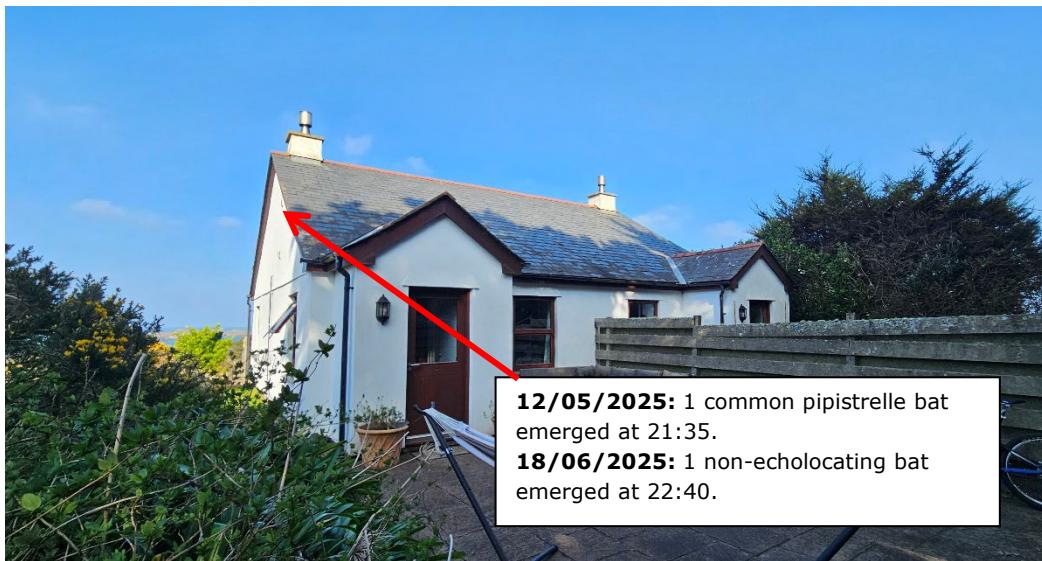
During the first survey on 12th May 2025, one common pipistrelle bat emerged from beneath the fascia on the west gable end (Fig. 13). During the second emergence survey on 18th June 2025, one non-echolocating bat emerged from the same access point as during the first survey; based on the results of the first emergence survey, this bat is assumed to be a common pipistrelle.

Figure 13: South elevation and west gable end of North Watch showing bat emergence location.

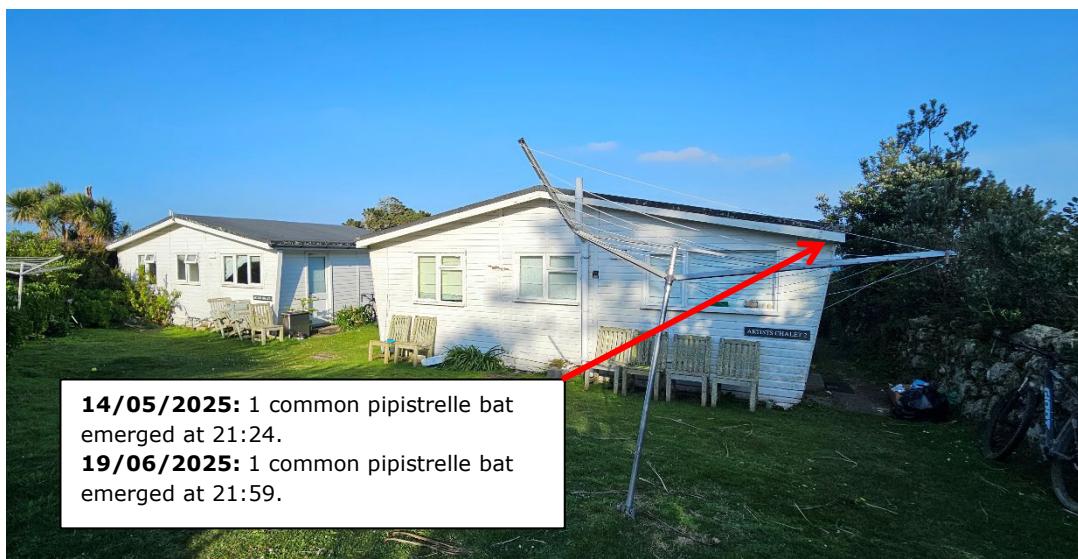
During the first emergence survey of Artist Chalet 2 on 14th May 2025, a single common pipistrelle bat emerged from beneath the soffit on the south-west corner of the building. During the second emergence survey, undertaken on 19th June 2025, a single common pipistrelle bat emerged from the same location as during the first survey. **NB.** A second survey of Artist Chalet 2 was required because a bat emerged from the building during the first emergence survey.

Figure 14: West elevation of Artist Chalet 2 (right) showing bat emergence location.

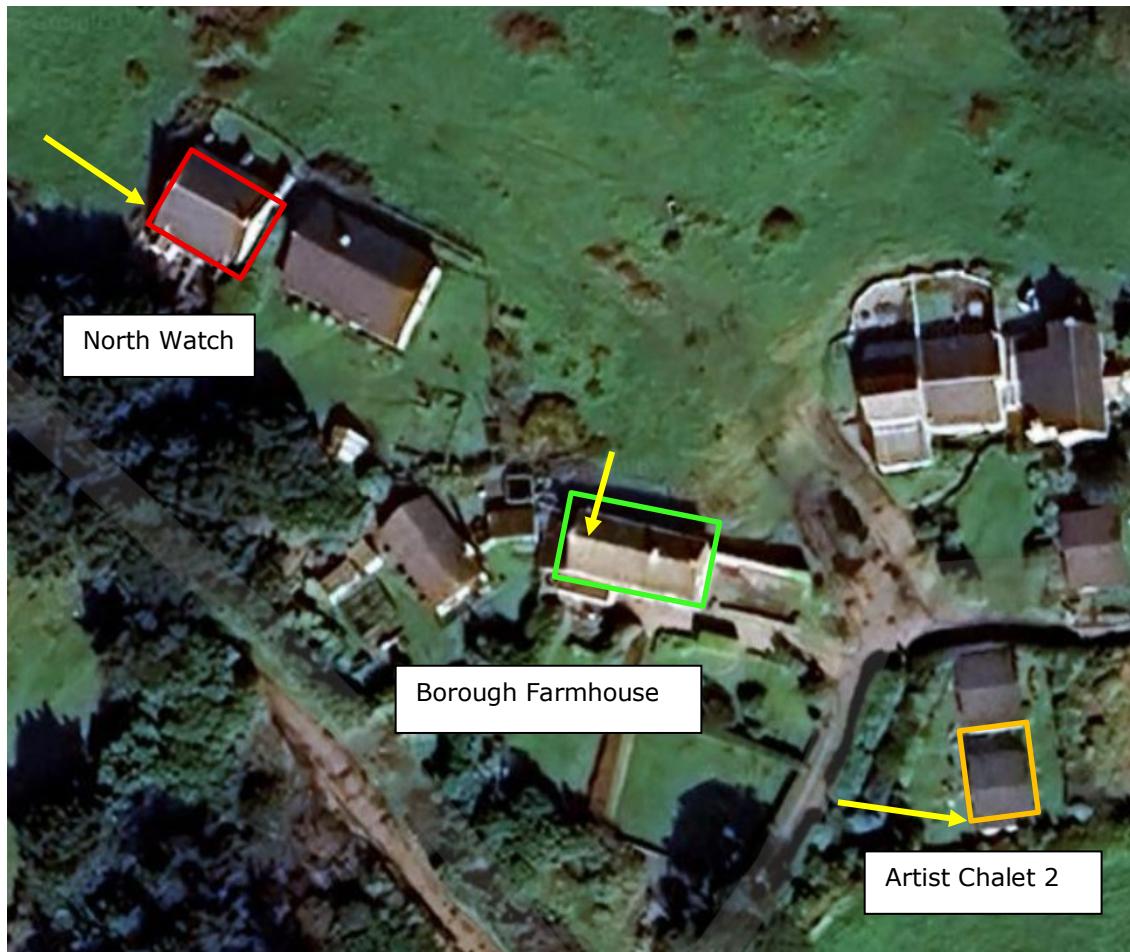
Figure 15: Aerial view of Borough Farm showing location of identified bat roosts: yellow arrows indicate locations of common pipistrelle bat day roosts.

The survey results have shown that the buildings at Borough Farm support three common pipistrelle bat day roosts in total, each supporting likely a single individual, as described in Section 4.5, above. The proposed site plans are provided at Appendix 1. The applicant seeks planning consent to demolish and replace the existing residential and holiday units (including Borough Farmhouse, North Watch 1 and 2 and Artist Chalet 2), convert an existing residential property (Staff Bungalow) into a sauna and gym, erect two energy stores and construct two staff accommodation blocks.

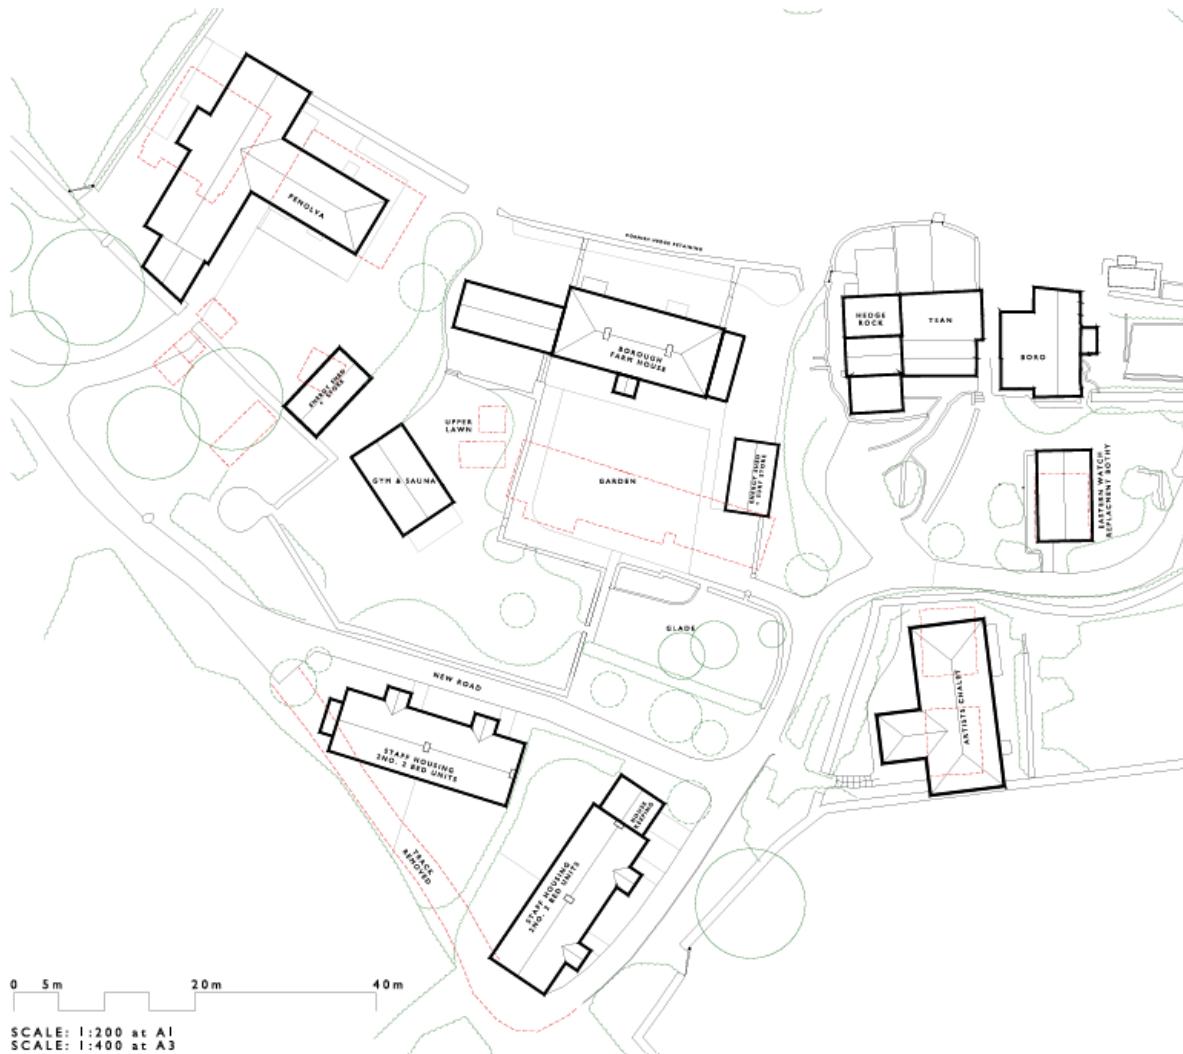
7.0 Appendix 1: Proposed site plans.

Indicative layout (excerpt from Llewellyn, Harker, Lowe, 2025; drawing no. 4171_01_010 L)
