## PRELIMINARY ROOST ASSESSMENT (PRA)

HANJAGUE,  
ROCKY HILL, ST MARY'S, ISLES OF SCILLY

# PRELIMINARY ROOST ASSESSMENT (PRA)

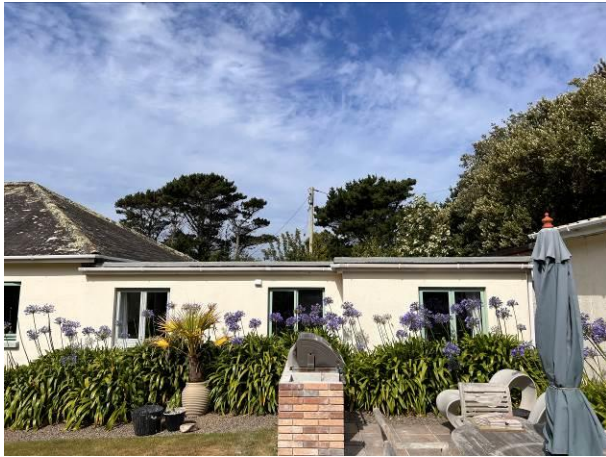
The flat-roof component is connected with the main bungalow with flashing – this junction lies just beneath the fascia on the eaves of the bungalow and appears to be tightly fitted.

**Photograph 1:** Showing the flat-roof extension tied in with the bungalow on the LHS

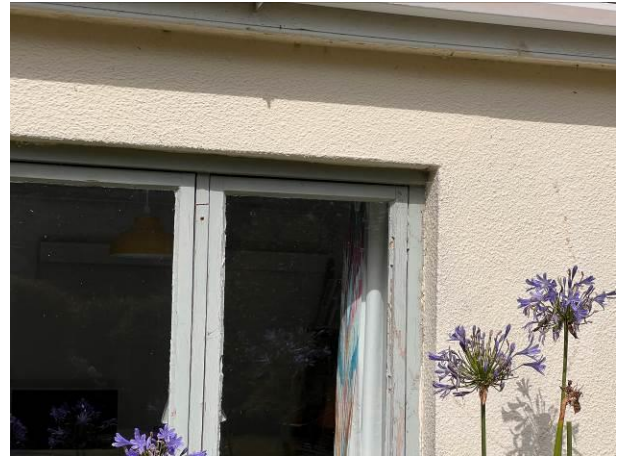
The single-storey flat-roof extension is block built with a combination of painted blockwork and rendered sections externally. Both pointing and render are in good condition throughout with no gaps or cracks noted.

The window and door frames are well sealed in their apertures with no gaps, cracks or cavities associated.

**Photograph 2:** Showing an example of the well-fitted window frames and the wall finish.

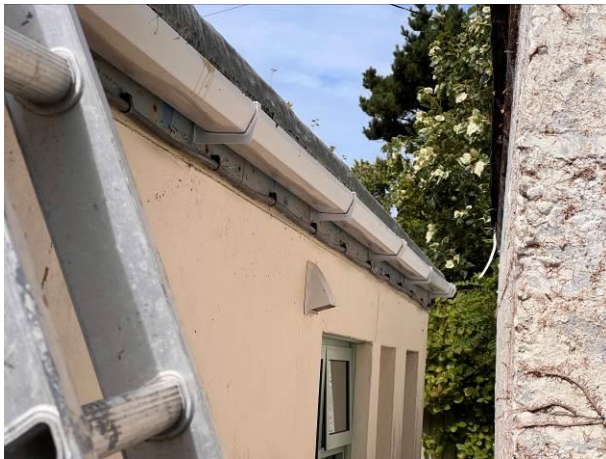
**Photograph 3:** Showing the location where the flat-roof extension on the LHS abuts the detached outbuilding on the RHS.

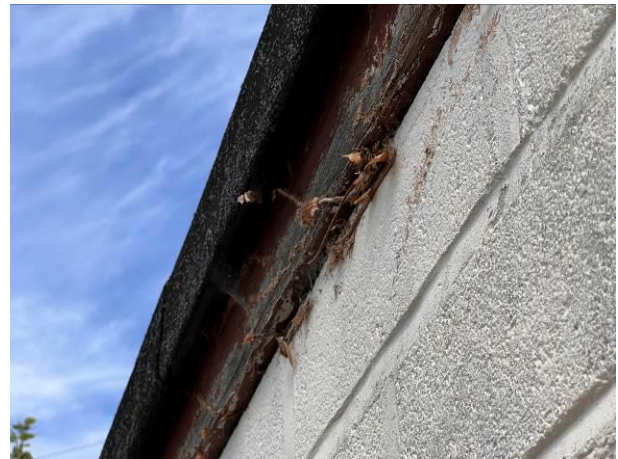
The fascia or soffit around the structure is well-fitted and in good condition.

**Photograph 4:** Showing an example of the well-sealed fascia

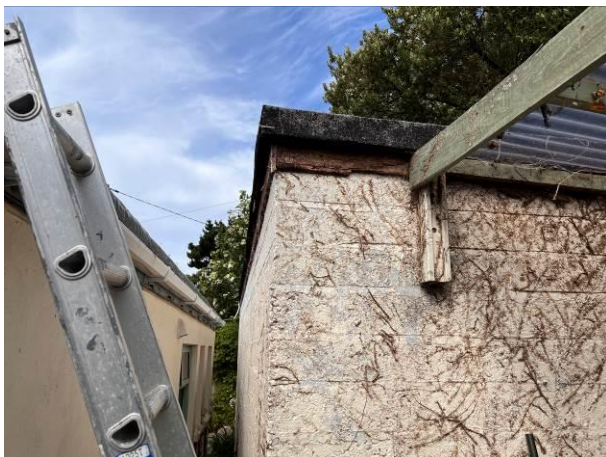
The detached outbuilding is a single-storey flat-roof structure constructed of breeze blocks which are well-pointed.

The window and door frames are well sealed in their apertures with no gaps, cracks or cavities associated.

There is a fascia running around the edge of the structure – this is well fitted and any minor gaps have dense cobwebs indicating long-term lack of disturbance.

**Photograph 5:** Showing the detached outbuilding on the RHS

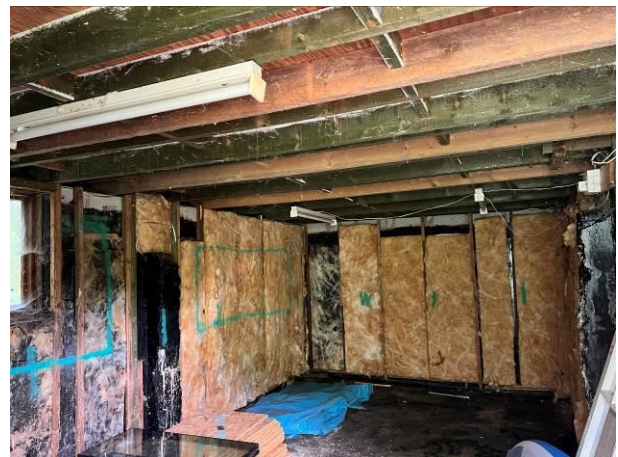
Internally, the outbuilding has been stripped back to the battens. Whilst discreet internal roosting opportunities may be present associated with the wall plate, the degree to which the exterior is sealed following a comprehensive inspection would preclude further consideration of this potential.

**Photograph 6:** Showing the interior of the outbuilding.
