PERMISSION FOR DEVELOPMENT

Proposal: Re-modelling of existing house and extension for garage and utility room
(AMENDED PLANS)

PRELIMINARY ROOST ASSESSMENT (PRA)

BAT PRESENCE/ABSENCE SURVEYS (PAS)

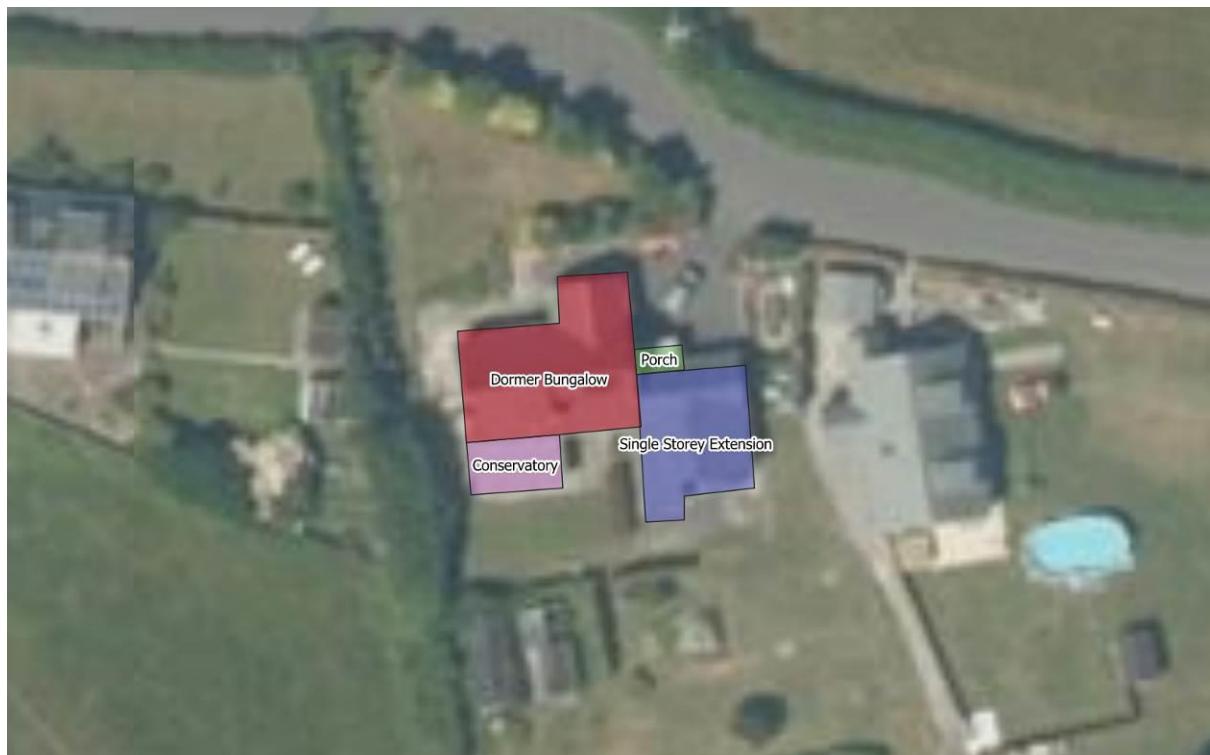
Map 02 – Showing the various structural components of the property as described in this report.

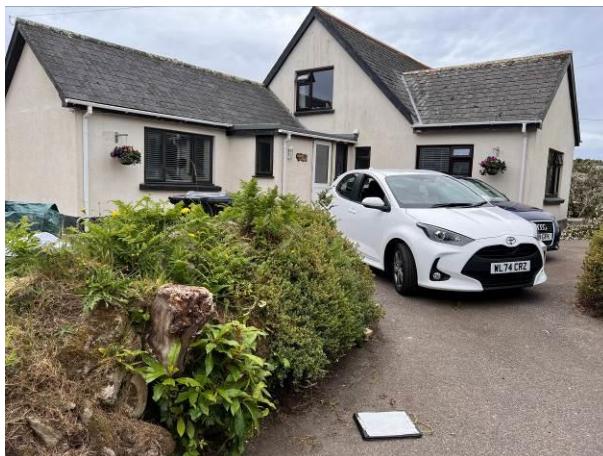
Photograph 1: Showing the view from the north-eastern corner of the property with the dormer bungalow on the RHS and the Single Storey Extension on the RHS with the Porch in between.

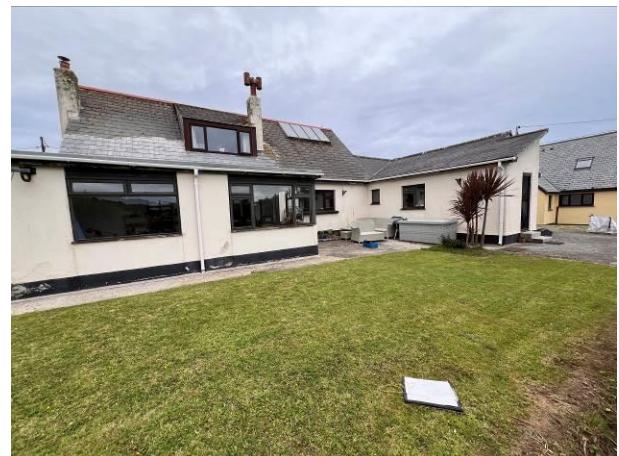
Photograph 2: Showing the view of the property from the south-western corner with the Conservatory visible on the LHS with the Dormer Bungalow behind. The Single Storey Extension is visible on the RHS.

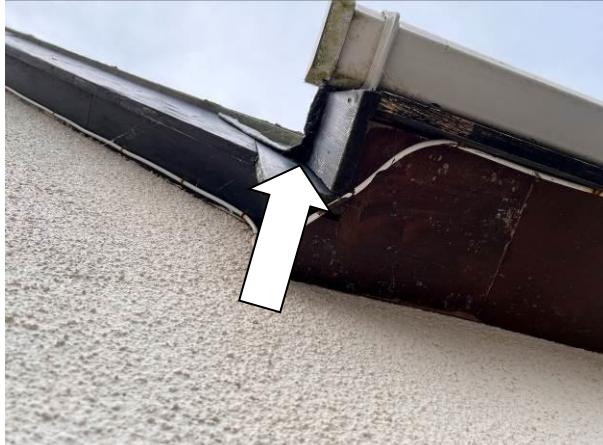
There are two chimneys present within the roof structure – these are rendered and in good condition with sealed flaunching to the capped pots. A minor element of lifted flashing appears to be present on the western gable but this appears to be superficial.

Photograph 3: Showing an example of the lifted flashing offering a potential roosting opportunity.

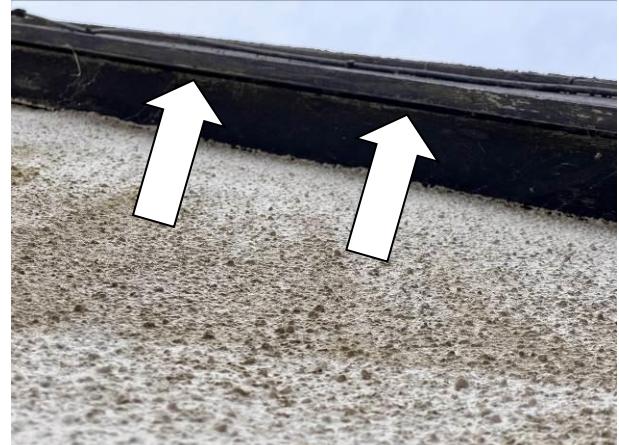
There are timber soffits around the roofline including both eaves and gables – these are largely in good condition but occasional gaps were noted including on the northern and eastern aspects. These features could provide access to roosting opportunities associated with the soffit itself, or with the wall plate of the main building.

Photograph 4: Showing an example of a structural gap between the soffits on the western gable.

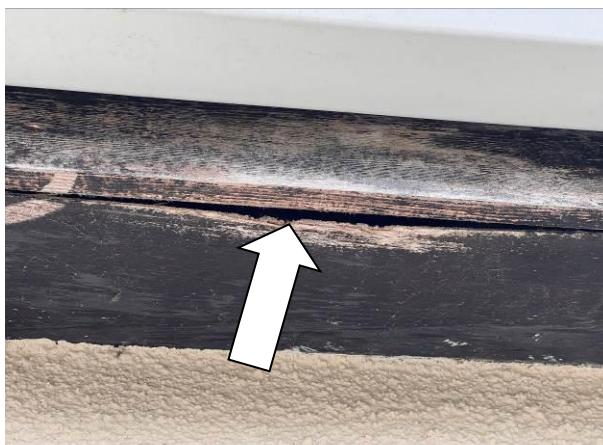
The extension on the eastern aspect of the Dormer Bungalow uses the same materials and overall aesthetic including the asbestos tiles, timber soffits and rendered walls. Internally the roof structure is of a more recent and modern material including insulation between the joists and polyethylene underfelting. Rodent droppings – including white-toothed shrew – were again identified within the loft space. Light is visible at the eaves, and a historic bird's nest was identified in one location which corresponds with a damage feature on the external soffit where access is permitted.

The soffits on the southern and western aspects of this property have rot or damage features which could provide access to roosting opportunities associated with the soffit itself, or with the wall plate. Slight gaps also occur on the eastern aspect where soffit boards have been replaced.

Photograph 5: Showing a damaged portion of the soffit on the Single Storey Extension with indications of historic access by animals or birds.

It is recommended that bird boxes are installed to offer nesting habitat for common garden bird species. This would compensate for the removal of existing features which are associated with damage or structural deterioration of the soffits and would therefore be removed as part of the renovation works proposed.

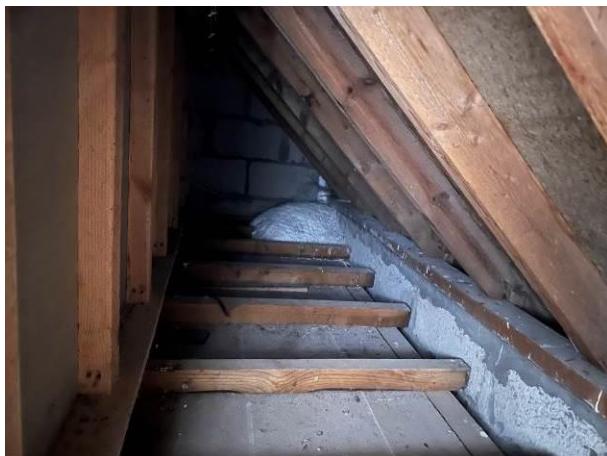
Photograph 7: Showing the interior of the eaves storage within the Dormer Bungalow.

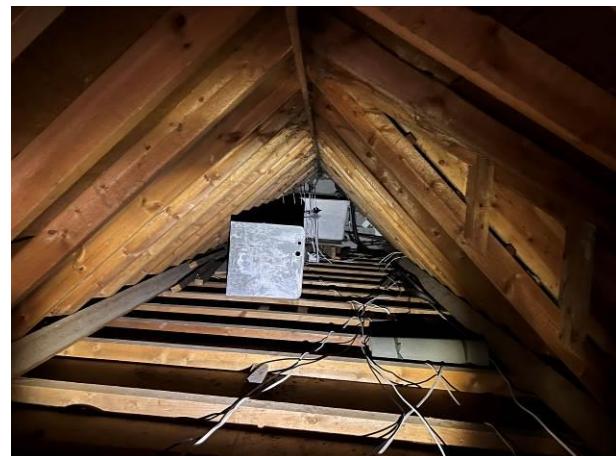
Internally, there are voids at the apex and at the eaves of the roof. The roof is lined with tar paper with a boarded floor and no insulation. There are occasional tears in the tar paper which would allow access to the void from beneath the tiles. There are exposed timber trusses which were tightly fitted with no gaps between timbers. Daylight visible at the eaves indicates that there is potential for bats or birds to access these voids in principle. Evidence of rodents was noted but no evidence of bats was recorded in this void.

Photograph 8: Showing the interior of the loft space at the apex of the Dormer Bungalow.

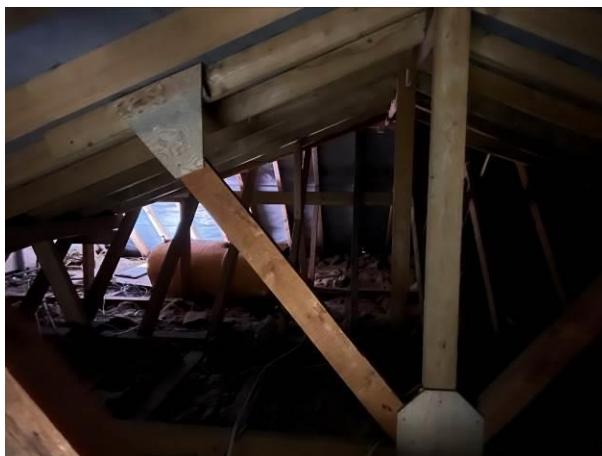
Photograph 9: Showing the interior of the more recently constructed Single Storey Extension loft space.

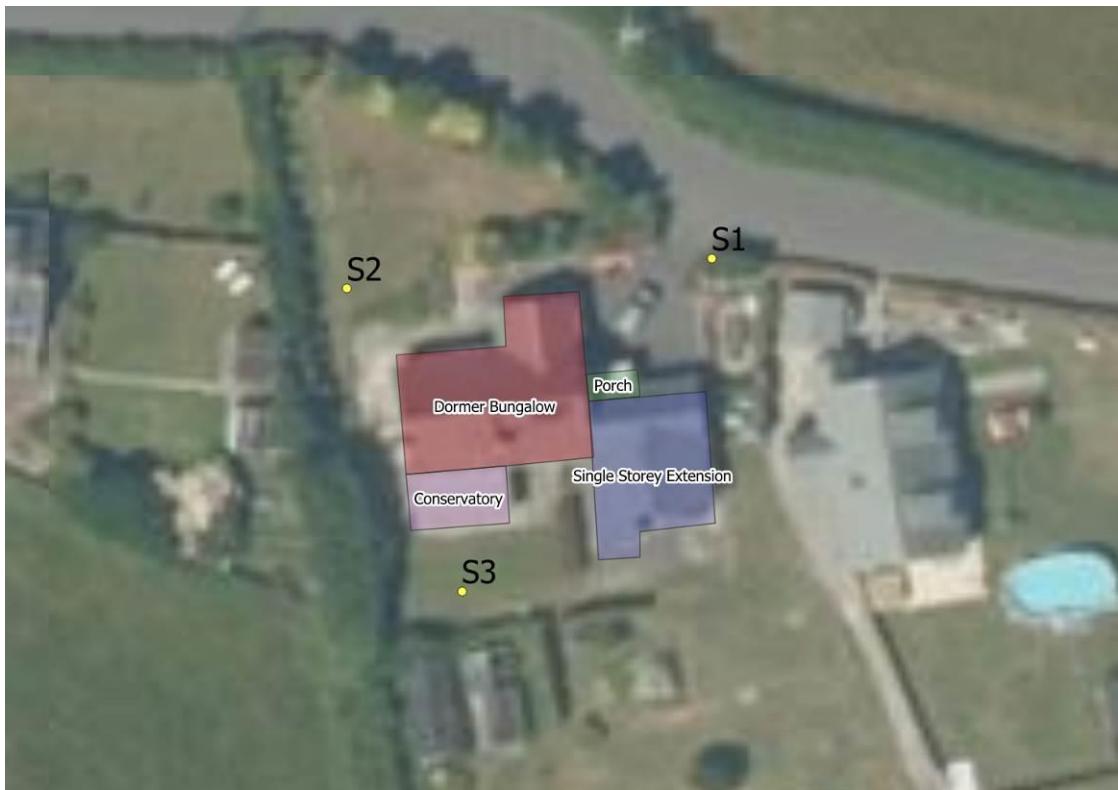
In order to ensure that the building received a survey effort of a single bat survey for a Low Potential building (in line with the Best Practice Guidance), three surveyor positions each with an NVA were deployed. These are identified in Map 01 below.

Map 01 – showing the surveyor position (S1 – S3).

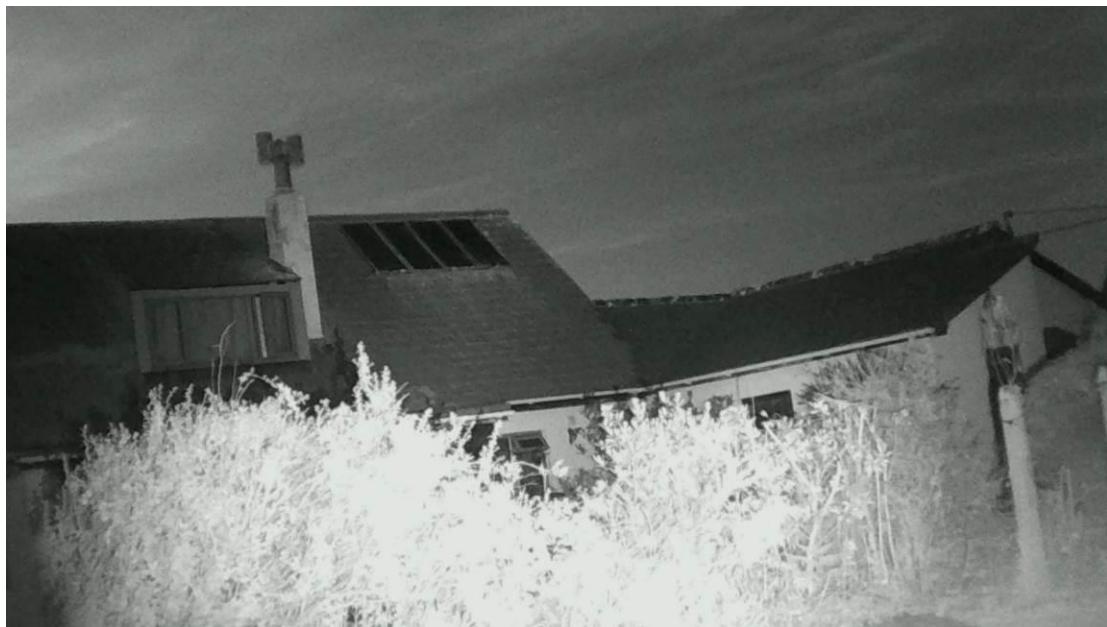
NVA3 – showing a screenshot from the Nightfox Whisker at position S3. The NVA did not comprehensively cover the conservatory due to the vegetation; however no suitable features for use by roosting bats were identified on this structure.
