## PRELIMINARY ROOST ASSESSMENT (PRA)

### ESPERANCE, MCFARLAND'S DOWN, ST MARY'S, ISLES OF SCILLY

**Our reference:** 25-12-2

**Report date:** 20<sup>th</sup> January 2026

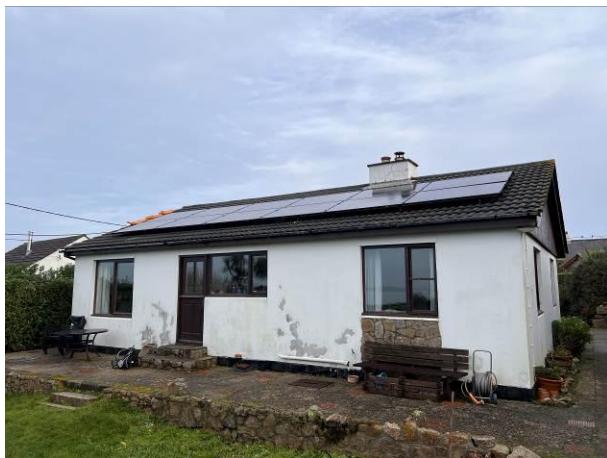
The property is a single storey bungalow with a hipped projection to the main gable roof.

The external rendering is in good condition and timber door and window frames are well-fitted in their apertures.

**Photograph 1:** Showing the rear aspect of the property.

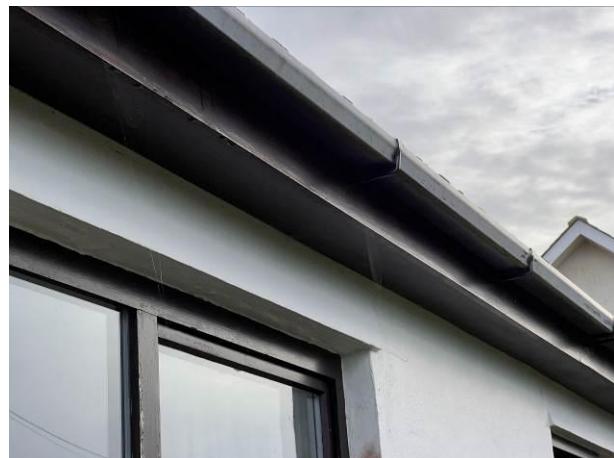
Wooden soffits run along both the eaves and gables – these are tightly fitted and sealed and have guttering attached which would obstruct a direct fly-in access to any gaps between terminal tiles. The only gap noted is minor damage to the soffit on the south-western corner – the void behind this is filled with nesting material indicating use by birds but sufficiently dense to preclude recent access to suitable voids by roosting bats.

**Photograph 2:** Showing the well-sealed soffits of the property on the rear aspect.

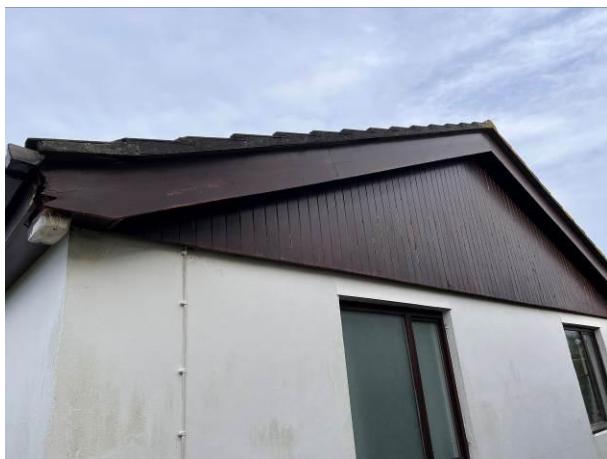
Gables are clad in timber – this is tightly fitted and sealed with no gaps noted. The roof verge is well-pointed throughout, with the exception of a minor missing section on the northern aspect which is physically separated from the proposed area of works and on a different aspect of the building.

**Photograph 3:** Showing the gable end of the property with the soffit and vertical timber cladding.

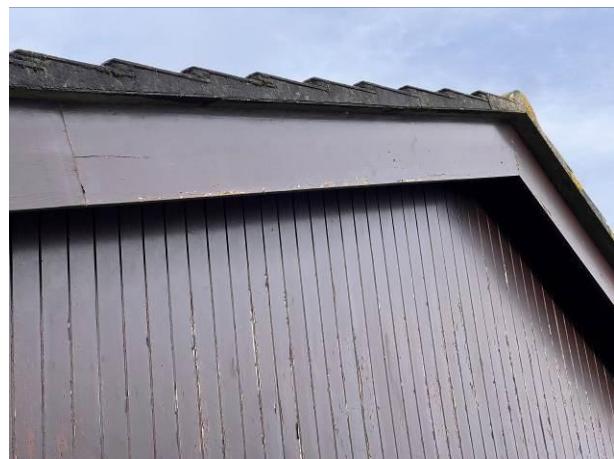
**Photograph 4:** Showing a closer view of the timber cladding and well-sealed soffit as well as the well-pointed verge on the gable.

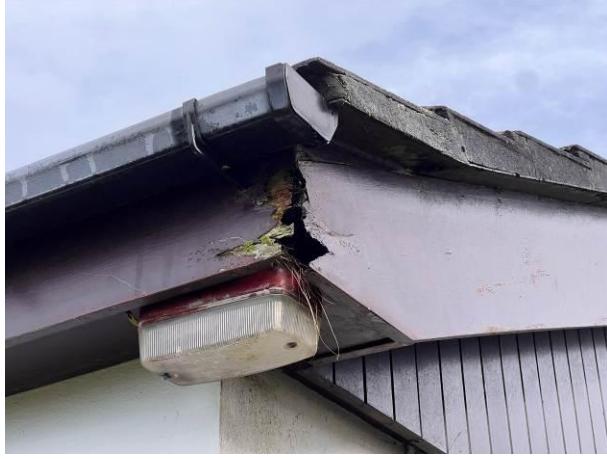
- Damage to the soffit on the south-western corner, though the dense nesting material present would preclude recent use by roosting bats to access roosting features;
- A minor gap in the roof verge on the northern aspect – this location would not be directly or indirectly impacted by the proposed extension works and is not therefore given further consideration in this report.

A nest was confirmed in the damaged soffit in the south-western corner of the property. Additional minor opportunities may be found elsewhere on the structure, or within the associated garden.

**Photograph 5:** Showing the gap in the soffit on the south-west corner of the property.

- The gap in the south-western corner of the soffit and any voids which might be accessible from that location.

If the recommended timing of works is not possible, then contractors should visually inspect the work area internally and externally before they are affected by the works, in order to confirm that no nests are present – specifically in the gaps in the soffit on the south-western corner. In the event that a bird nest is present, it must be left undisturbed until chicks have fledged the nest, at which point works can proceed.

There is a section of damage to the soffit on the south-western corner of the property. Care must be taken to ensure that no active nests are present within this feature when the works are undertaken – see main report for guidance relating to nesting birds.

Whilst the use by nesting birds and significant obstruction caused by nesting materials would preclude recent access by bats, a change in condition or maintenance work to remove the old materials could result in the feature becoming suitable for use by roosting bats.

The void should be exposed carefully and by hand following removal of the soffit using hand tools. Any accessible voids or spaces including gaps beneath tiles, the wall plate and structural elements associated with the soffit framework should be carefully inspected prior to works proceeding. Further dismantling of features by hand may be necessary depending on the features identified as the works progress.

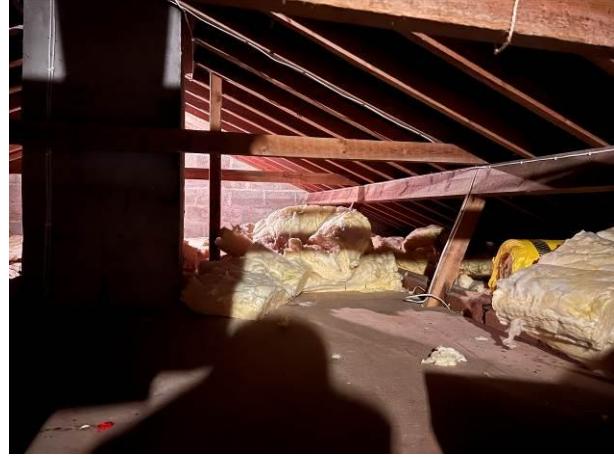
The loft space is used for routine storage and the floor is boarded out with relatively new insulation present above the boarding in much of the loft space. The roof is built around a typical timber truss framework.

There is thick felting between the rafters and the battens – this is generally in good condition however occasional tears occur.

The breeze block gable walls are well-pointed with no gaps noted. The timbers which abut the chimney breast create a minor cavity in places, but these were densely cobwebbed.

Rat and mouse droppings were noted – however no evidence of bats was identified.

**Photograph 6:** Showing the interior of the loft space of the property.
