SCOPING-LEVEL HYDROLOGICAL ASSESSMENT OF LOWER MOORS SSSI, ISLES OF SCILLY

1575_r1_final, January 2015

Isles of Scilly Wildlife Trust

Dr. Rob Low (Rigare Ltd, Abergavenny)

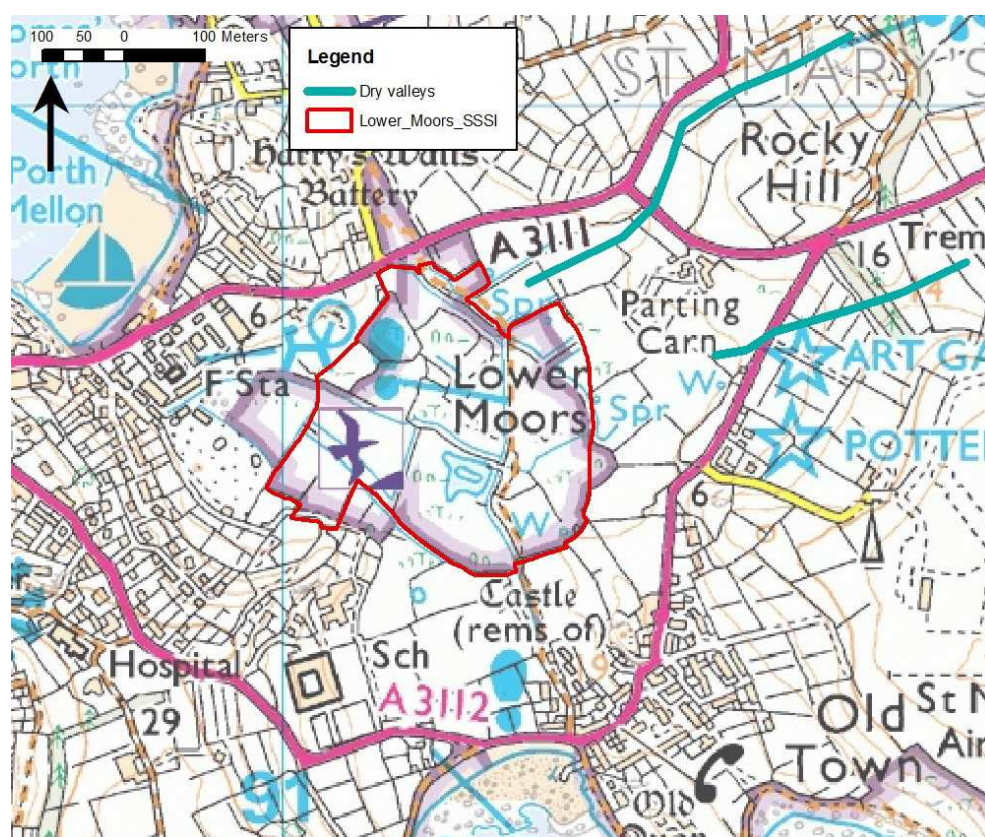
Figure 2.1-1 Extract from OS 1:25,000 scale mapping showing site and environs

The site occupies the central area of a larger, irregular-shaped basin (< 5 mAOD) surrounded predominantly by steep slopes leading to higher ground (~ 30 mAOD), as shown in Figure 2.1-1 which is an extract from the OS 1:25,000 scale mapping. The exceptions to this are where two tributary valleys (marked on Figure 2.1-1) enter the basin along its eastern boundary, and where the basin lies close to the coast along its north-western and southern boundaries.

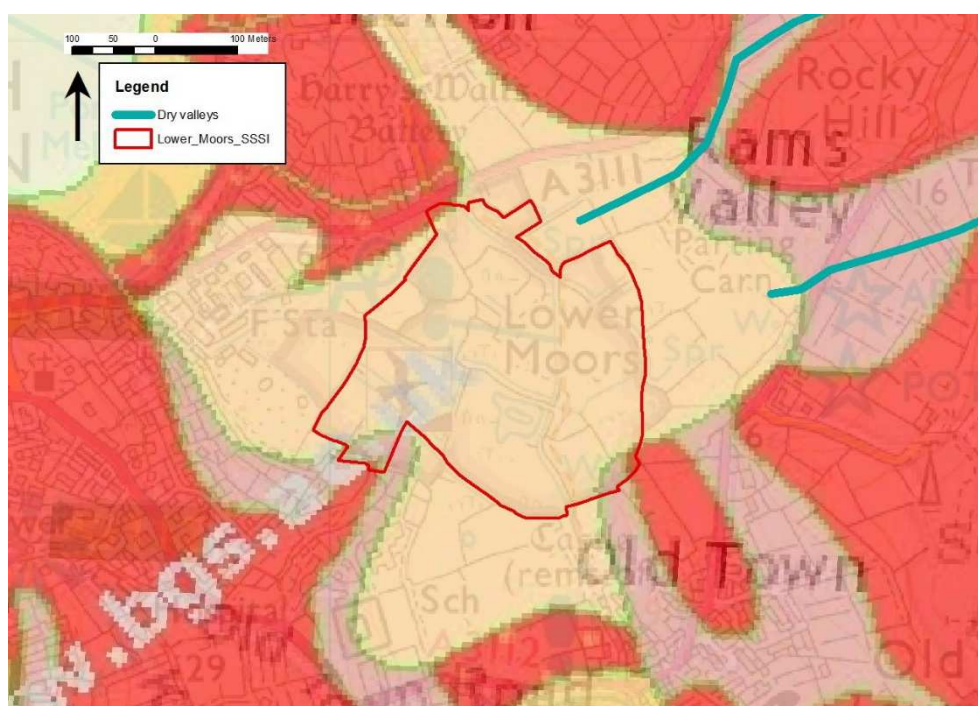
Figure 2.2-1 Surface geology (BGS on-line viewer); see text for geological key

Figure 2.2-1⁴ shows the surface geology of the area. St Mary's island is composed of the Isles of Scilly granite (red in Figure 2.2-1), which therefore represents the bedrock

- Head; clay, silt, sand and gravel (purple). During the last Ice Age the Irish Sea Ice extended only to the northern parts of the Isles of Scilly. South of this, cold tundra conditions resulted in the accumulation of orange-brown slope and wind-blown deposits known locally as 'ram'. It is very likely that these deposits extend, perhaps continuously, beneath the site.
- Blown Sand (light yellow). These form slightly higher ground along the north-western and southern boundaries of the basin, separating it topographically from the coast, and they could extend beneath the site, above the ram deposits, to some extent.
- Alluvium (dirty yellow). These deposits are generically described as clay, silt, sand and gravel. These deposits form the immediately substrate within the basin and the SSSI.

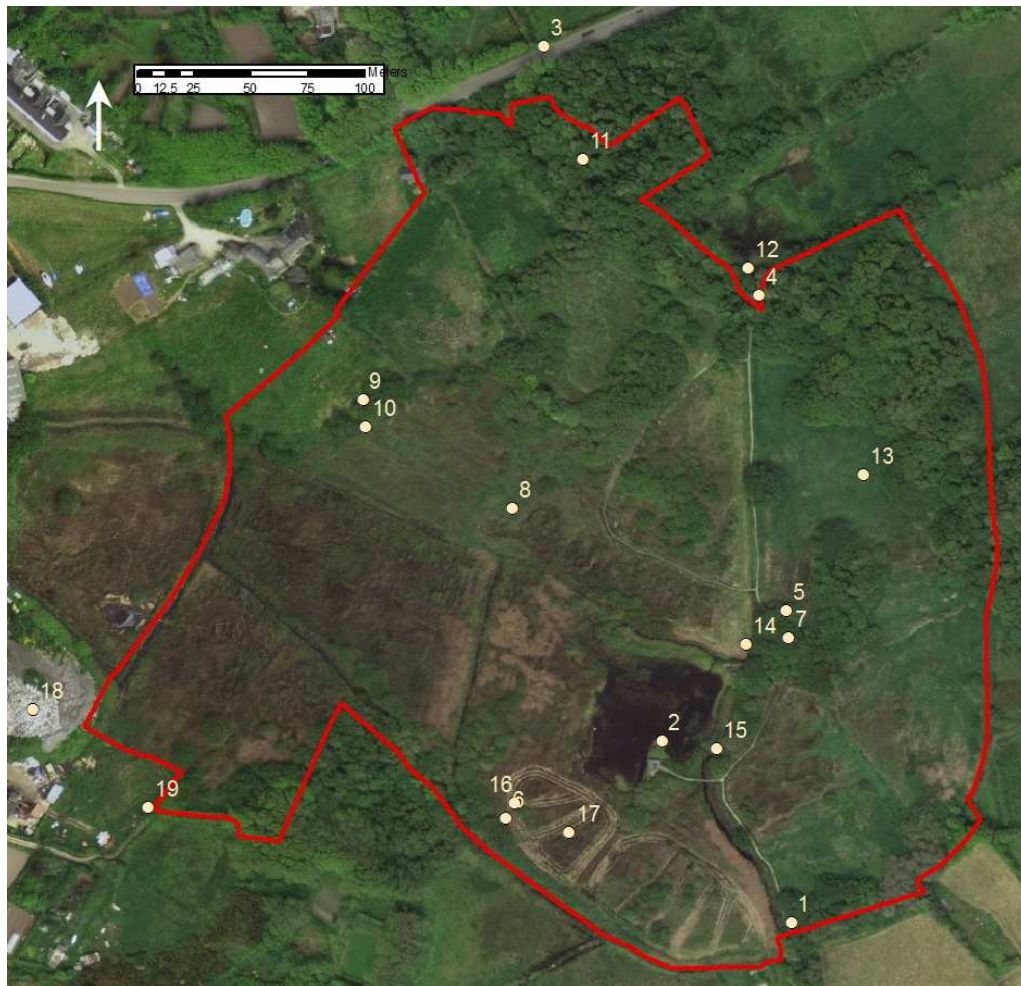
Figure A1-1 Site map over aerial photograph showing observation points

#	Easting	Northing	Feature/comment	pH	EC ($\mu\text{S}/\text{cm}$)	Temp (deg C)	Photo
1	91293	10443	Water control structure on outlet channel. Facility for stop-logs, but none in place. No channel restriction.	6.9	o/s	17
