REFURBISHMENT AND DEMOLITION  
ASBESTOS SURVEY REPORT

Mundesley Boarding House  
Church Road  
St Marys  
Isles of Scilly  
TR21 0NA

JOB NO: J017965

HSG 264 Refurbishment Demolition survey of the  
SCOPE OF WORKS: areas affected by the proposed fire alarm upgrade  
works.

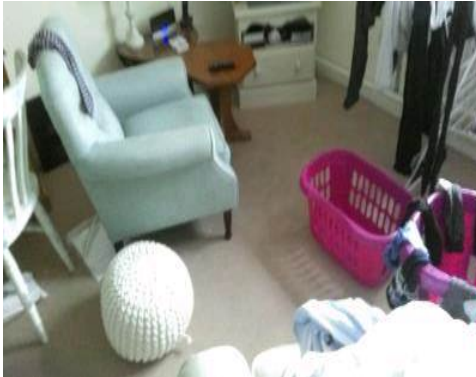
Item No.	Site Sample Reference	Location	Description of Material and Recommended Action				Area or Quantity	Photographs	
1	AJ002908	1st Floor.  Room 1 (Lounge 117).	Beige vinyl floor tiles and adhesive beneath existing flooring.  Contains Chrysotile asbestos materials.  Materials can be removed by a non-licensed contractor in accordance with the Control of Asbestos Regulations 2012.  <div>Recommended Action</div> <div>D</div>				18m²

Material Risk Assessment									
Product Type	Condition	Surface Treatment	Asbestos Type	Risk Factor	Risk Level	Accessibility	Material Classification		
1	0	(0) Completely Sealed	1	2	Very Low	Low	NNL

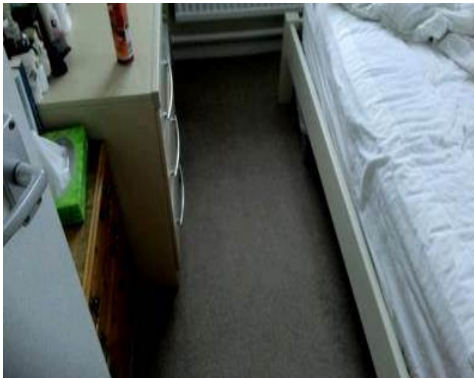
Item No.	Site Sample Reference	Location	Description of Material and Recommended Action				Area or Quantity	Photographs	
3	AJ002910	1st Floor.  Room 3 (Bedroom 118).	Cream vinyl floor tiles and adhesive beneath existing flooring.  Contains Chrysotile asbestos materials.  Materials can be removed by a non-licensed contractor in accordance with the Control of Asbestos Regulations 2012. <div>Recommended Action</div>				14m²

Material Risk Assessment									
Product Type	Condition	Surface Treatment	Asbestos Type	Risk Factor	Risk Level	Accessibility	Material Classification		
1	0	(0) Completely Sealed	1	2	Very Low	Low	NNL

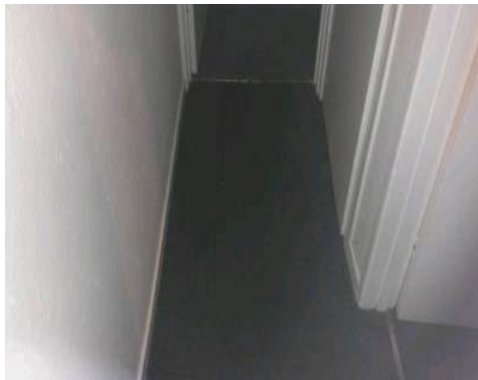
Item No.	Site Sample Reference	Location	Description of Material and Recommended Action		Area or Quantity	Photographs	
8	AS PER SAMPLE AJ002912	Ground Floor.  Room 2 (Hall 020).	<p>Beige vinyl floor tiles and adhesive underneath existing flooring - including cupboard (as sample AJ002912).</p> <p>Strongly presumed to contain Chrysotile asbestos materials.</p> <p>Materials can be removed by a non-licensed contractor in accordance with the Control of Asbestos Regulations 2012.</p> <div>Recommended Action</div> <div>D</div>		4m²

Material Risk Assessment							
Product Type	Condition	Surface Treatment	Asbestos Type	Risk Factor	Risk Level		Accessibility
1	0	(0) Completely Sealed	1	2	Very Low	Low	NNL

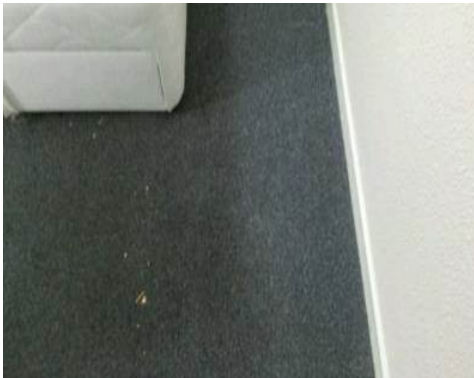
Item No.	Site Sample Reference	Location	Description of Material and Recommended Action		Area or Quantity	Photographs	
9	AJ002913	Ground Floor.  Room 3 (Bedroom 017).	Beige vinyl floor tiles and adhesive underneath existing flooring.  Contains Chrysotile asbestos materials.  Materials can be removed by a non-licensed contractor in accordance with the Control of Asbestos Regulations 2012.	Recommended Action	D

Material Risk Assessment							
Product Type	Condition	Surface Treatment	Asbestos Type	Risk Factor	Risk Level		Accessibility
1	0	(0) Completely Sealed	1	2	Very Low	Low	NNL

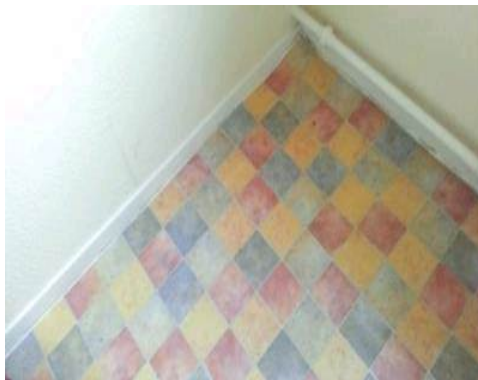
Item No.	Site Sample Reference	Location		Description of Material and Recommended Action			Area or Quantity	Photographs	
10	AJ002914	Ground Floor.	Room 4 (Bathroom 018).	Grey vinyl flooring underneath existing flooring.  Contains Chrysotile asbestos materials.  Materials can be removed by a non-licensed contractor in accordance with the Control of Asbestos Regulations 2012.			5m²

Recommended Action	D				
Material Risk Assessment									
Product Type	Condition	Surface Treatment	Asbestos Type	Risk Factor	Risk Level	Accessibility	Material Classification		
1	0	(0) Completely Sealed	1	2	Very Low	Low	NL

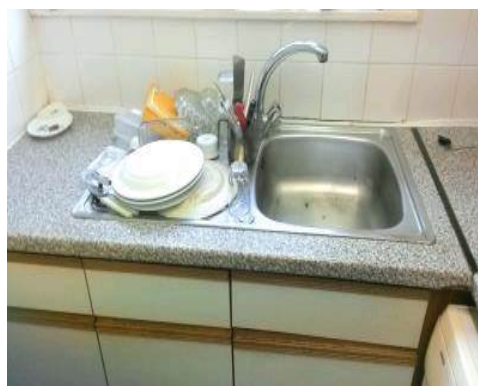
Item No.	Site Sample Reference	Location	Description of Material and Recommended Action				Area or Quantity	Photographs	
11	AJ002915	Ground Floor.  Room 5 (Kitchen 019).	Sound pad to sink unit.  No Asbestos Detected.  No further action required.  <div>Recommended Action</div> <div>-</div>				1no.

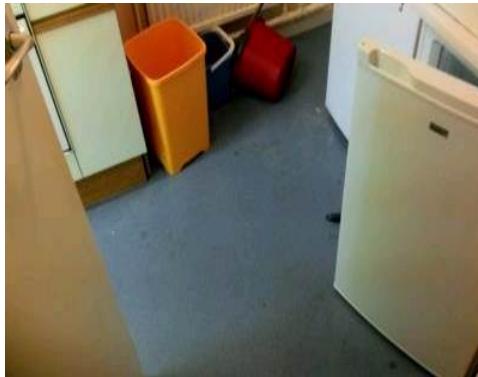
Item No.	Site Sample Reference	Location	Description of Material and Recommended Action					Area or Quantity	Photographs
12	AJ002916	Ground Floor.  Room 5 (Kitchen 019).	Green vinyl floor tiles and adhesive underneath existing altro flooring.  Contains Chrysotile asbestos materials.  Materials can be removed by a non-licensed contractor in accordance with the Control of Asbestos Regulations 2012. <div>Recommended Action</div>					6m²

D						
Material Risk Assessment									
Product Type	Condition	Surface Treatment	Asbestos Type	Risk Factor	Risk Level	Accessibility	Material Classification		
1	0	(0) Completely Sealed	1	2	Very Low	Low	NL

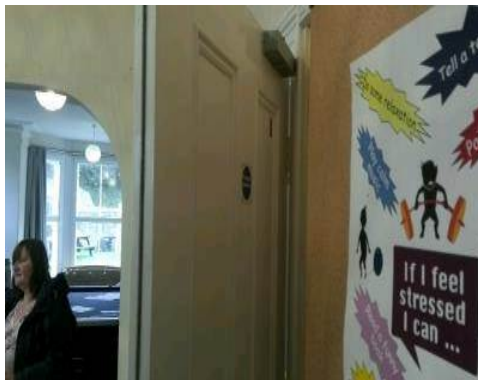
Item No.	Site Sample Reference	Location		Description of Material and Recommended Action			Area or Quantity	Photographs
13	AJ002917	Ground Floor.  Room 6 (Meeting Room 007).		Insulating board lining to door.  Contains Chrysotile + Amosite asbestos materials.  These materials can be removed by a licensed contractor only, in accordance with the Control of Asbestos Regulations 2012.  Recommended Action			2m <sup>2</sup>

Material Risk Assessment								
Product Type	Condition	Surface Treatment	Asbestos Type	Risk Factor	Risk Level	Accessibility	Material Classification	
2	0	(1) Surface Sealed	2	5	Low	Low	L

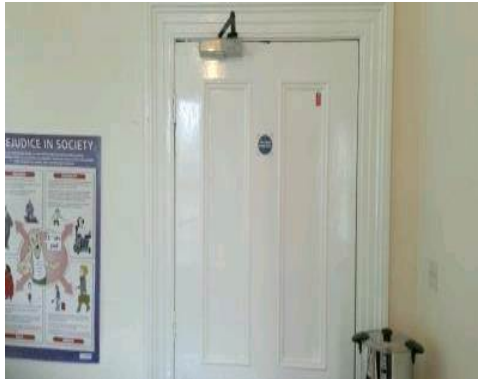
Item No.	Site Sample Reference	Location	Description of Material and Recommended Action		Area or Quantity	Photographs	
14	AS PER SAMPLE AJ002917	Ground Floor.  Room 7 (Games Room 008).	Insulating board lining to door (as sample AJ002917).  Strongly presumed to contain Chrysotile + Amosite asbestos materials.  These materials can be removed by a licensed contractor only, in accordance with the Control of Asbestos Regulations 2012.  Recommended Action		2m²

D				
Material Risk Assessment							
Product Type	Condition	Surface Treatment	Asbestos Type	Risk Factor	Risk Level	Accessibility	Material Classification
2	0	(1) Surface Sealed	2	5	Low	Low	L

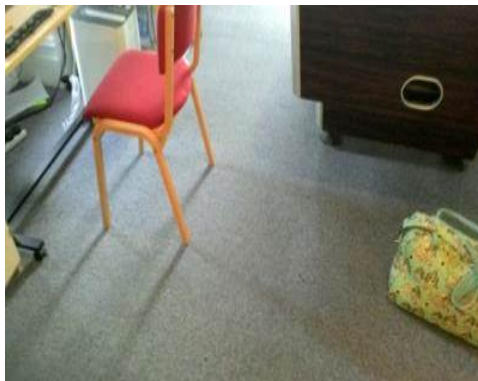
Item No.	Site Sample Reference	Location	Description of Material and Recommended Action				Area or Quantity	Photographs	
15	AJ002918	Ground Floor.  Room 7 (Games Room 008).	Green vinyl flooring beneath existing flooring.  No Asbestos Detected.  No further action required.  <div>Recommended Action</div>				40m²

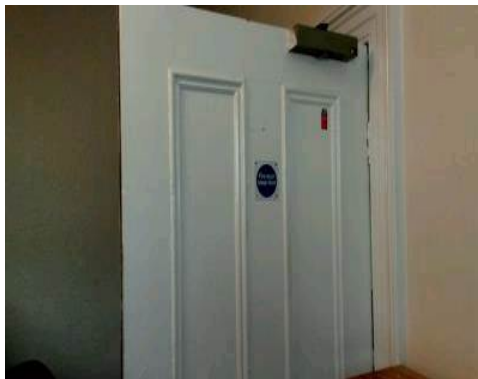
Item No.	Site Sample Reference	Location		Description of Material and Recommended Action			Area or Quantity	Photographs
16	AS PER SAMPLE AJ002917	Ground Floor.	Insulating board lining to door (as sample AJ002917).  Strongly presumed to contain Chrysotile + Amosite asbestos materials.  These materials can be removed by a licensed contractor only, in accordance with the Control of Asbestos Regulations 2012.			2m²

Room 8 (Office 010).						
			Recommended Action	D				
Material Risk Assessment								
Product Type	Condition	Surface Treatment	Asbestos Type	Risk Factor	Risk Level	Accessibility	Material Classification	
2	0	(1) Surface Sealed	2	5	Low	Low	L

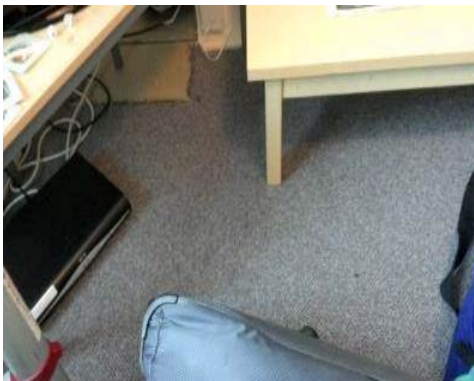
Item No.	Site Sample Reference	Location	Description of Material and Recommended Action				Area or Quantity	Photographs	
17	AS PER SAMPLE AJ002918	Ground Floor.  Room 8 (Office 010).	Green vinyl flooring beneath existing flooring (as sample AJ002918).  No Asbestos Detected.  No further action required.  <div>Recommended Action</div>				20m²

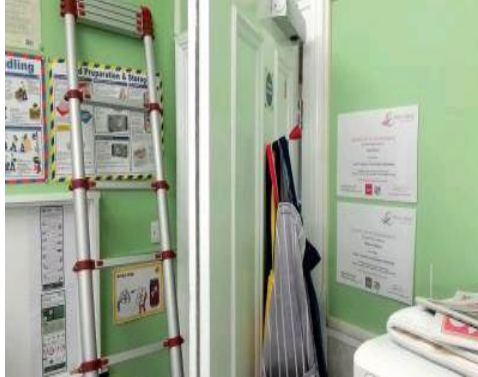
Item No.	Site Sample Reference	Location		Description of Material and Recommended Action			Area or Quantity	Photographs	
18	AJ002919	Ground Floor.  Room 9 (Kitchen 009).		Insulating board lining to door.  Contains Chrysotile + Amosite asbestos materials.  These materials can be removed by a licensed contractor only, in accordance with the Control of Asbestos Regulations 2012.  Recommended Action			2m²

Material Risk Assessment									
Product Type	Condition	Surface Treatment	Asbestos Type	Risk Factor	Risk Level	Accessibility	Material Classification		
2	0	(1) Surface Sealed	2	5	Low	Low	L

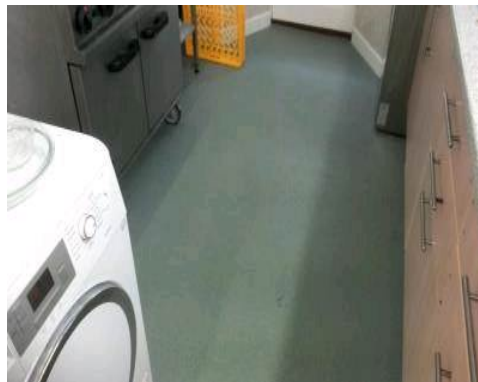
Item No.	Site Sample Reference	Location	Description of Material and Recommended Action				Area or Quantity	Photographs	
19	AJ002920	Ground Floor.  Room 9 (Kitchen 009).	Green altro flooring and adhesive.  No Asbestos Detected.  No further action required.  <div>Recommended Action</div> <div>-</div>				30m²

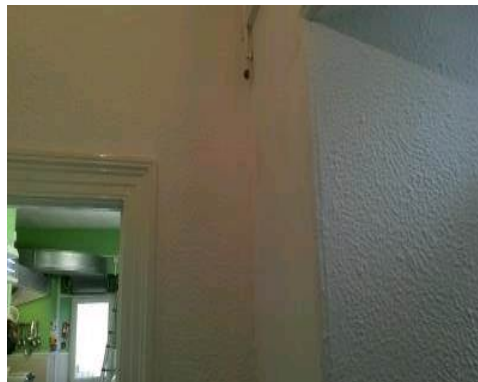
Item No.	Site Sample Reference	Location	Description of Material and Recommended Action				Area or Quantity	Photographs	
20	AJ002921	Ground Floor.  Room 10 (Larder 015).	Textured coating to walls.  No Asbestos Detected.  No further action required.  <div>Recommended Action</div>				6m <sup>2</sup>

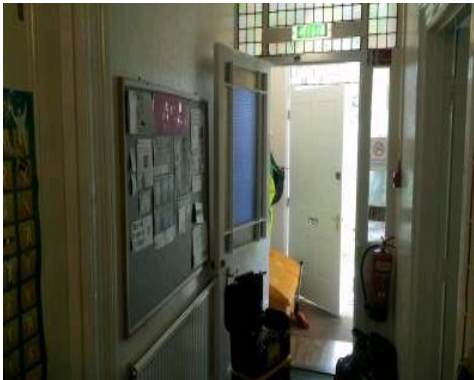
Item No.	Site Sample Reference	Location	Description of Material and Recommended Action				Area or Quantity	Photographs	
22	No Sample Taken	Ground Floor.  Room 11 (Hall 014).	Accessed - no suspect materials found to areas of work.  No further action required.  <div>Recommended Action</div> <div>-</div>				N/A

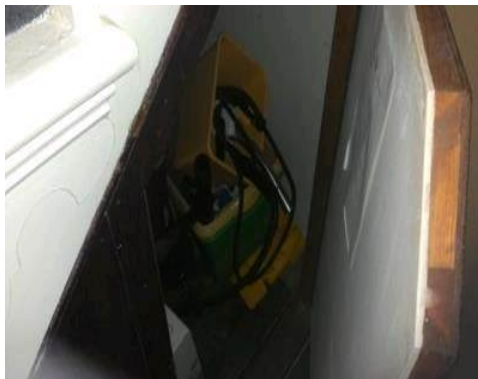
Item No.	Site Sample Reference	Location	Description of Material and Recommended Action		Area or Quantity	Photographs	
23	AJ002922	Ground Floor.  Room 12 (Understairs Cupboard 012).	Insulating board downstairs lining, wall linings and lining to door.  No Asbestos Detected.  No further action required.  Recommended Action		3m²

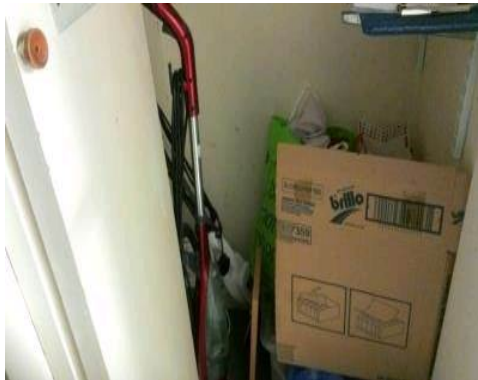
Item No.	Site Sample Reference	Location	Description of Material and Recommended Action		Area or Quantity	Photographs	
24	No Sample Taken	Ground Floor.  Room 13 (Cupboard 013).	Accessed - no suspect materials found to areas of work.  No further action required.  <div>Recommended Action</div>		N/A

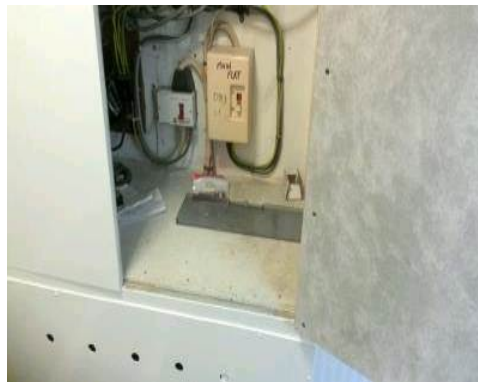
Item No.	Site Sample Reference	Location	Description of Material and Recommended Action	Area or Quantity	Photographs		
25	AJ002923	Ground Floor.  Room 14 (Electrical Cupboard 011).	Insulating board wall and base linings and lining to doors.  No Asbestos Detected.  No further action required.  Recommended Action -	2m²

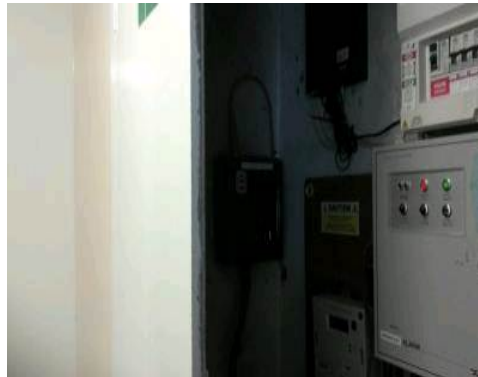
Item No.	Site Sample Reference	Location	Description of Material and Recommended Action	Area or Quantity	Photographs		
26	No Sample Taken	Ground Floor.  Room 14 (Electrical Cupboard 011).	Textile flashguards to electrical switchgear - presumed as live.  Presumed - Chrysotile asbestos materials.  Materials can be removed by a non-licensed contractor in accordance with the Control of Asbestos Regulations 2012. <div>Recommended Action</div>	1no. <div>D</div>

Material Risk Assessment							
Product Type	Condition	Surface Treatment	Asbestos Type	Risk Factor		Risk Level	Accessibility
2	0	(1) Surface Sealed	1	4	Low	Low	NL

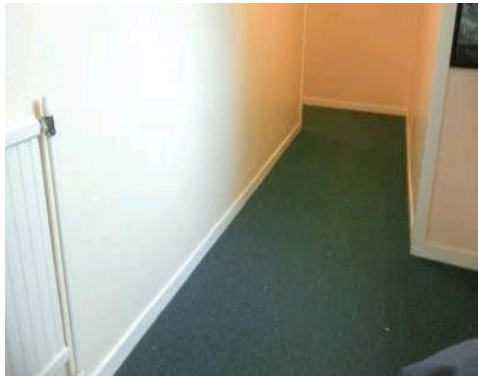
Item No.	Site Sample Reference	Location	Description of Material and Recommended Action		Area or Quantity	Photographs	
27	AJ002924	Ground Floor.  Room 15 (Corridor 016).	Beige vinyl floor tiles and adhesive beneath existing carpet tiles.  Contains Chrysotile asbestos materials.  Materials can be removed by a non-licensed contractor in accordance with the Control of Asbestos Regulations 2012. <div>Recommended Action</div>		20m²

Material Risk Assessment							
Product Type	Condition	Surface Treatment	Asbestos Type	Risk Factor	Risk Level		Accessibility
1	1	(0) Completely Sealed	1	3	Very Low	Low	NNL

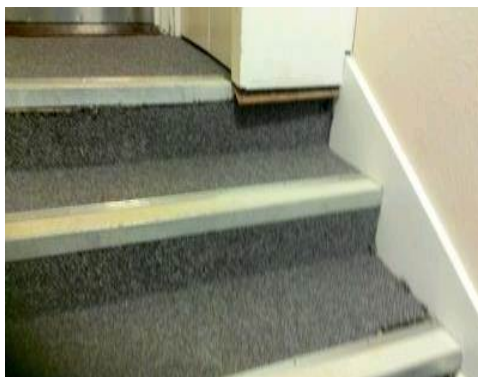
Item No.	Site Sample Reference	Location	Description of Material and Recommended Action				Area or Quantity	Photographs
28	AJ002925	Ground Floor.  Room 15 (Corridor 016).	White bull nosing to stairs.  No Asbestos Detected.  No further action required.  <div>Recommended Action</div>				5lm

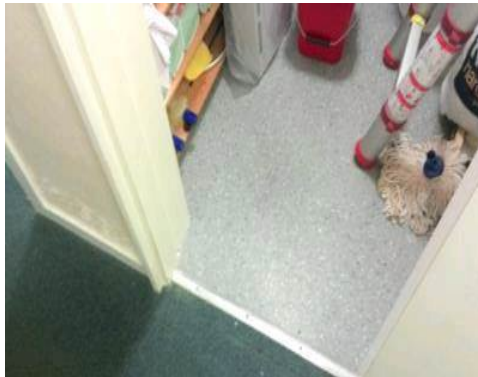
Item No.	Site Sample Reference	Location	Description of Material and Recommended Action		Area or Quantity	Photographs	
29	AS PER SAMPLE AJ002924	Ground Floor.  Room 16 (Linen 016).	<p>Beige vinyl floor tiles and adhesive beneath existing flooring (as sample AJ002924).</p> <p>Strongly presumed to contain Chrysotile asbestos materials.</p> <p>Materials can be removed by a non-licensed contractor in accordance with the Control of Asbestos Regulations 2012.</p> <div>Recommended Action</div> <div>D</div>		2m²

Material Risk Assessment							
Product Type	Condition	Surface Treatment	Asbestos Type	Risk Factor	Risk Level		Accessibility
1	0	(0) Completely Sealed	1	2	Very Low	Low	NNL

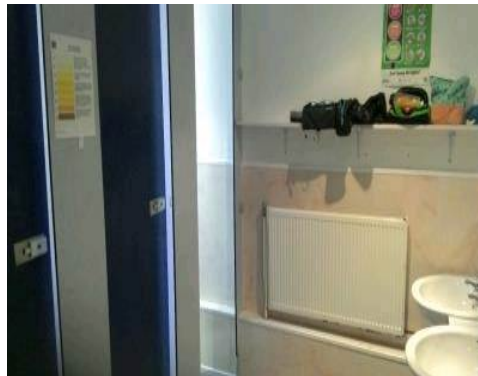
Item No.	Site Sample Reference	Location	Description of Material and Recommended Action					Area or Quantity	Photographs
30	No Sample Taken	Ground Floor.  Room 17 (Toilets 005).	Accessed - no suspect materials found to areas of work.  No further action required.					N/A

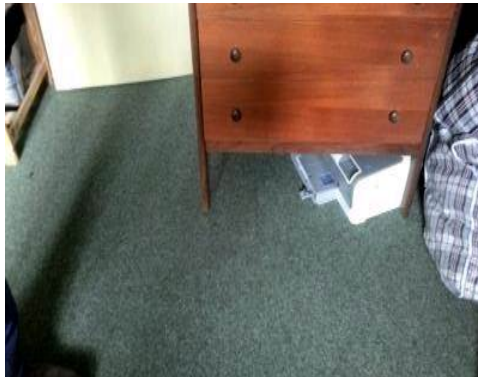
Item No.	Site Sample Reference	Location	Description of Material and Recommended Action				Area or Quantity	Photographs	
31	AJ002926	Ground Floor.  Room 18 (Office 004).	<p>Grey vinyl floor tiles and adhesive underneath existing flooring.</p> <p>Contains Chrysotile asbestos materials.</p> <p>Materials can be removed by a non-licensed contractor in accordance with the Control of Asbestos Regulations 2012.</p> <div>Recommended Action</div> <div>D</div>				16m²

Material Risk Assessment									
Product Type	Condition	Surface Treatment	Asbestos Type	Risk Factor	Risk Level	Accessibility	Material Classification		
1	0	(0) Completely Sealed	1	2	Very Low	Low	NNL

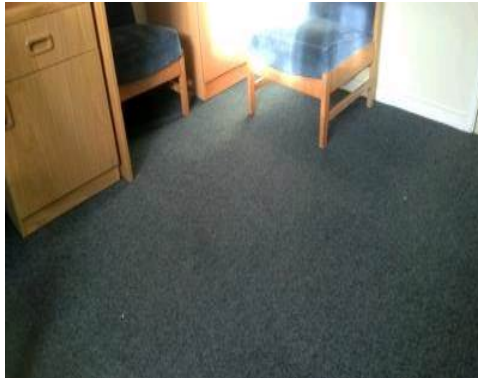
Item No.	Site Sample Reference	Location	Description of Material and Recommended Action		Area or Quantity	Photographs	
32	AS PER SAMPLE AJ002924	Ground Floor.  Room 19 (Bedroom 002).	Beige vinyl floor tiles and adhesive underneath existing flooring (as sample AJ002924).		16m²

Strongly presumed to contain Chrysotile asbestos materials.				
Materials can be removed by a non-licensed contractor in accordance with the Control of Asbestos Regulations 2012.							
Recommended Action		D					
Material Risk Assessment							
Product Type	Condition	Surface Treatment	Asbestos Type	Risk Factor	Risk Level	Accessibility	Material Classification
1	1	(0) Completely Sealed	1	3	Very Low	Low	NNL

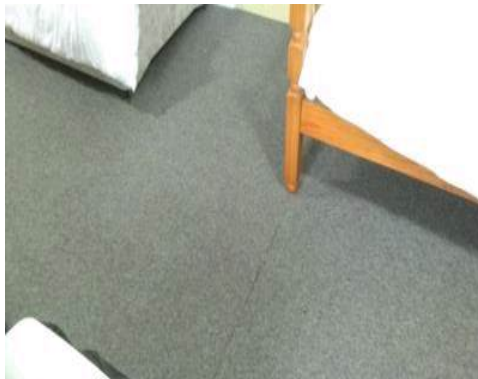
Item No.	Site Sample Reference	Location	Description of Material and Recommended Action	Area or Quantity	Photographs		
33	AS PER SAMPLE AJ002924	Ground Floor.  Room 20 (Bedroom 003).	<p>Beige vinyl floor tiles and adhesive underneath existing flooring (as sample AJ002924).</p> <p>Strongly presumed to contain Chrysotile asbestos materials.</p> <p>Materials can be removed by a non-licensed contractor in accordance with the Control of Asbestos Regulations 2012.</p> <p>Recommended Action <span>D</span></p>	16m²

Material Risk Assessment							
Product Type	Condition	Surface Treatment	Asbestos Type	Risk Factor		Risk Level	Accessibility
1	1	(0) Completely Sealed	1	3	Very Low	Low	NNL

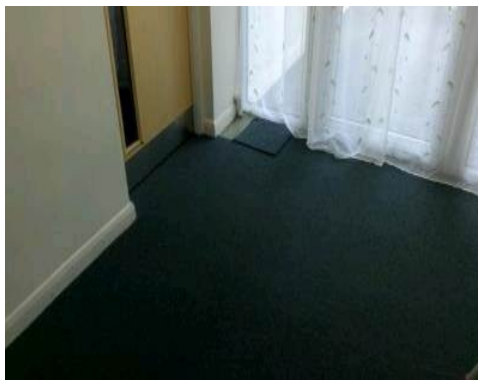
Item No.	Site Sample Reference	Location	Description of Material and Recommended Action		Area or Quantity	Photographs	
34	AJ002927	Ground Floor.  Room 21 (Stairway).	Green vinyl flooring and adhesive beneath existing flooring.  No Asbestos Detected.  No further action required.  <div>Recommended Action<div>-</div></div>		6m²

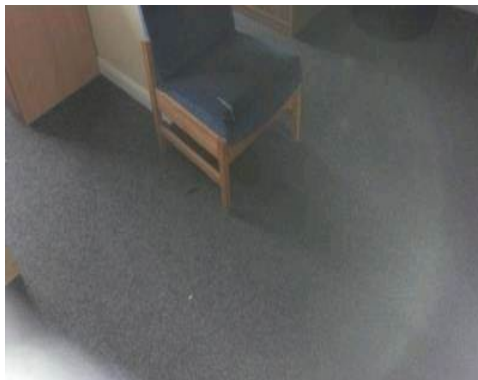
Item No.	Site Sample Reference	Location	Description of Material and Recommended Action				Area or Quantity	Photographs	
35	AS PER SAMPLE AJ002927	Ground Floor.  Room 22 (Bedroom 001).	Green vinyl flooring and adhesive beneath existing flooring (as sample AJ002927).  No Asbestos Detected.  No further action required.  <div>Recommended Action</div> -				24m²

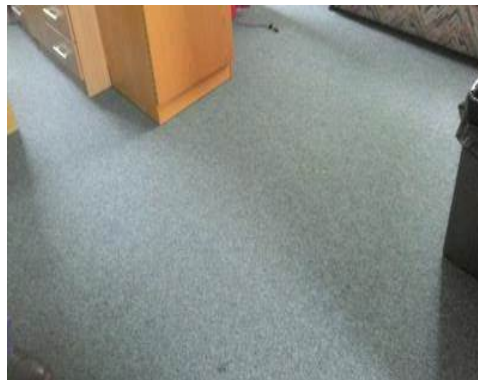
Item No.	Site Sample Reference	Location	Description of Material and Recommended Action				Area or Quantity	Photographs	
36	AS PER SAMPLE AJ002927	1st Floor.  Room 6 (Bedroom 101).	Green vinyl flooring beneath existing flooring (as sample AJ002927).  No Asbestos Detected.  No further action required.  <div>Recommended Action</div> -				25m²

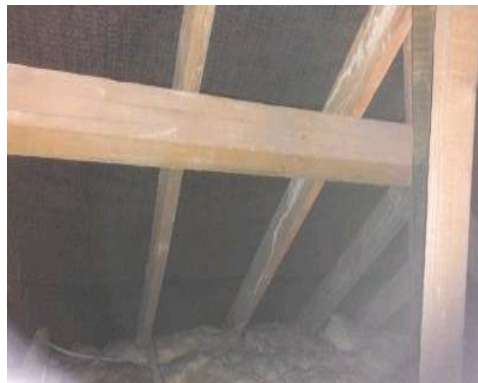
Item No.	Site Sample Reference	Location	Description of Material and Recommended Action				Area or Quantity	Photographs	
37	AJ002928	Roof Void.  Room 1 (Roofspace 101a).	Bitumen roofing felt to main roof areas.  No Asbestos Detected.  No further action required.  <div>Recommended Action</div> -				500m²

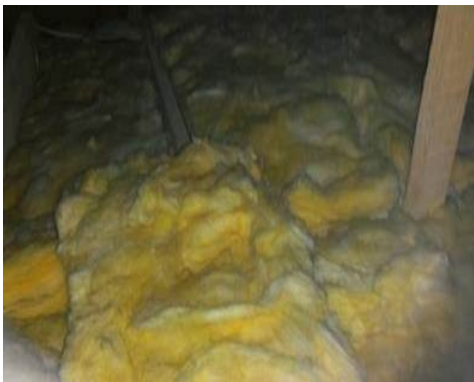
Item No.	Site Sample Reference	Location	Description of Material and Recommended Action				Area or Quantity	Photographs	
38	AJ002929	Roof Void.  Room 1 (Roofspace 101a).	Fibreglass insulation and debris .  No Asbestos Detected.  No further action required.  <div>Recommended Action</div>				25m²

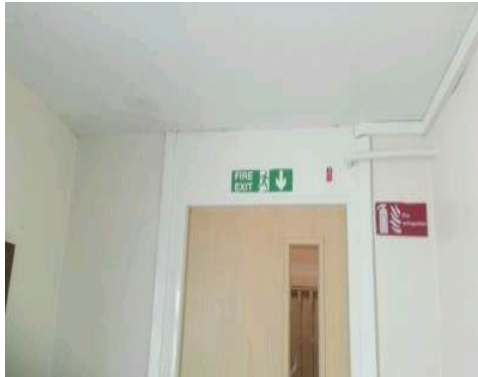
Item No.	Site Sample Reference	Location		Description of Material and Recommended Action			Area or Quantity	Photographs
39	AJ002930	1st Floor.	Room 7 (Corridor 107).	Insulating board door header panels (double sided).  Contains Chrysotile + Amosite asbestos materials.  These materials can be removed by a licensed contractor only, in accordance with the Control of Asbestos Regulations 2012.			2no.

Recommended Action	D			
Material Risk Assessment								
Product Type	Condition	Surface Treatment	Asbestos Type	Risk Factor	Risk Level	Accessibility	Material Classification	
2	0	(1) Surface Sealed	2	5	Low	Low	L

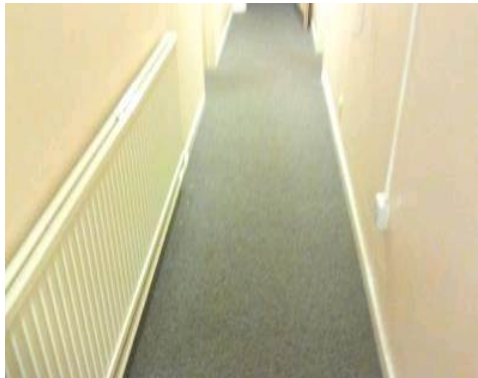
Item No.	Site Sample Reference	Location	Description of Material and Recommended Action	Area or Quantity	Photographs		
40	AS PER SAMPLE AJ002909	1st Floor.  Room 7 (Corridor 107).	Beige vinyl floor tiles and adhesive underneath existing flooring (as sample AJ002909).  Strongly presumed to contain Chrysotile asbestos materials.  Materials can be removed by a non-licensed contractor in accordance with the Control of Asbestos Regulations 2012. <div>Recommended Action</div> <div>D</div>	25m <sup>2</sup>

Material Risk Assessment							
Product Type	Condition	Surface Treatment	Asbestos Type	Risk Factor		Risk Level	Accessibility
1	0	(0) Completely Sealed	1	2	Very Low	Low	NNL

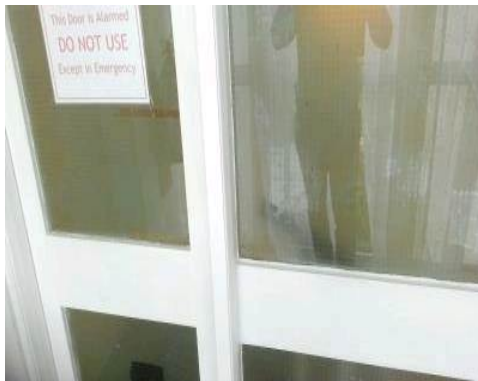
Item No.	Site Sample Reference	Location	Description of Material and Recommended Action				Area or Quantity	Photographs	
41	No Sample Taken	1st Floor.  Room 8 (Stairwell 121).	Accessed - no suspect materials found to areas of work.  No further action required.  <div>Recommended Action</div> -				N/A

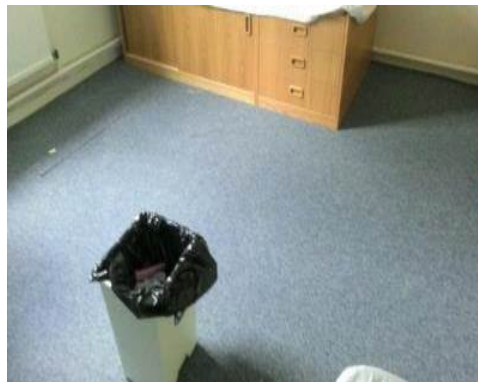
Item No.	Site Sample Reference	Location	Description of Material and Recommended Action				Area or Quantity	Photographs	
42	AJ002931	1st Floor.  Room 9 (Bedroom 102).	Grey vinyl floor tiles and adhesive beneath existing flooring.  Contains Chrysotile asbestos materials.  Materials can be removed by a non-licensed contractor in accordance with the Control of Asbestos Regulations 2012. <div>Recommended Action</div> <div>D</div>				18m²

Material Risk Assessment									
Product Type	Condition	Surface Treatment	Asbestos Type	Risk Factor	Risk Level	Accessibility	Material Classification		
1	0	(0) Completely Sealed	1	2	Very Low	Low	NNL

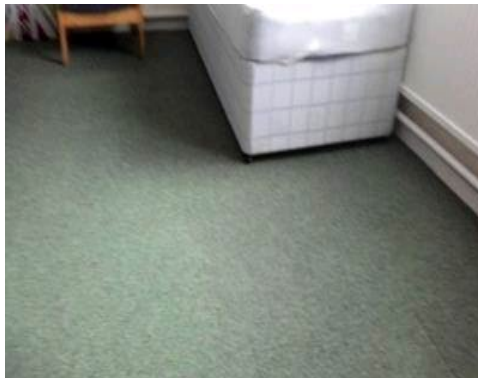
Item No.	Site Sample Reference	Location	Description of Material and Recommended Action	Area or Quantity	Photographs		
43	AS PER SAMPLE AJ002931	1st Floor.  Room 10 (Bedroom 103).	<p>Grey vinyl floor tiles and adhesive beneath existing flooring (as sample AJ002931).</p> <p>Strongly presumed to contain Chrysotile asbestos materials.</p> <p>Materials can be removed by a non-licensed contractor in accordance with the Control of Asbestos Regulations 2012.</p> <p>Recommended Action <span>D</span></p>	20m²

Material Risk Assessment							
Product Type	Condition	Surface Treatment	Asbestos Type	Risk Factor		Risk Level	Accessibility
1	0	(0) Completely Sealed	1	2	Very Low	Low	NNL

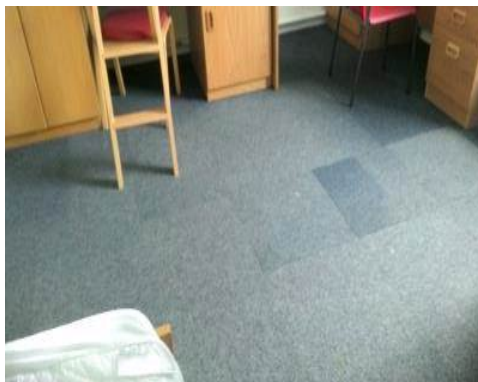
Item No.	Site Sample Reference	Location	Description of Material and Recommended Action	Area or Quantity	Photographs		
44	AS PER SAMPLE AJ002931	1st Floor.  Room 11 (Bedroom 104).	<p>Grey vinyl floor tiles and adhesive beneath existing flooring (as sample AJ002931).</p> <p>Strongly presumed to contain Chrysotile asbestos materials.</p> <p>Materials can be removed by a non-licensed contractor in accordance with the Control of Asbestos Regulations 2012.</p> <p>Recommended Action <span>D</span></p>	16m²

Material Risk Assessment							
Product Type	Condition	Surface Treatment	Asbestos Type	Risk Factor		Risk Level	Accessibility
1	0	(0) Completely Sealed	1	2	Very Low	Low	NNL

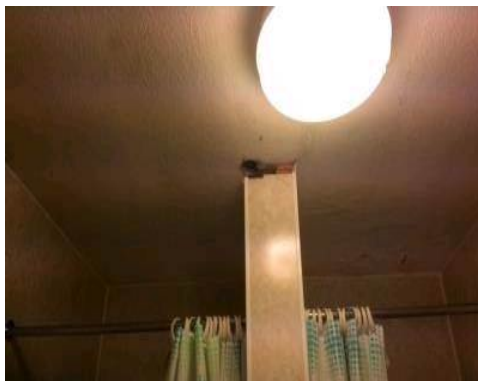
Item No.	Site Sample Reference	Location	Description of Material and Recommended Action				Area or Quantity	Photographs	
46	AJ002932	1st Floor.  Room 13 (Shower 104).	Textured coating to plasterboard ceiling.  No Asbestos Detected.  No further action required.  <div>Recommended Action</div> <div>-</div>				5m²

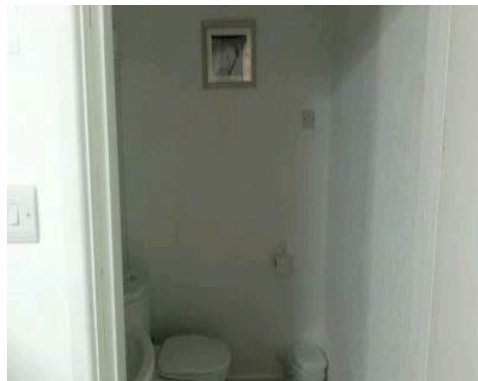
Item No.	Site Sample Reference	Location	Description of Material and Recommended Action				Area or Quantity	Photographs	
47	No Sample Taken	1st Floor.  Room 14 (WC).	Accessed - no suspect materials found to areas of work.  No further action required.  <div>Recommended Action</div> -				N/A

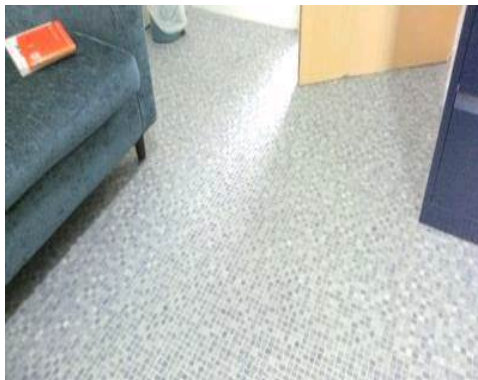
Item No.	Site Sample Reference	Location	Description of Material and Recommended Action				Area or Quantity	Photographs	
48	AJ002933	1st Floor.  Room 15 (First Aid 115).	Red vinyl floor tiles and adhesive underneath existing flooring.  Contains Chrysotile asbestos materials.  Materials can be removed by a non-licensed contractor in accordance with the Control of Asbestos Regulations 2012. <div>Recommended Action</div> <div>D</div>				9m²

Material Risk Assessment									
Product Type	Condition	Surface Treatment	Asbestos Type	Risk Factor	Risk Level	Accessibility	Material Classification		
1	0	(0) Completely Sealed	1	2	Very Low	Low	NNL

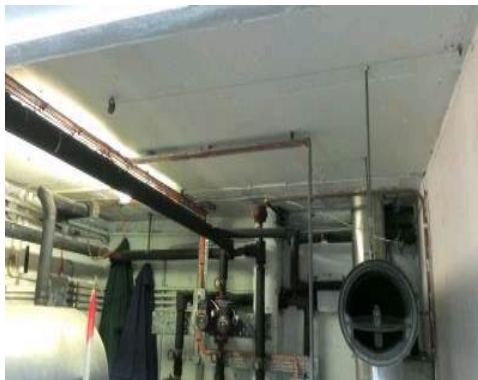
Item No.	Site Sample Reference	Location	Description of Material and Recommended Action		Area or Quantity	Photographs	
49	AJ002934	Ground Floor.  Room 23 (Boiler Room).	Insulation residue to ceiling and walls - previously identified.  Contains Amosite asbestos materials.  These materials can be removed by a licensed contractor only, in accordance with the Control of Asbestos Regulations 2012. <div>Recommended Action</div>		50m²

Material Risk Assessment							
Product Type	Condition	Surface Treatment	Asbestos Type	Risk Factor	Risk Level		Accessibility
3	3	-	2	11	High	Medium	L

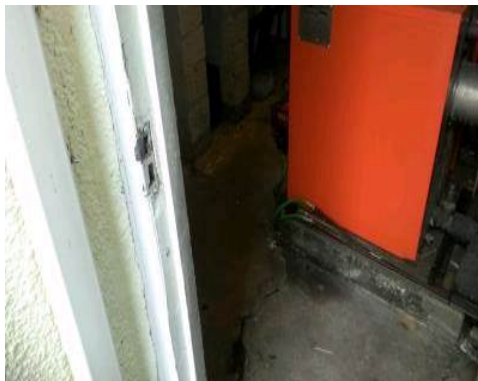
Item No.	Site Sample Reference	Location	Description of Material and Recommended Action				Area or Quantity	Photographs	
50	AJ002935	Ground Floor.  Room 23 (Boiler Room).	Dust sample to floor.  No Asbestos Detected.  No further action required.  <div>Recommended Action</div> -				20m²

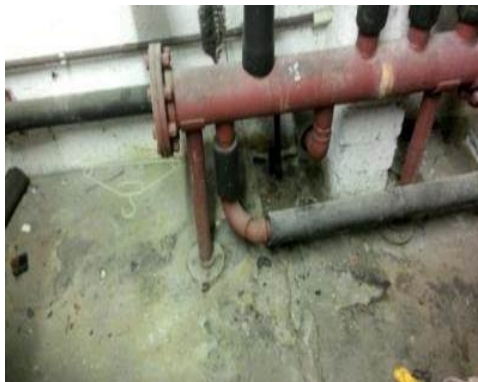
Item No.	Site Sample Reference	Location	Description of Material and Recommended Action				Area or Quantity	Photographs	
51	AJ002936	Ground Floor.  Room 23 (Boiler Room).	Insulation residue to floor void access.  No Asbestos Detected.  No further action required.  <div>Recommended Action</div> -				<1m²

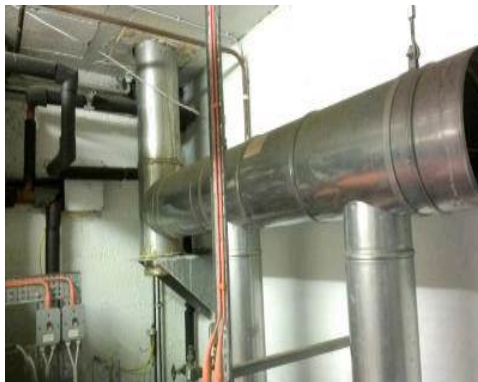
Item No.	Site Sample Reference	Location	Description of Material and Recommended Action				Area or Quantity	Photographs	
52	AJ002937	Ground Floor.  Room 23 (Boiler Room).	Insulation within boiler flue.  No Asbestos Detected.  No further action required.  <div>Recommended Action</div> -				2m²

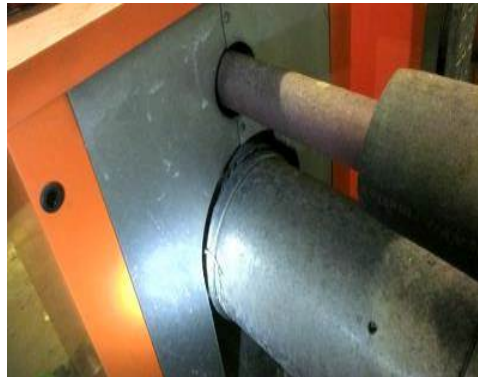
Item No.	Site Sample Reference	Location		Description of Material and Recommended Action			Area or Quantity	Photographs
53	AJ002938	Ground Floor.	Room 23 (Boiler Room).	Rope seals to boiler sections and flue connection.  Contains Chrysotile asbestos materials.  Materials can be removed by a non-licensed contractor in accordance with the Control of Asbestos Regulations 2012.			2no.

Recommended Action		D		
Material Risk Assessment								
Product Type	Condition	Surface Treatment	Asbestos Type	Risk Factor	Risk Level	Accessibility	Material Classification	
2	0	(1) Surface Sealed	1	4	Low	Low	NNL

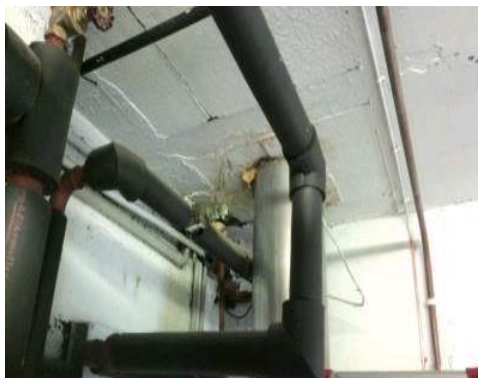
Item No.	Site Sample Reference	Location	Description of Material and Recommended Action				Area or Quantity	Photographs	
54	AJ002939	Ground Floor.  Room 23 (Boiler Room).	Insulation to flue penetration.  No Asbestos Detected.  No further action required.  <div>Recommended Action</div> -				<1m²

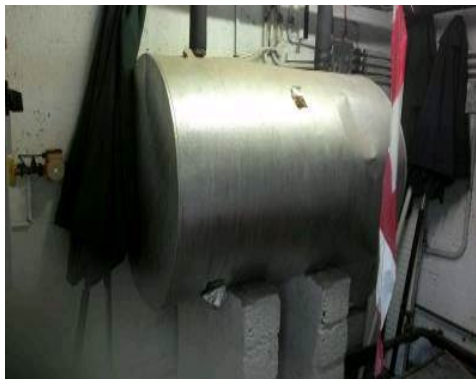
Item No.	Site Sample Reference	Location	Description of Material and Recommended Action				Area or Quantity	Photographs	
55	AJ002940	Ground Floor.  Room 23 (Boiler Room).	Insulation and residue to copper calorifier.  No Asbestos Detected.  No further action required.  <div>Recommended Action</div> <div>-</div>				3m²

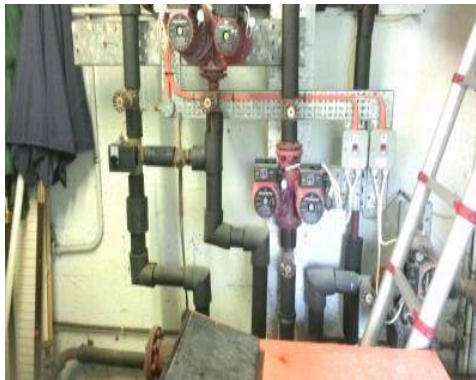
Item No.	Site Sample Reference	Location		Description of Material and Recommended Action			Area or Quantity	Photographs	
56	AJ002941	Ground Floor.  Room 23 (Boiler Room).		Gaskets to pipework flanges and pumps.  Contains Chrysotile asbestos materials.  Materials can be removed by a non-licensed contractor in accordance with the Control of Asbestos Regulations 2012.  <div>Recommended Action</div> <div>D</div>			<10no.

Material Risk Assessment									
Product Type	Condition	Surface Treatment	Asbestos Type	Risk Factor	Risk Level	Accessibility	Material Classification		
1	0	(0) Completely Sealed	1	2	Very Low	Low	NL

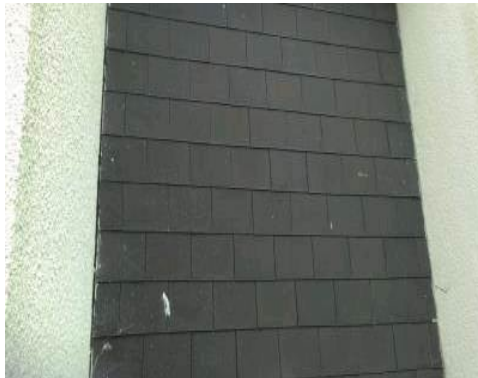
Item No.	Site Sample Reference	Location		Description of Material and Recommended Action			Area or Quantity	Photographs	
57	AJ002942	External.	Room 1 (Main Building).	Cement wall cladding tiles.  Contains Chrysotile asbestos materials.  Materials can be removed by a non-licensed contractor in accordance with the Control of Asbestos Regulations 2012.			30m²

Recommended Action		D			
Material Risk Assessment									
Product Type	Condition	Surface Treatment	Asbestos Type	Risk Factor	Risk Level	Accessibility	Material Classification		
1	0	(1) Surface Sealed	1	3	Very Low	Low	NL

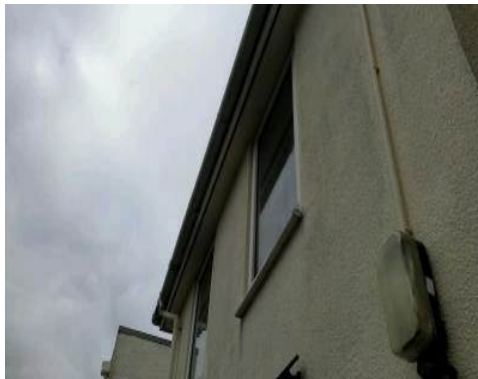
Item No.	Site Sample Reference	Location	Description of Material and Recommended Action				Area or Quantity	Photographs	
58	AJ002943	External.  Room 1 (Main Building).	Insulating board soffit boards to newer wing of building.  No Asbestos Detected.  No further action required.  <div>Recommended Action</div> -				50m

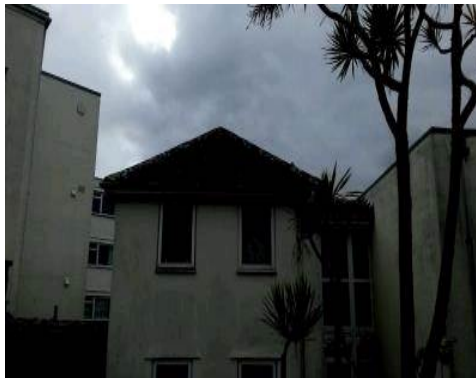
Item No.	Site Sample Reference	Location	Description of Material and Recommended Action	Area or Quantity	Photographs		
59	No Sample Taken	External.  Room 1 (Main Building).	Roofing tiles tonewer wing of building -no safe access to sample.  Presumed - Crocidolite (or unknown) asbestos materials.  Materials can be removed by a non-licensed contractor in accordance with the Control of Asbestos Regulations 2012. <div>Recommended Action</div> <div>D</div>	75m²

Material Risk Assessment							
Product Type	Condition	Surface Treatment	Asbestos Type	Risk Factor		Risk Level	Accessibility
1	0	(1) Surface Sealed	3	5	Low	Low	NL

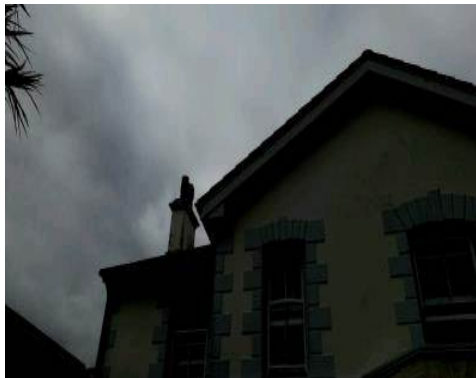
Item No.	Site Sample Reference	Location		Description of Material and Recommended Action			Area or Quantity	Photographs
60	No Sample Taken	External.	Room 1 (Main Building).	No access to older wing soffit boards due to height.  Presumed - Crocidolite (or unknown) asbestos materials.  These materials can be removed by a licensed contractor only, in accordance with the Control of Asbestos Regulations 2012.			75m

Recommended Action	D			
Material Risk Assessment								
Product Type	Condition	Surface Treatment	Asbestos Type	Risk Factor	Risk Level	Accessibility	Material Classification	
2	0	(1) Surface Sealed	3	6	Low	Low	L

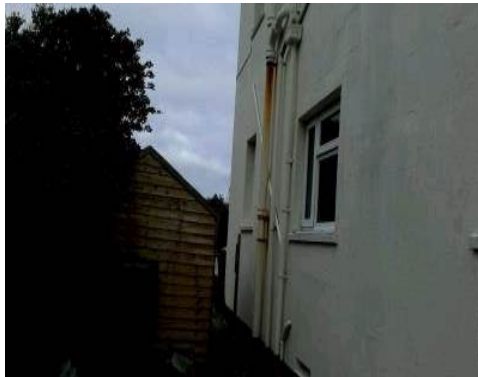
Item No.	Site Sample Reference	Location		Description of Material and Recommended Action			Area or Quantity	Photographs
61	AJ002944	External.	Room 1 (Main Building).	Cement soil and vent pipe to right side of building.			10lm

Contains Chrysotile asbestos materials.				
				Materials can be removed by a non-licensed contractor in accordance with the Control of Asbestos Regulations 2012.				
				Recommended Action			D	
Material Risk Assessment								
Product Type		Condition	Surface Treatment	Asbestos Type	Risk Factor	Risk Level	Accessibility	Material Classification
1		0	(1) Surface Sealed	1	3	Very Low	Low	NL

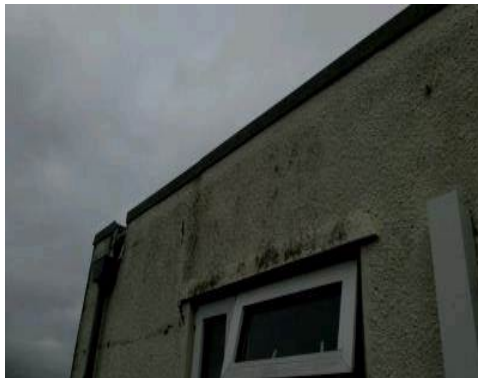
Item No.	Site Sample Reference	Location	Description of Material and Recommended Action				Area or Quantity	Photographs
62	AJ002945	External.  Room 1 (Main Building).	Bitumen roof coating to flat roof areas.  No Asbestos Detected.  No further action required.  Recommended Action				250m²

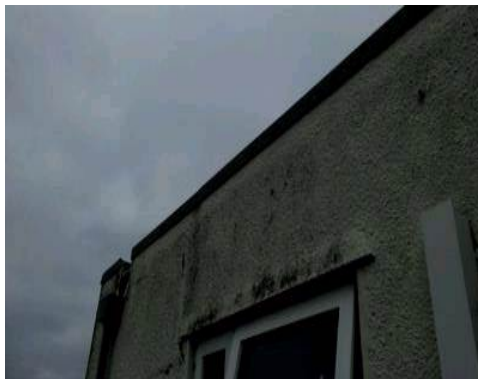
Item No.	Site Sample Reference	Location	Description of Material and Recommended Action				Area or Quantity	Photographs	
63	AJ002946	External.  Room 1 (Main Building).	Cement coverstrip/ fascias to perimeter of flat roof areas.  No Asbestos Detected.  No further action required.  <div>Recommended Action</div>				150lm

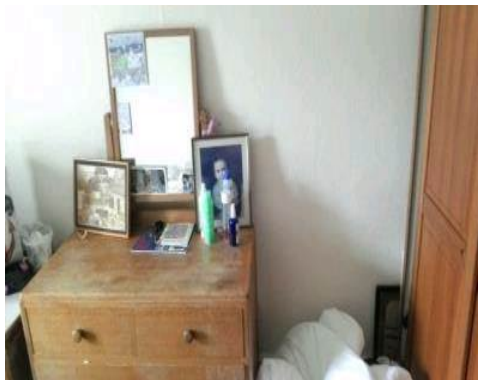
Item No.	Site Sample Reference	Location	Description of Material and Recommended Action				Area or Quantity	Photographs	
64	AJ002947	1st Floor.  Room 16 (Bedroom 113).	Paper to fibreboard wall lining.  No Asbestos Detected.  No further action required.  <div>Recommended Action</div>				6m²

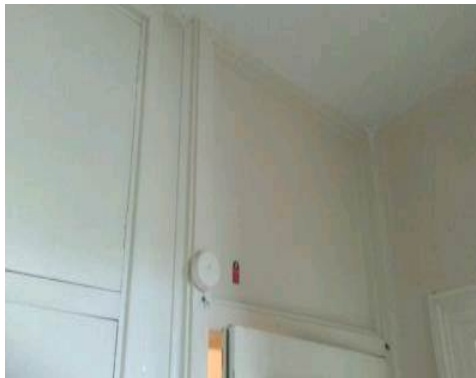
Item No.	Site Sample Reference	Location	Description of Material and Recommended Action	Area or Quantity	Photographs		
65	AS PER SAMPLE AJ002930	1st Floor.  Room 17 (Landing 114).	<p>Insulating board door header panel (as sample AJ002930).</p> <p>Strongly presumed to contain Chrysotile + Amosite asbestos materials.</p> <p>These materials can be removed by a licensed contractor only, in accordance with the Control of Asbestos Regulations 2012.</p> <p>Recommended Action <span>D</span></p>	1m²

Material Risk Assessment							
Product Type	Condition	Surface Treatment	Asbestos Type	Risk Factor		Risk Level	Accessibility
2	0	(1) Surface Sealed	2	5	Low	Low	L

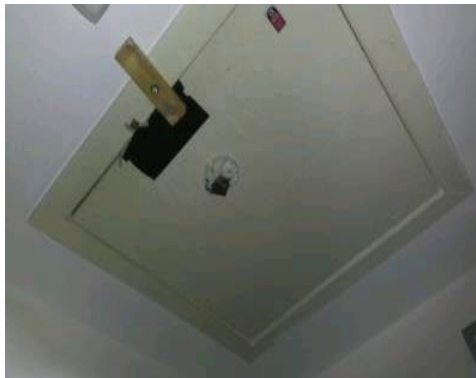
Item No.	Site Sample Reference	Location	Description of Material and Recommended Action		Area or Quantity	Photographs	
66	AJ002948	1st Floor.  Room 17 (Landing 114).	Insulating board lining to loft hatch.  Contains Chrysotile + Amosite asbestos materials.  These materials can be removed by a licensed contractor only, in accordance with the Control of Asbestos Regulations 2012.  Recommended Action		1m²

Material Risk Assessment							
Product Type	Condition	Surface Treatment	Asbestos Type	Risk Factor	Risk Level		Accessibility
2	1	(1) Surface Sealed	2	6	Low	Medium	L

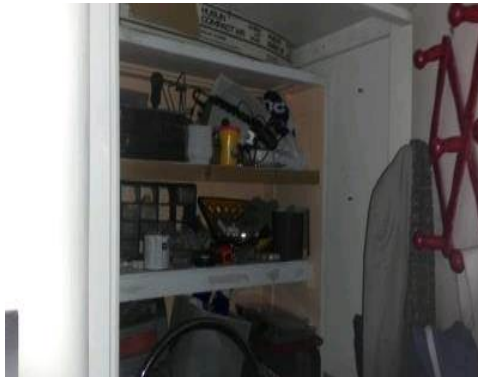
Item No.	Site Sample Reference	Location		Description of Material and Recommended Action			Area or Quantity	Photographs
67	AJ002949	1st Floor.  Room 17 (Landing 114).		Insulating board ceiling and wall lining within cupboard.  Contains Chrysotile + Amosite asbestos materials.  These materials can be removed by a licensed contractor only, in accordance with the Control of Asbestos Regulations 2012. <div>Recommended Action</div>			2m²

Material Risk Assessment								
Product Type	Condition	Surface Treatment	Asbestos Type	Risk Factor	Risk Level	Accessibility	Material Classification	
2	1	(1) Surface Sealed	2	6	Low	Medium	L

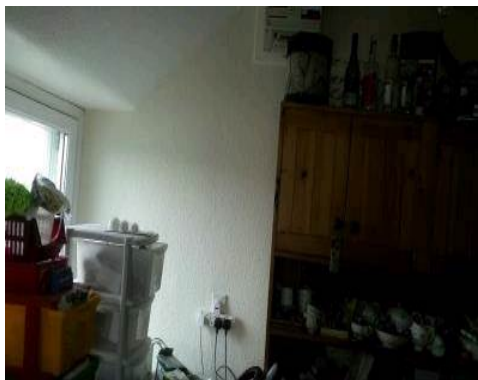
Item No.	Site Sample Reference	Location	Description of Material and Recommended Action	Area or Quantity	Photographs		
68	AS PER SAMPLE AJ002947	1st Floor.  Room 18 (Kitchen 108).	Paper to fibreboard wall lining (as sample AJ002947).  No Asbestos Detected.  No further action required.  <div>Recommended Action</div> <div>-</div>	5m²

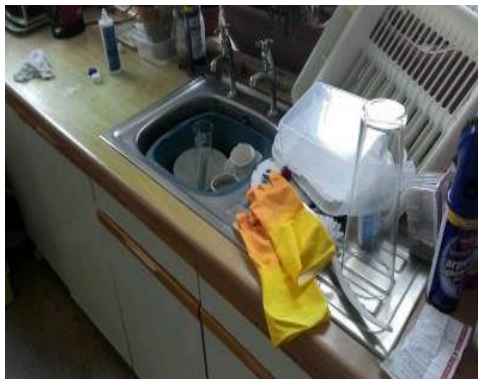
Item No.	Site Sample Reference	Location	Description of Material and Recommended Action				Area or Quantity	Photographs	
69	AJ002950	1st Floor.  Room 18 (Kitchen 108).	Sound pad to sink unit.  No Asbestos Detected.  No further action required.  <div>Recommended Action</div> -				1no.

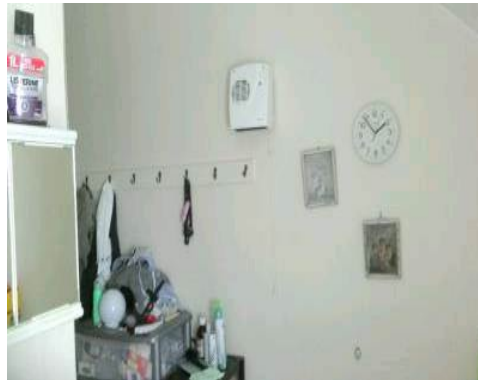
Item No.	Site Sample Reference	Location	Description of Material and Recommended Action				Area or Quantity	Photographs	
70	AS PER SAMPLE AJ002947	1st Floor.  Room 19 (Bathroom 109).	Paper to fibreboard wall lining (as sample AJ002947).  No Asbestos Detected.  No further action required.  <div>Recommended Action</div>				5m²

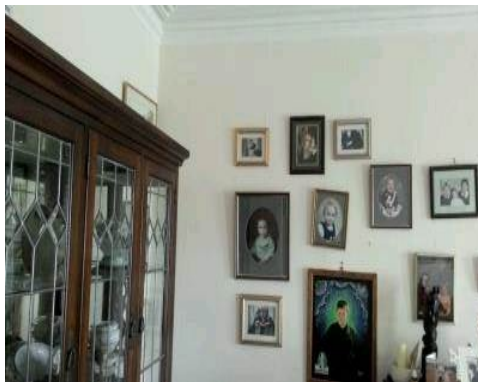
Item No.	Site Sample Reference	Location	Description of Material and Recommended Action				Area or Quantity	Photographs
71	AS PER SAMPLE AJ002947	1st Floor.  Room 20 (Lounge 110).	Paper to fibreboard wall lining (as sample AJ002947).  No Asbestos Detected.  No further action required.				10m²

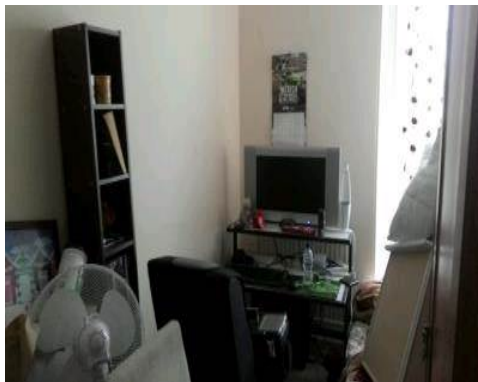
Item No.	Site Sample Reference	Location	Description of Material and Recommended Action		Area or Quantity	Photographs	
72	No Sample Taken	1st Floor.  Room 21 (Bedroom 111).	Accessed - no suspect materials found to areas of works.  No further action required.		N/A

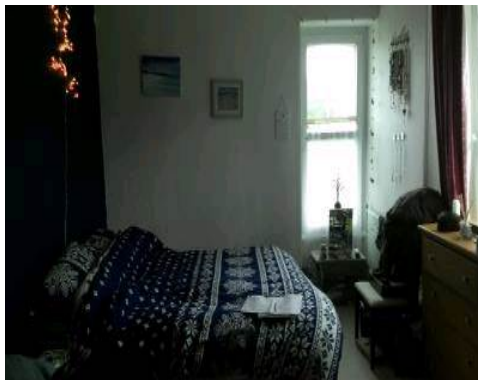
Item No.	Site Sample Reference	Location	Description of Material and Recommended Action				Area or Quantity	Photographs	
73	No Sample Taken	1st Floor.  Room 22 (Bedroom 112).	Accessed - no suspect materials found to areas of works.  No further action required.  <div>Recommended Action</div>				N/A

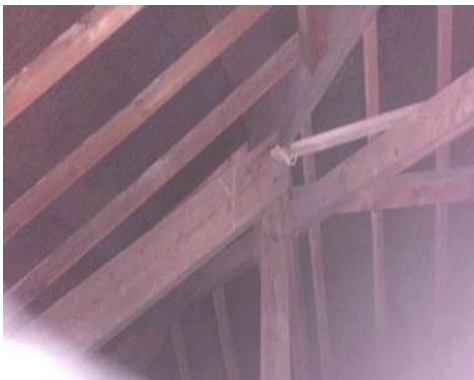
Item No.	Site Sample Reference	Location	Description of Material and Recommended Action				Area or Quantity	Photographs	
74	AJ002951	Roof Void.  Room 3 (Roofspace 114a).	Bitumen roofing felt to older wing of property.  No Asbestos Detected.  No further action required.  <div>Recommended Action</div> -				120m²

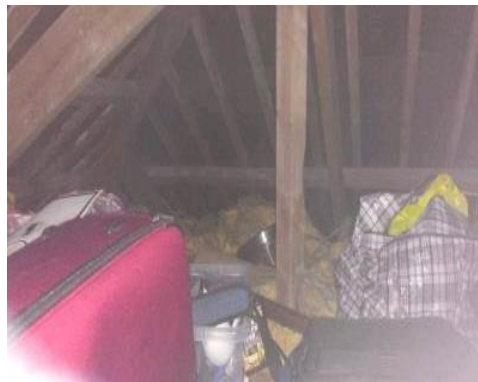
Item No.	Site Sample Reference	Location	Description of Material and Recommended Action				Area or Quantity	Photographs	
75	AJ002952	Roof Void.  Room 3 (Roofspace 114a).	Roofing tile debris throughout.  No Asbestos Detected.  No further action required.  <div>Recommended Action</div>				75m²

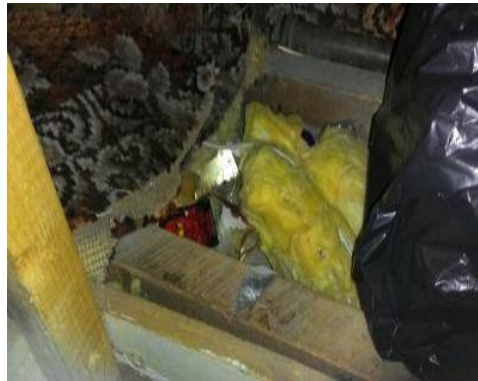
Item No.	Site Sample Reference	Location	Description of Material and Recommended Action				Area or Quantity	Photographs	
76	AS PER SAMPLE AJ002929	Roof Void.  Room 3 (Roofspace 114a).	Fibreglass loft insulation (as sample AJ002929).  No Asbestos Detected.  No further action required.  <div>Recommended Action</div>				75m²

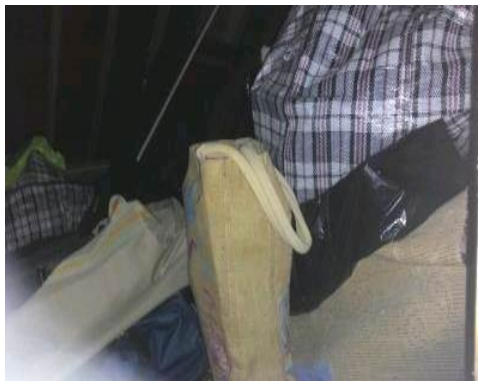
Item No.	Site Sample Reference	Location	Description of Material and Recommended Action		Area or Quantity	Photographs	
77	No Sample Taken	Roof Void.  Room 3 (Roofspace 114a).	Limited access due to stored items.  Inaccessible - Presumed to contain asbestos materials.  Further Inspection Required  <div>Recommended Action</div>		N/A
