**6 CONCLUSIONS****6.1 General**

**APPENDIX 1: LEEWARD AND SEAWARD SIDE WAVE WALL PHOTOS**

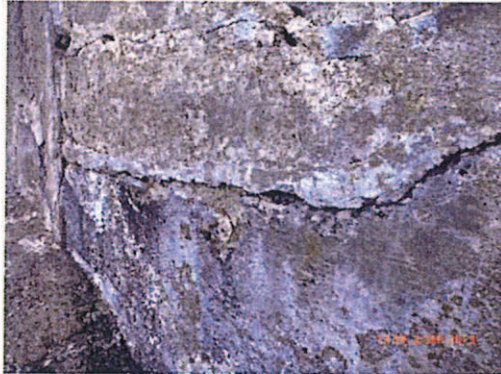
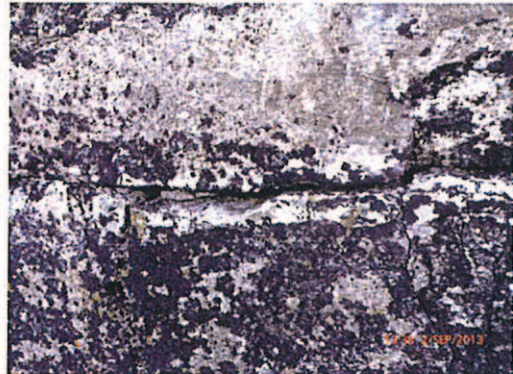
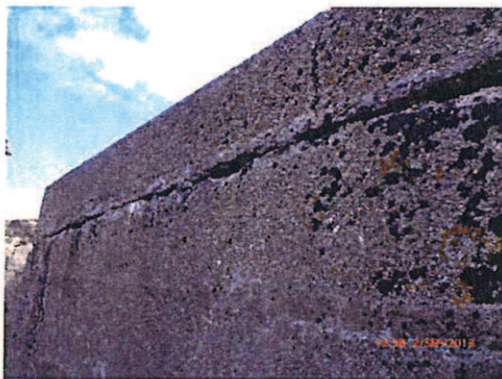
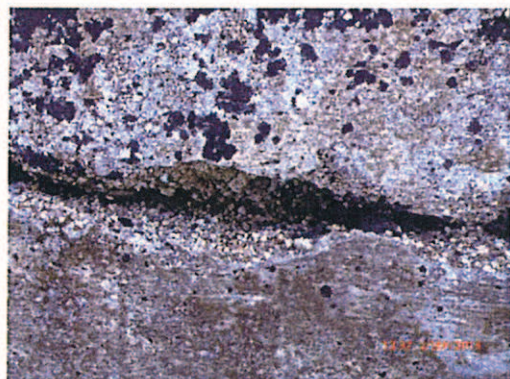
**Seaward Side**

The condition of the reinforced concrete works are heavily cracked and potentially delaminated from the existing masonry leading to the probability that the reinforcement within the section is either corroding or likely to commence corroding in the near future. These findings are substantiated from large areas of hollow sounding concrete and crack measurements from hammer sounding surveys and visual inspections respectively together with evidence of spalled concrete.
