PERMISSION FOR DEVELOPMENT

Application No:	P/22/019/HH	Date Application Registered:	8th February 2022
Applicant:	Mr Alistair Martin Duchy Of Cornwall 10 Buckingham Gate London SW1E 6LA	Agent:	Mr Nathan Dean Duchy Of Cornwall Hugh House St Mary's Isles Of Scilly TR21 0LS
Site address:	Ashvale Farmhouse Lower Town St Martin's Isles Of Scilly TR25 0QW		
Proposal:	Replacement of existing wet laid scantle slate with dry laid Trevilletts slate (Listed Building).

The proposal is to replace the slate roof covering of a farmhouse.

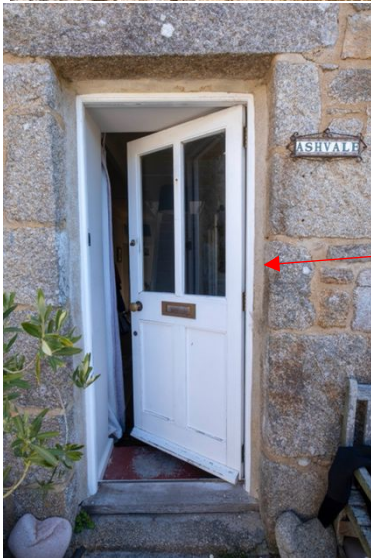
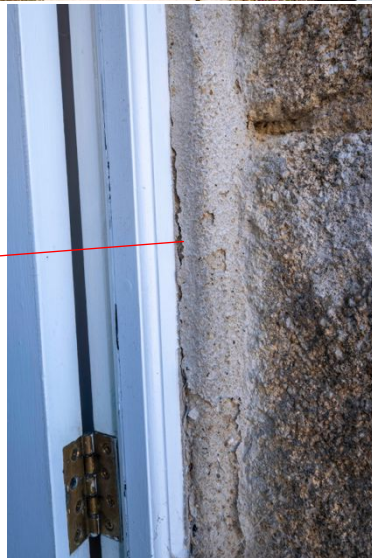
West elevation

Example of the friable mortar around windows and doors

Example of perimeter shrinkage and cracking of mortar

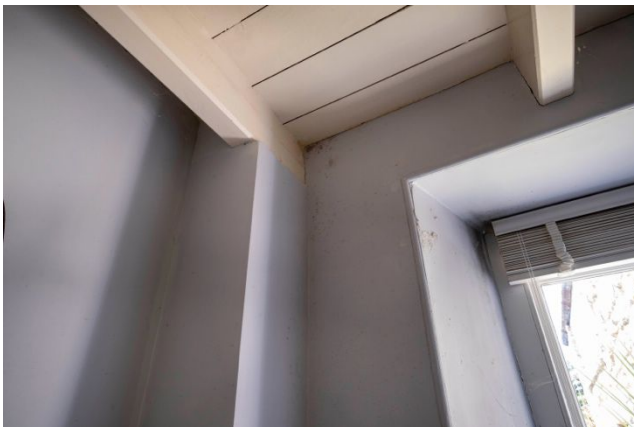
Ground Floor Bathroom

Shows damp to reveals and wall at ceiling height

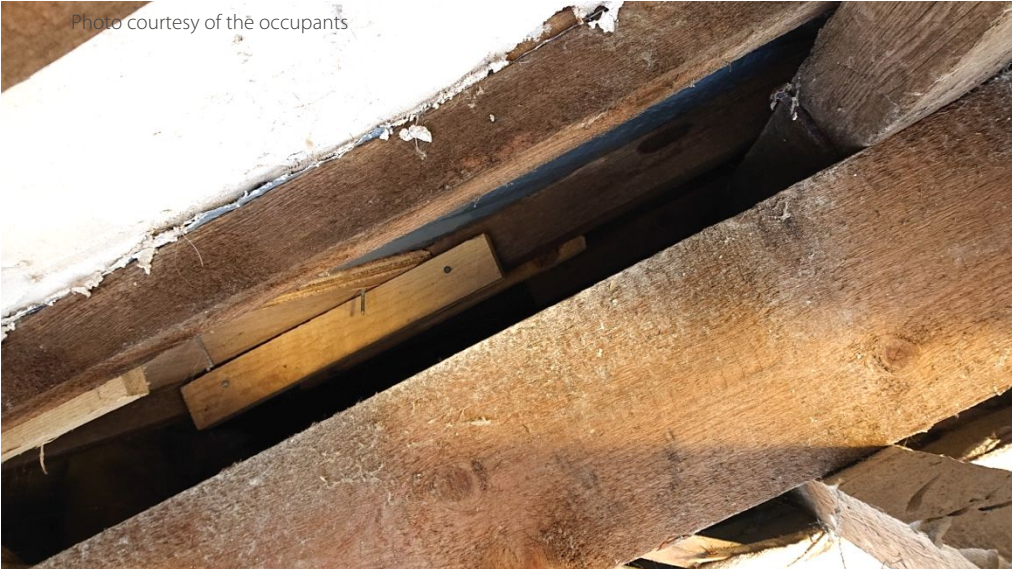
As above. A small blade (approx. 6") shows the decayed timber

Photo courtesy of the occupants

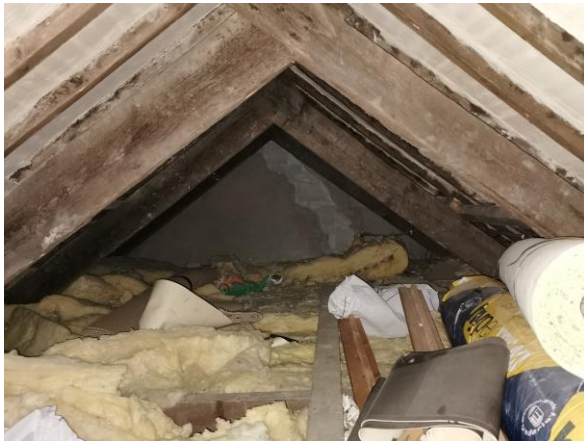
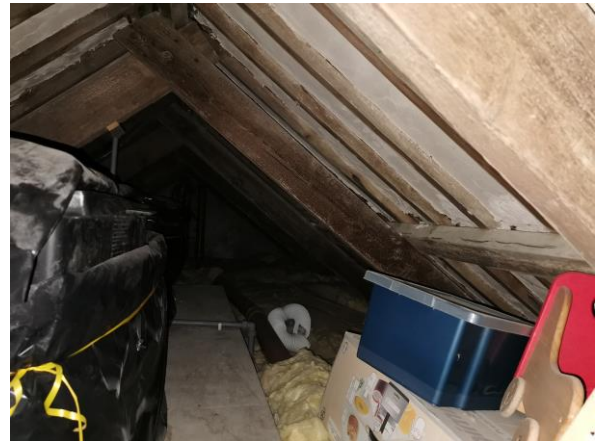
Internally there is a single open roof void which stretches the length of the building. The roof is supported by timber trusses and is open with no crossing timbers but does contain a large water tank. The underside of the roof is lined with lime mortar as the roof is covered with wet-laid scantle slate, see photos 5 and 6.

Photo 5 and 6. Showing the roof void over the house

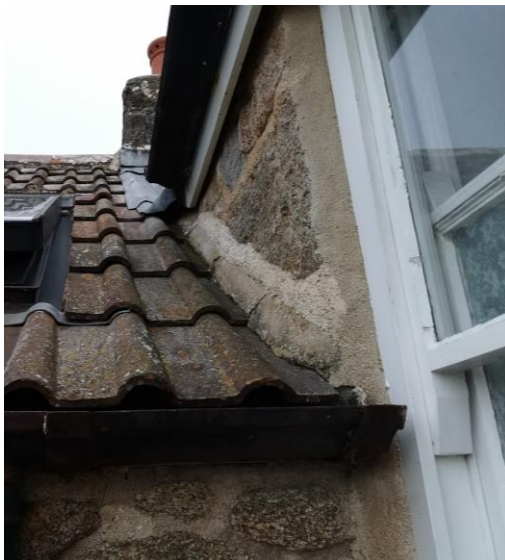
Externally the southern gable end is rendered with the other walls being stonework. There are deep cavities behind the fascia board on the two long walls, creating roosting habitat for bats, which extend up the wall tops above creating access to them for roosting bats. There are similar cavities behind the row of hanging slates lining the northern gable end giving access to the wall tops and behind the leadwork where the house joins the attached barn, see photo 7.

Photo 7. Showing the point where the house and barn join
and an example of the gaps behind the fascia board

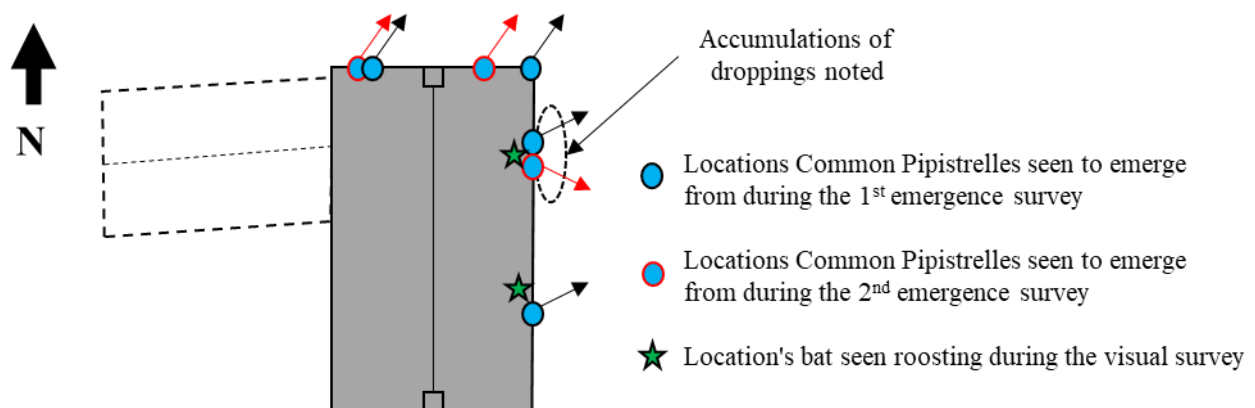
9 Common Pipistrelles were seen to emerge the house during this survey with six individuals coming from a single location, see figure 2.

5 Common Pipistrelles were seen to emerge the house during this survey, see figure 2.

Figure 2. Summary of the location's bats were seen to emerge from during the emergence surveys
