Climate Adaptation Scilly
Porthmellon Enterprise Centre
St Mary's
Isles of Scilly TR21 0LW

Information on the materials present in the Periglis embankment, St Agnes

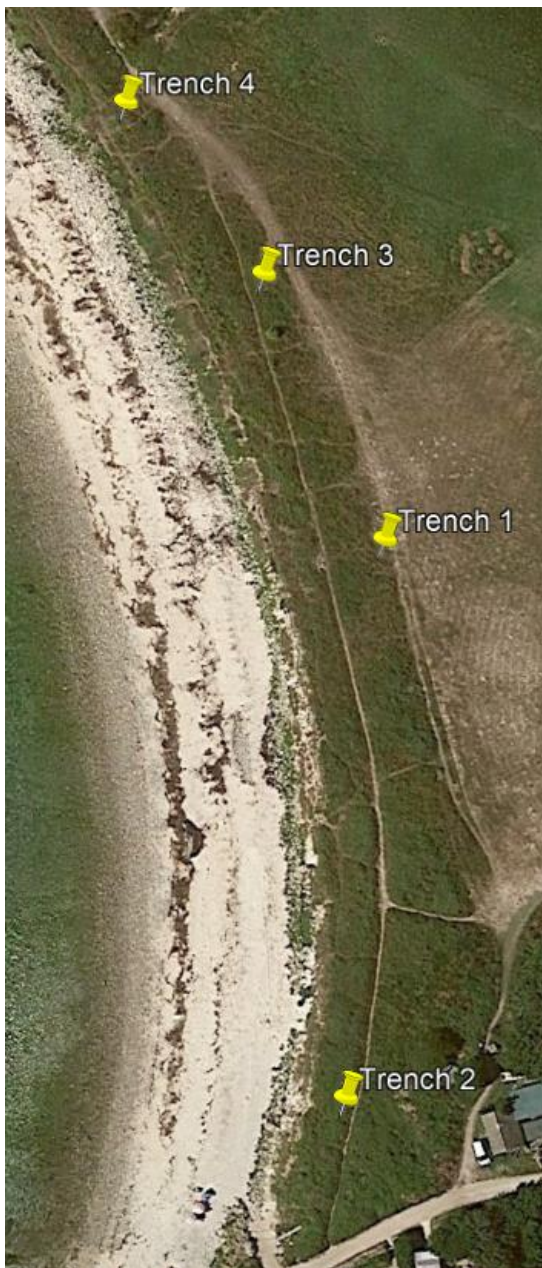
The investigation trenches were placed at four locations likely to be representative of the types of material in the embankment (Figure 1).

Figure 1: Location of investigation trenches at Periglis, St Agnes
