## PRELIMINARY ROOST ASSESSMENT (PRA)

### SIGNAL ROCK STABLE BLOCK HIGHER TOWN, ST MARTIN'S, ISLES OF SCILLY

*Report date: 23<sup>rd</sup> July 2023*

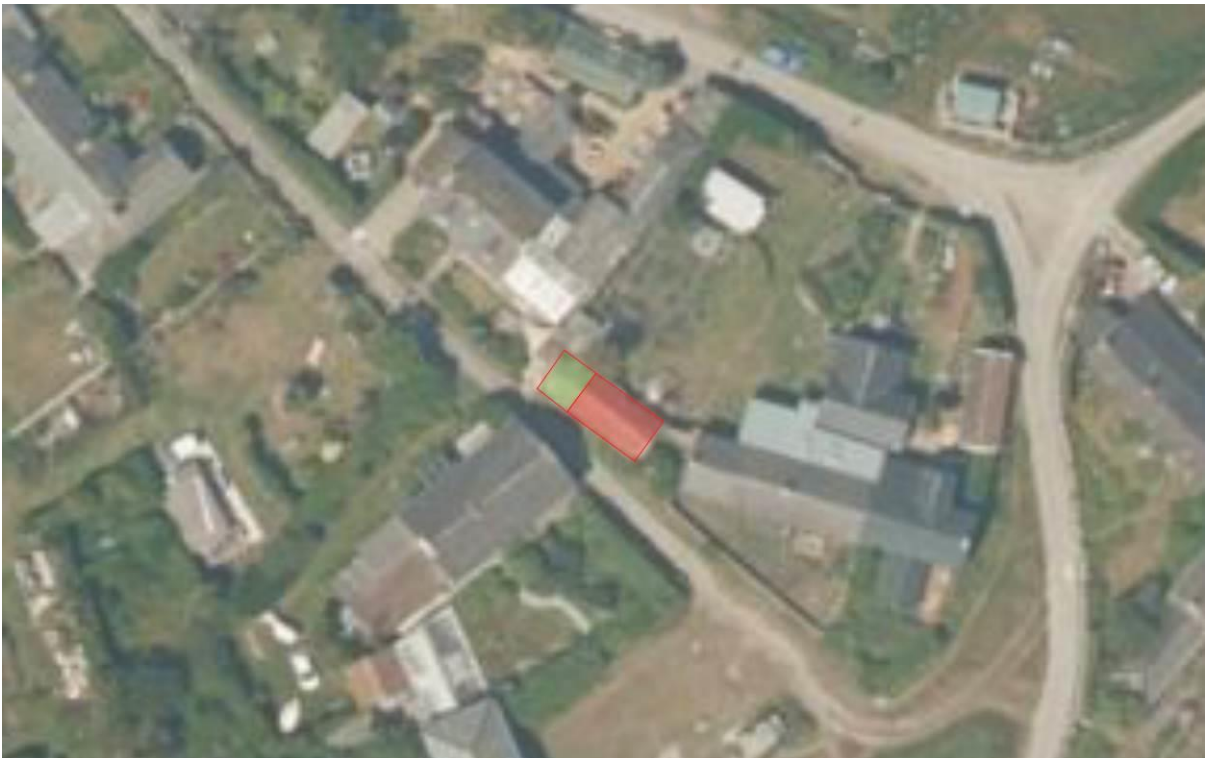
**Map 02** – Showing the stable block (red wash) under consideration. The offsite outbuilding attached on the north-western aspect is shown in the green wash and was not subject to survey. Signal Rock is the residential property (not indicated) to the east of the stable block.
