PRELIMINARY ROOST ASSESSMENT (PRA)

CONSERVATORY REPLACEMENT, TURK'S HEAD, ST AGNES, ISLES OF SCILLY

Our reference: 23-6-5

Report date: 11th July 2023

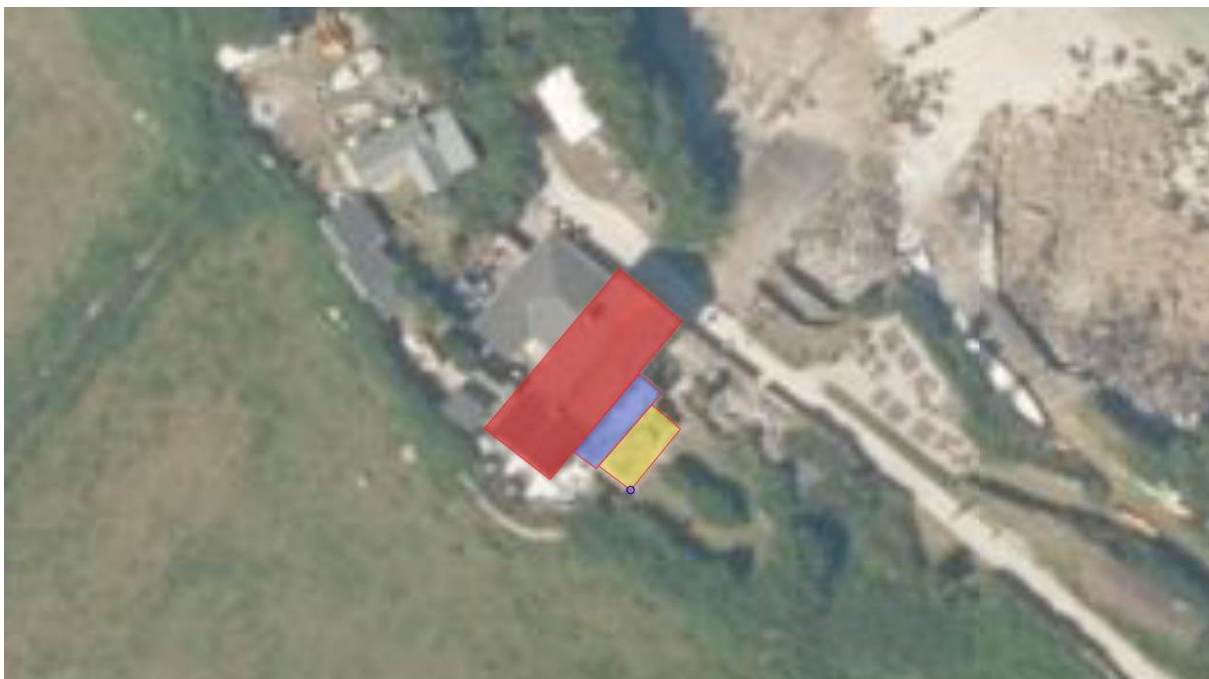
The roof is tiled with flat slate tiles and ridge tiles – all appear well fitted and in good condition. A chimney is present – the flashing at the junction with the tiled roof is well-sealed and in good condition. Soffits around the eaves of the roof are well-sealed with attached guttering. The potential for minor gaps beneath tiles at the eaves is largely restricted by the position of the guttering which would preclude a direct fly-in access.

The junction between the conservatory and the main pub building (Section A) against which it is built is well-sealed with no gaps noted.

Map 02 - Showing the different building sections including the main roof of the pub (Section A) in the red wash; the conservatory (Section B) in the blue wash; and the flat-roof extension on which the conservatory is built (Section C) in the yellow wash. Note Section C also extends beneath Section B.
