PRELIMINARY ROOST ASSESSMENT (PRA)

PARKSIDE, ST MARY'S, ISLES OF SCILLY

Our reference: 23-8-2

Report date: 29th August 2023

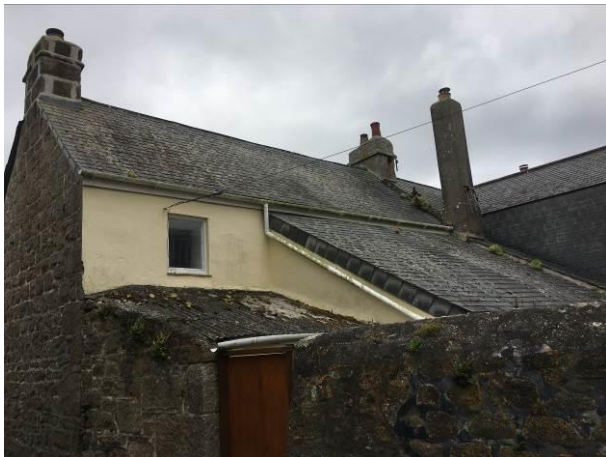
Photograph 3: Showing the rear of the property from the adjacent access road – the main Extension is present on this aspect with the lean-to Utility room just visible adjacent to it.
