PRELIMINARY ROOST ASSESSMENT (PRA)

HARBOUR BUILDING, ST MARY'S, ISLES OF SCILLY

Our reference: 24-6-2

Report date: 2nd July 2024

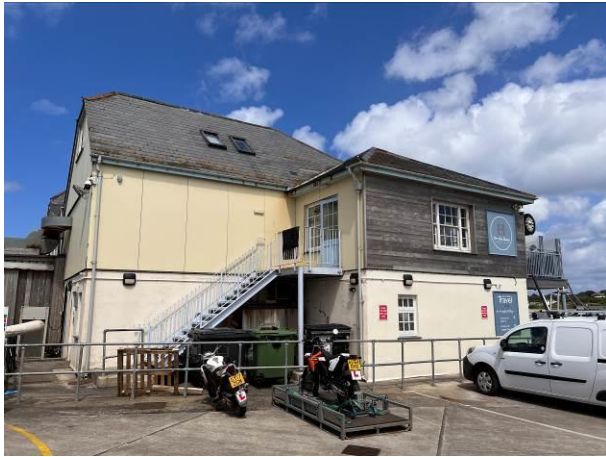
Photograph 1: Showing the northern gable of Harbour B on the LHS- the small section of the two-storey building included in the Harbour B assessment is visible on the RHS of the image.

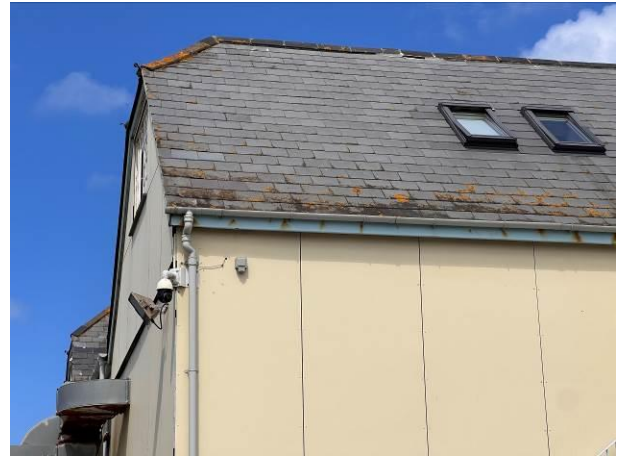
Photograph 2: Showing an example of the partially hipped roof structure of Harbour B with occasional roof lights within the span.
