PRELIMINARY ROOST ASSESSMENT (PRA)

WINDRIDGE,
MCFARLAND'S DOWN, ST MARY'S, ISLES OF SCILLY

Report date: 1st March 2025

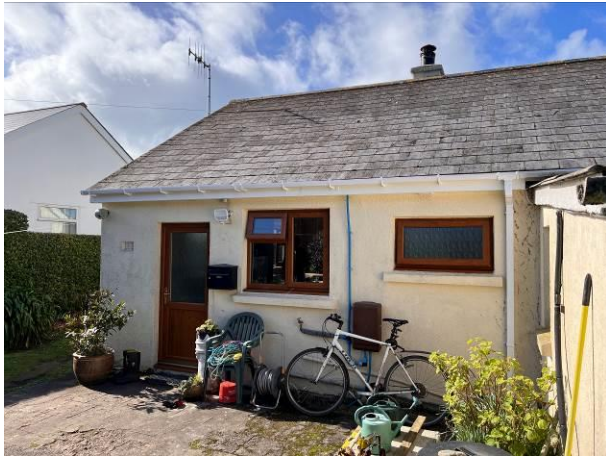
The main dwelling is rendered externally to a high standard with no gaps, cracks or cavities which could support roosting bats.

The uPVC windows, doors and soffits on the rear aspect of the main property are well-fitted with no gaps noted around apertures or behind boards. Guttering runs along the soffits at the eaves which would preclude direct fly-in access at this location. uPVC fascias at the gables are well-fitted with no gaps noted.

Photograph 1: Showing rear aspect of the property – the lean-to structure is just visible on the LHS

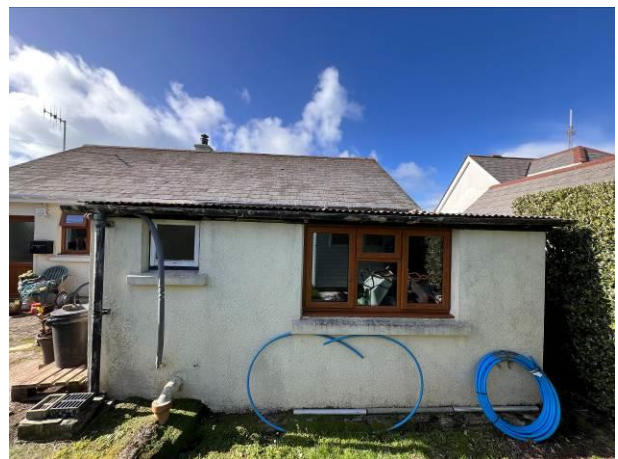
The lean-to structure to the rear is rendered externally to a high standard with no gaps, cracks or cavities noted.

House sparrows have the potential to nest in features associated with the corrugated roof sheets on the lean-to structure. Additional minor opportunities may be found elsewhere on the structure, or within the associated garden.

Photograph 6: Showing the lean-to structure viewed from the rear garden.
