## PRELIMINARY ROOST ASSESSMENT (PRA)

4 PORTHCRESSA TERRACE,  
HUGH TOWN, ST MARY'S, ISLES OF SCILLY

***Report date:*** 28<sup>th</sup> October 2023

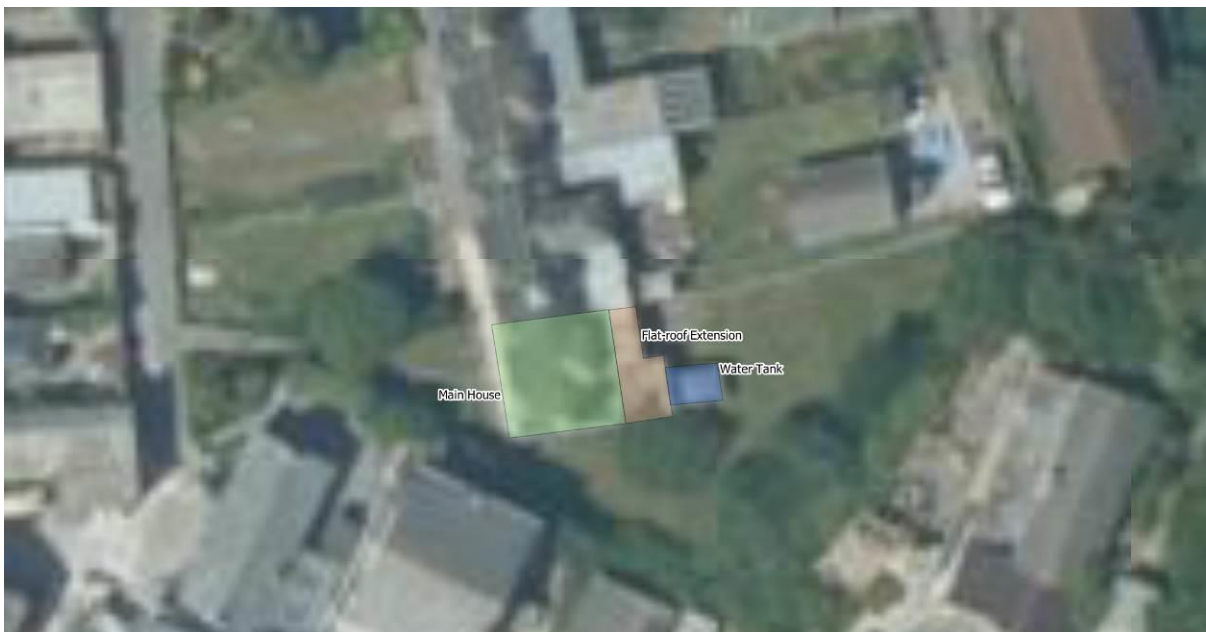
**Map 02** – Showing the different elements of the buildings.

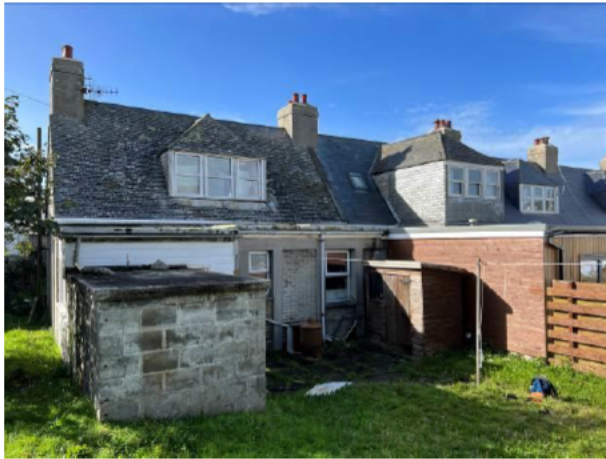
A flat-roof single-storey extension is attached on the eastern aspect of the property. This is block-built and uPVC-clad in places. No features were noted associated either with the pointing or the cladding. Window frames are well-fitted with no gaps noted at the edges.

There is a flat-roofed water tank enclosure attached on the eastern edge of the flat-roof extension. This also houses a small shed/garage unit which was accessed and inspected and found to provide no roosting opportunities.

**Photograph 1:** Showing the property – the main property of 4 Porthcressa Terrace spans the length between the two chimneys on the left-hand side. The flat-roof extension can be seen in the foreground with the enclosed water-tank.
