EXTERNAL WINDOW GROUP 1 -
TIMBER VERTICAL SLIDING SASH WITH
ROUNDED HORN PROFILES

REV	DESCRIPTION	DATE	INS
CAD HERITAGE			
THE CONSERVATION DIVISION OF CAD ARCHITECTS LTD COURTLEIGH HOUSE, 74-75 LEMON STREET TRURO, CORNWALL, TR1 2PN CALL: 01872 630 041 MAIL: info@cadheritage.co.uk WEB: www.cadheritage.co.uk			
RIBA   Chartered Practice			
DATE	NOV 25	SCALE	AS SHOWN @ A1
CLIENT	PAUL GROVES	CHECKED	SM
DRAWING NO.	3528-1-500	STATUS	EXISTING

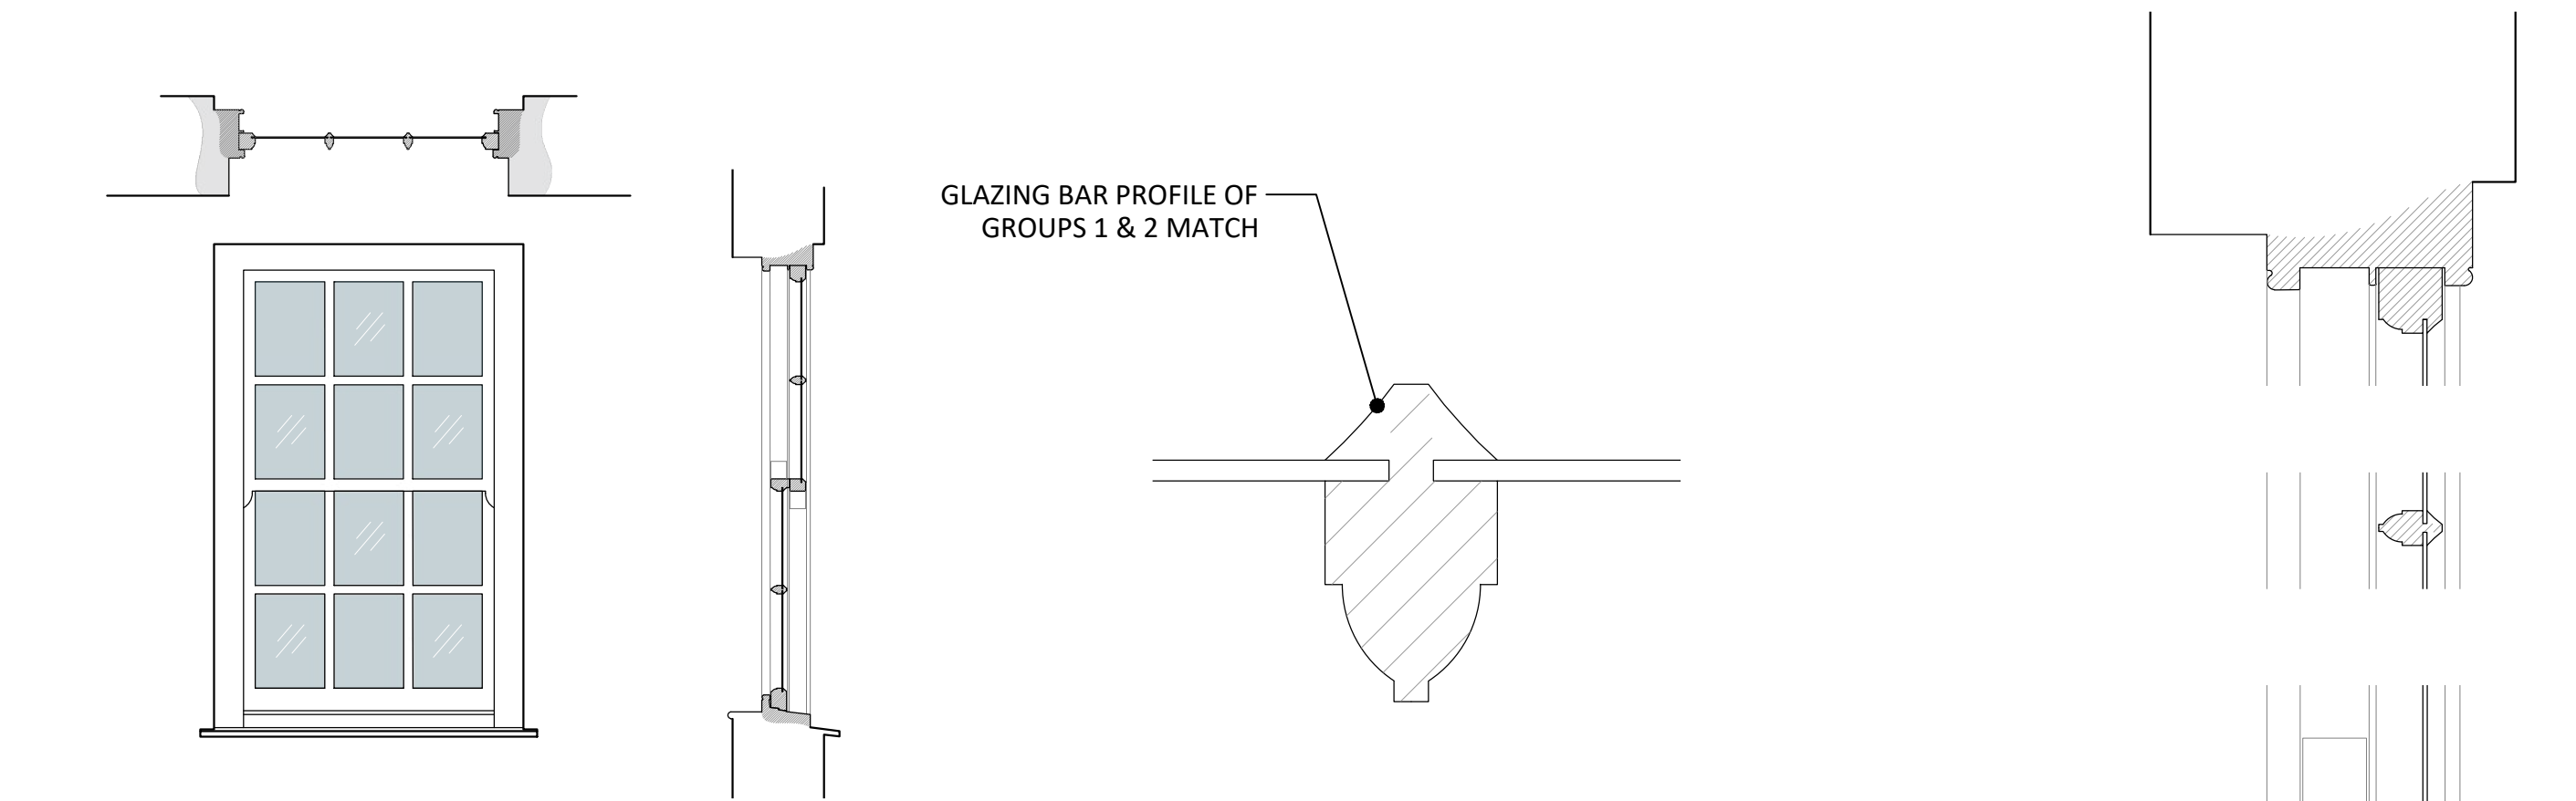
01 GROUP 1 TYPICAL ELEVATION
REF 3528-1-500
SCALE 1:20
W-04, W-05, W-09, W-10, W-11, W-13, W-15, W-16, W-17, W-26, W-29.

Windows in generally poor condition, with evidence of rot, failed repairs, rusting fixings, and previously replaced timber elements.

Replacements to be heritage slim-line double glazed units as per specialist design - please refer to David Gilbert Joinery Ltd drawings for details.
