EXTERNAL WINDOW GROUP 3 -
TIMBER VERTICAL SLIDING SASH WITH
CONCAVE HORN PROFILES

EXTERNAL WINDOW GROUP 3 DEFECTS

REV	DESCRIPTION	DATE	INS
CAD HERITAGE			
THE CONSERVATION DIVISION OF CAD ARCHITECTS LTD COURTLEIGH HOUSE, 74-75 LEMON STREET TRURO, CORNWALL, TR1 2PN CALL: 01872 630 041 MAIL: info@cadheritage.co.uk WEB: www.cadheritage.co.uk			
RIBA   Chartered Practice			
DATE	ALTERATIONS TO FORMER CUSTOMS HOUSE LOWER STRAND, ST MARYS, ISLES OF SCILLY TR21 0PS	DATE	JM NOV 25
CLIENT	PAUL GROVES	SCALE	AS SHOWN @ A1
DRAWN	AS EXISTING WINDOW DETAILS EXTERNAL WINDOW GROUP 3 CONCAVE HORNS	CHECKED	SM
STATUS	EXISTING	DRAWING NO.	3528-1-502
		REVISION

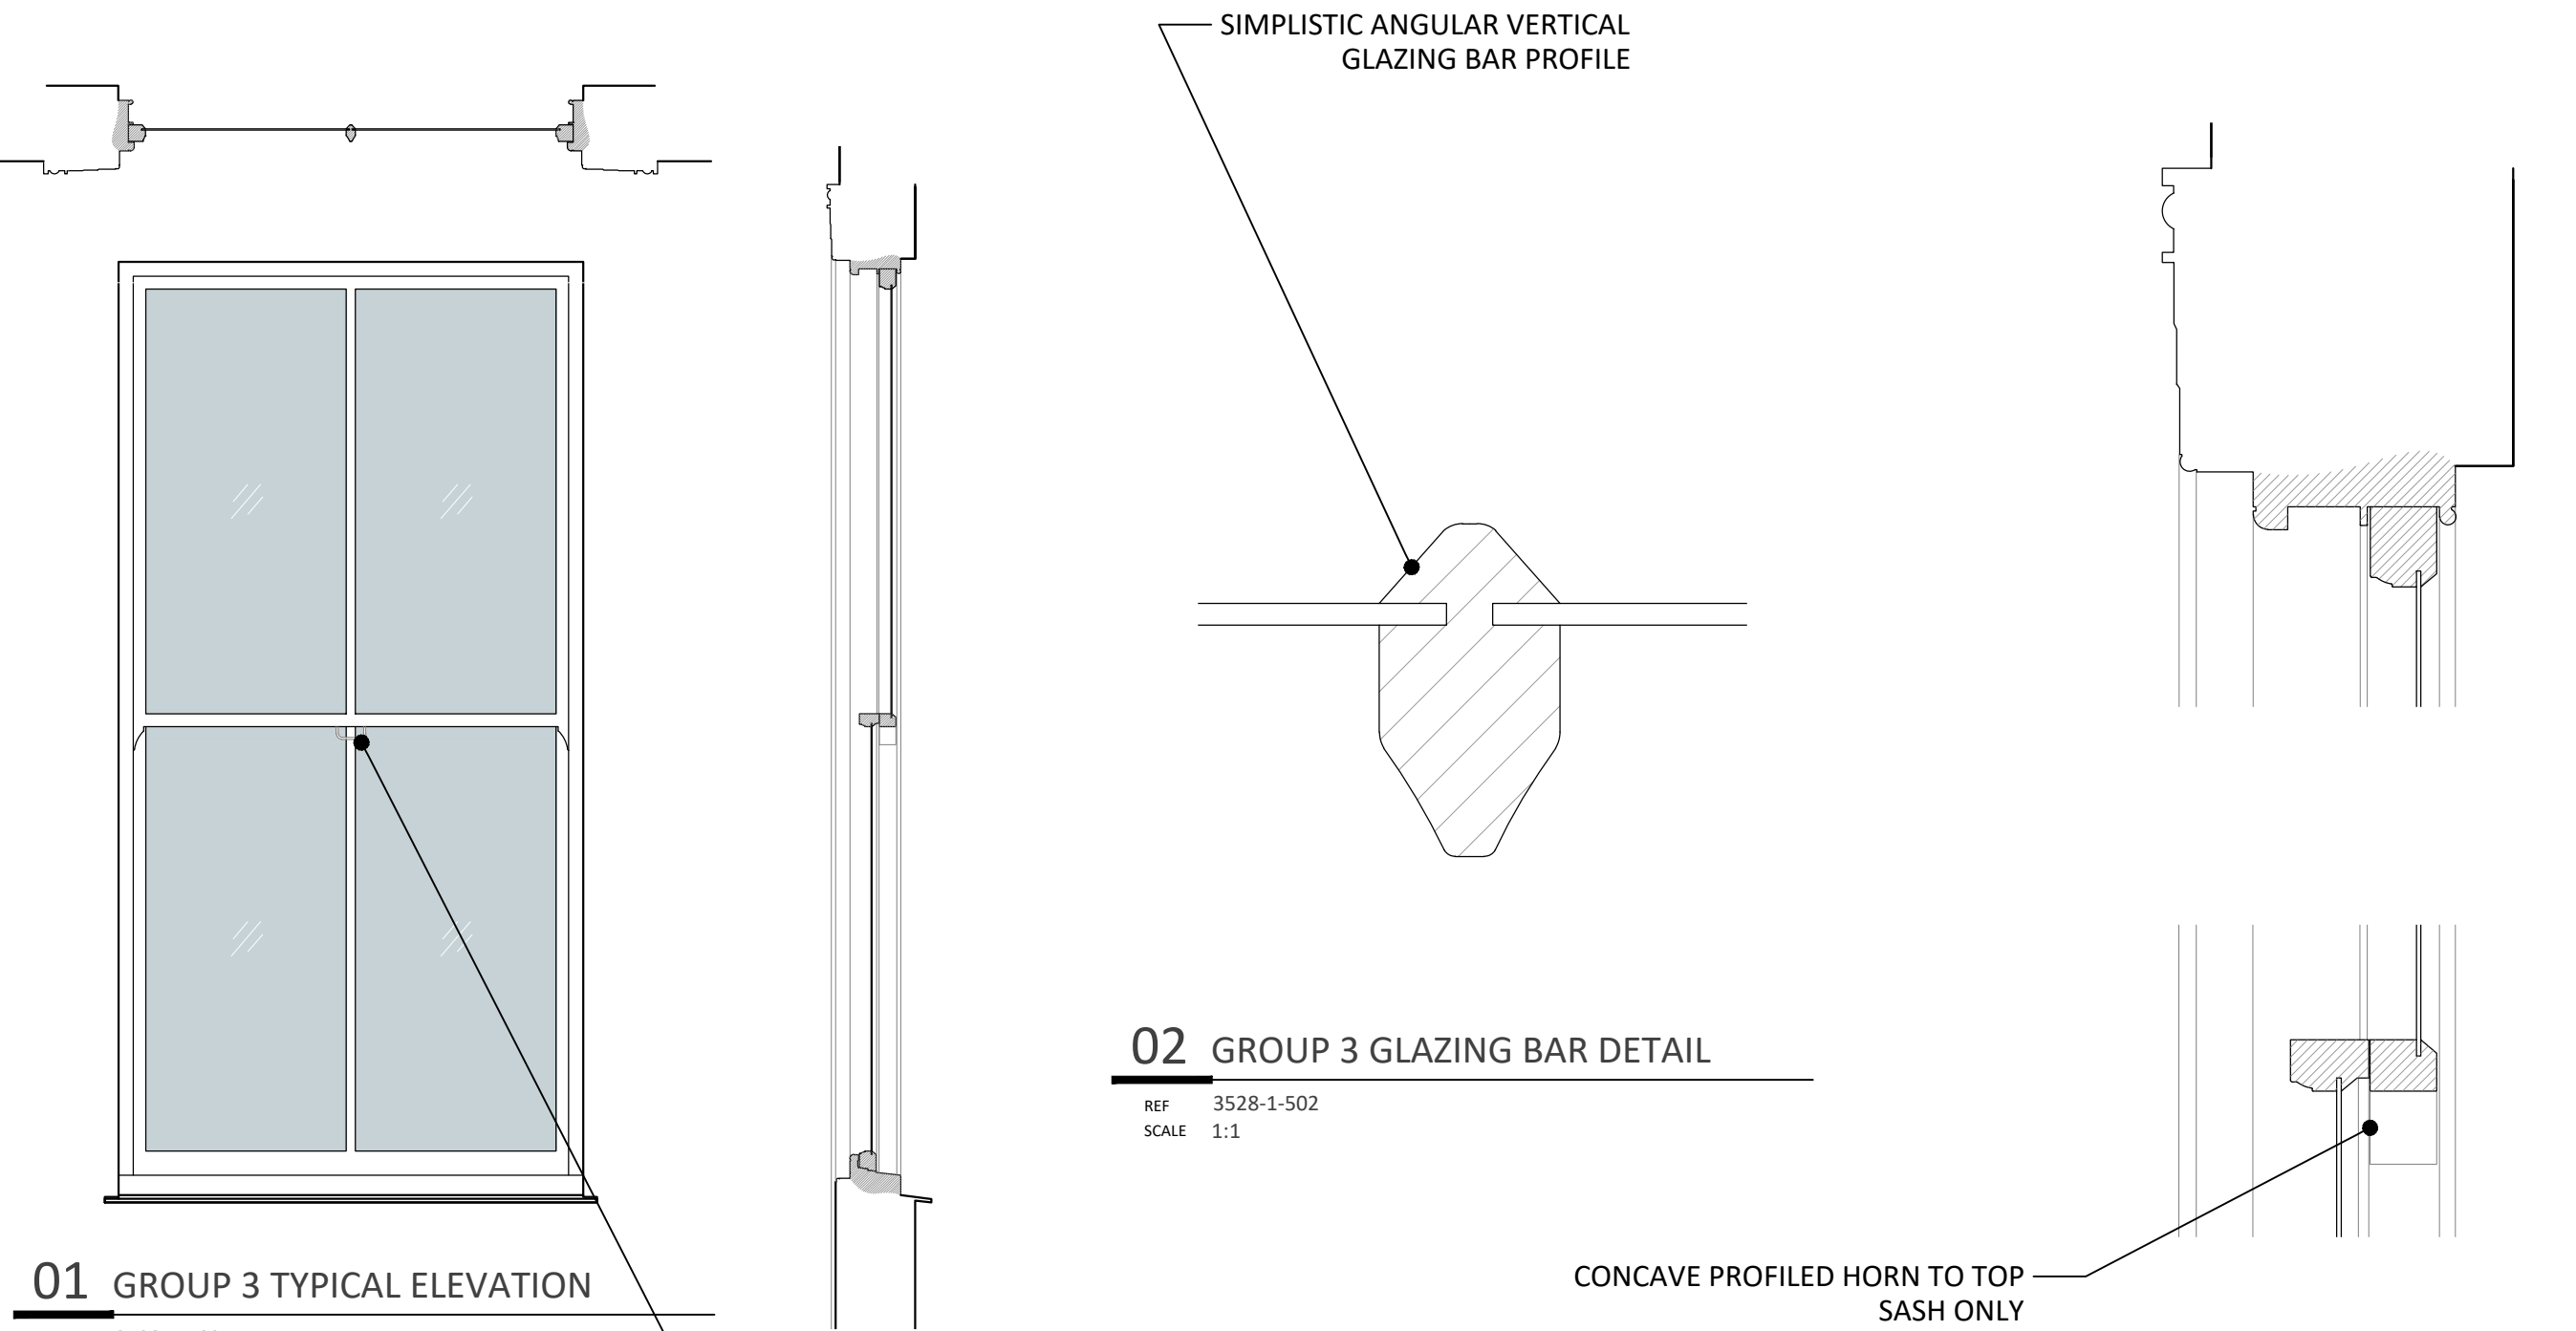
01 GROUP 3 TYPICAL ELEVATION
REF 3528-1-502
SCALE 1:20
W-01, W-18, W-19.

CONCAVE PROFILED HORN TO TOP SASH ONLY

EXTERNAL HANDLES TO WINDOWS W-18 & W-19

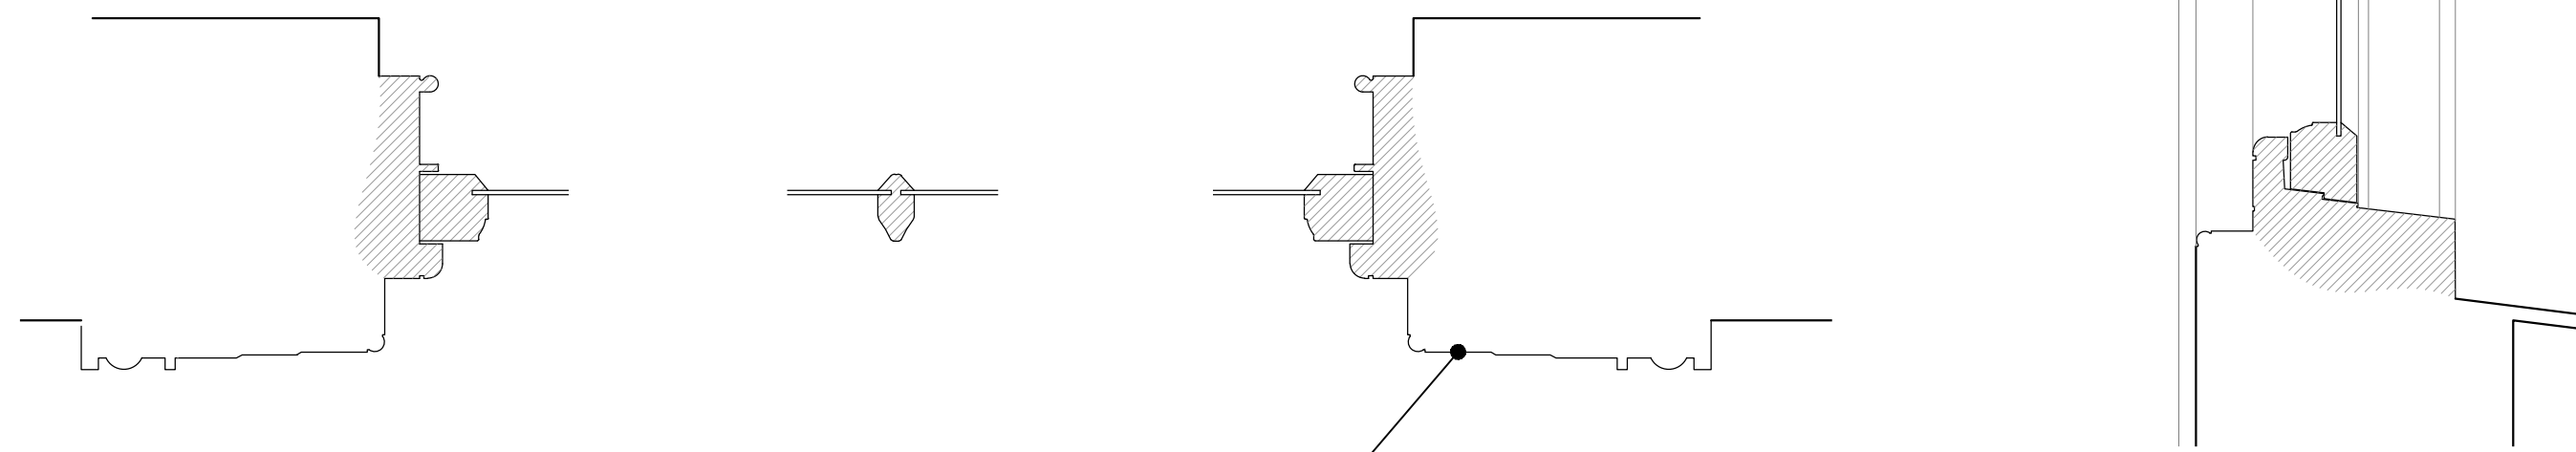
03 GROUP 3 TYPICAL PLAN DETAILS
REF 3528-1-502
SCALE 1:5

INTERIOR ARCHITRAVES AROUND WINDOWS W-18 & W-19.
