PRELIMINARY ROOST ASSESSMENT (PRA)

POLTAIR,
ST MARY'S, ISLES OF SCILLY

Client: Wright Construction

Our reference: 25-10-1

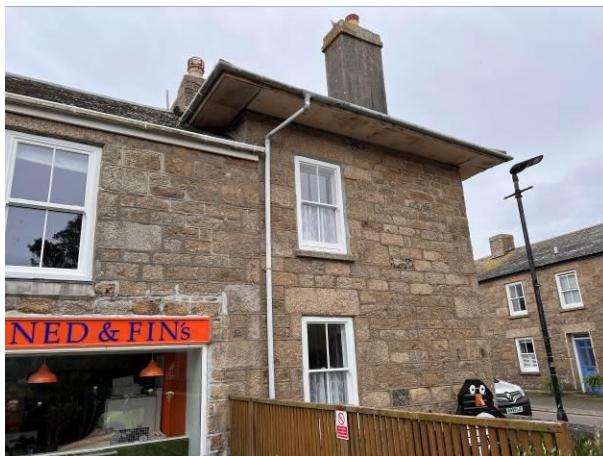
Photograph 1: Showing the western aspect of the property – Poltair is the structure on the RHS of the wooden fence.

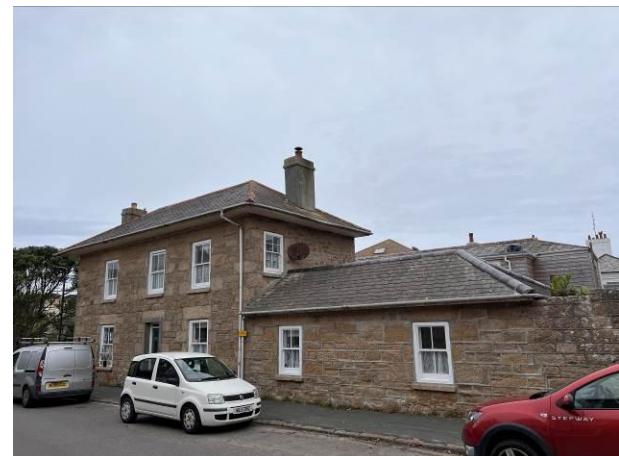
Photograph 2: Showing the southern aspect of the property with the main house visible on the LHS and the single-storey extension on the RHS.

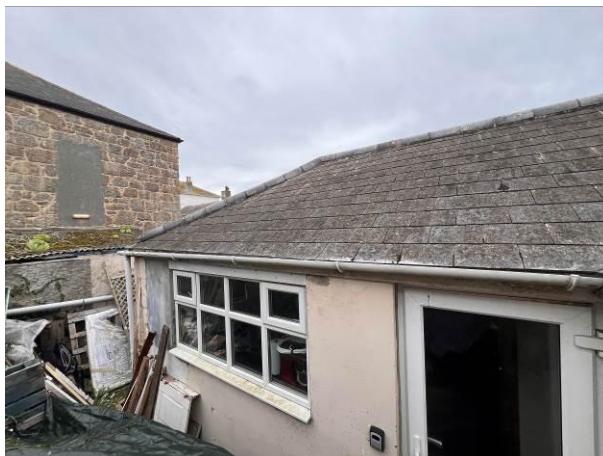
Minor gaps occur at the roof verge on the northern aspect of the structure where the roofline extends where the footprint of the building steps out – these gaps appear superficial offering minor access to the gaps beneath the tiles but were blocked with cobwebs and debris at the time of survey. This location was inspected with a video endoscope and no evidence of current or historic use by roosting bats was noted.

Photograph 3: Showing the northern aspect of the single-storey extension.

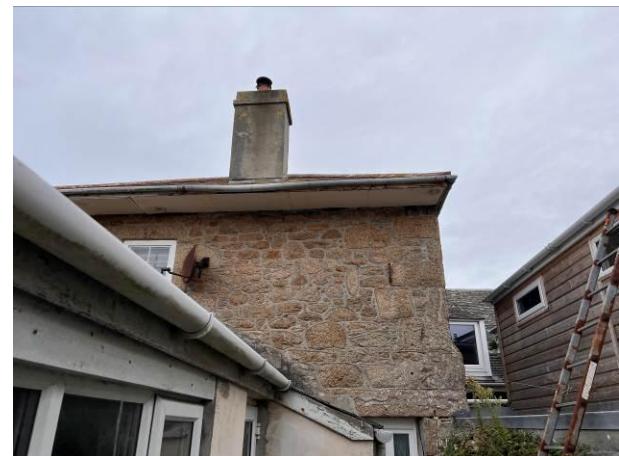
Photograph 4: Showing the eastern aspect of the main house with the single-storey extension in the foreground.
