PRELIMINARY ROOST ASSESSMENT (PRA)

PIER HOUSE, ST MARY'S, ISLES OF SCILLY

Report date: 20th January 2024

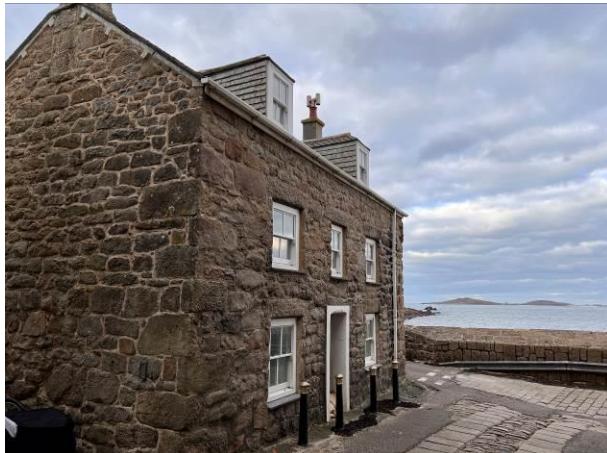
Dormer windows are present on the north-eastern aspect – these have hanging tiles which are generally in good condition with no gaps visible, though there are gaps beneath the flashing where the dormers join the main roof which could potentially provide roosting opportunities.

The fascia on the eaves of the south-western aspect is well-sealed with no gaps noted, but there are a range of different sized crevices created by the fascia on the north-eastern aspect. The gaps are formed at the interface between the fascia board and the irregular granite blockwork and could offer roosting opportunities in their own right, or access to further opportunities associated with the roof tiles.

The potential for roosting bats is associated primarily with the north-eastern aspect of the roof of Pier House – it should be noted that this aspect faces directly onto the Mermaid pub which will result in light, noise and disturbance during most evenings. The aspect is also very exposed to the weather given its location directly adjacent to the harbour wall to the north. These are considered to reduce the overall potential of the features to low, rather than moderate which they would likely be in a more sheltered and undisturbed location.

Photograph 1: Showing the north-eastern aspect of Pier House.

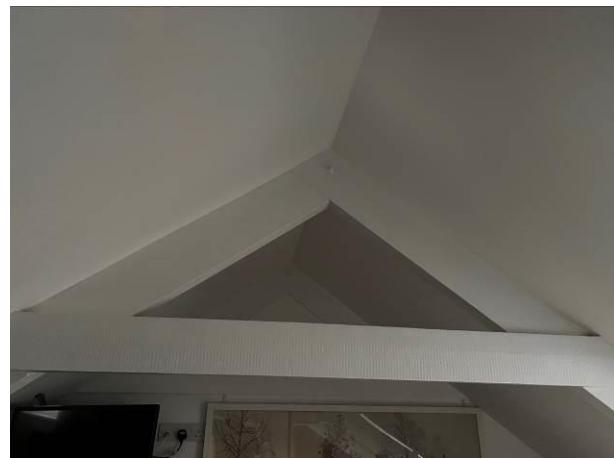
Photograph 8: Showing the upper floor of Pier House with the room built into the apex.
