## SHORT FORM DESIGN STATEMENT

<b>ARCADIS</b> <small>Design &amp; Consultancy for natural and built assets</small>	Project Name	Number and Activity code
	Isles of Scilly – Porth Hellick	UA008878-ARC-XX- XX-MS-CE-0561-P2
<p><b>Brief Description:</b></p> <p>Porth Hellick is located on the south-east coast of St. Marys. The 250-m wide bay is flanked on both ends by rocky outcrops.</p> <p>The backshore dune is made of coarse sand (4-10 mm particle size) and vegetation is well established along its crest including <i>Fascicularia Bicolour</i> &amp; <i>Hottentot Fig</i> (<i>C.edulis</i>). There are gaps and low points due to the action of storm events during the past decade. It has been reported though that the dune is not particularly mobile.</p> <p>The eastern end of the dune suffers from severe human-induced erosion due to the action of boat launching. Additionally, the construction of the existing outfall required the excavation of dune which was not reinstated to match the existing dune levels.</p> <p>These low spots are potential paths for saline intrusion into the Higher Moors Pool, the main fresh water resource for St. Mary's, hence the sand dune defence needs improvement to con

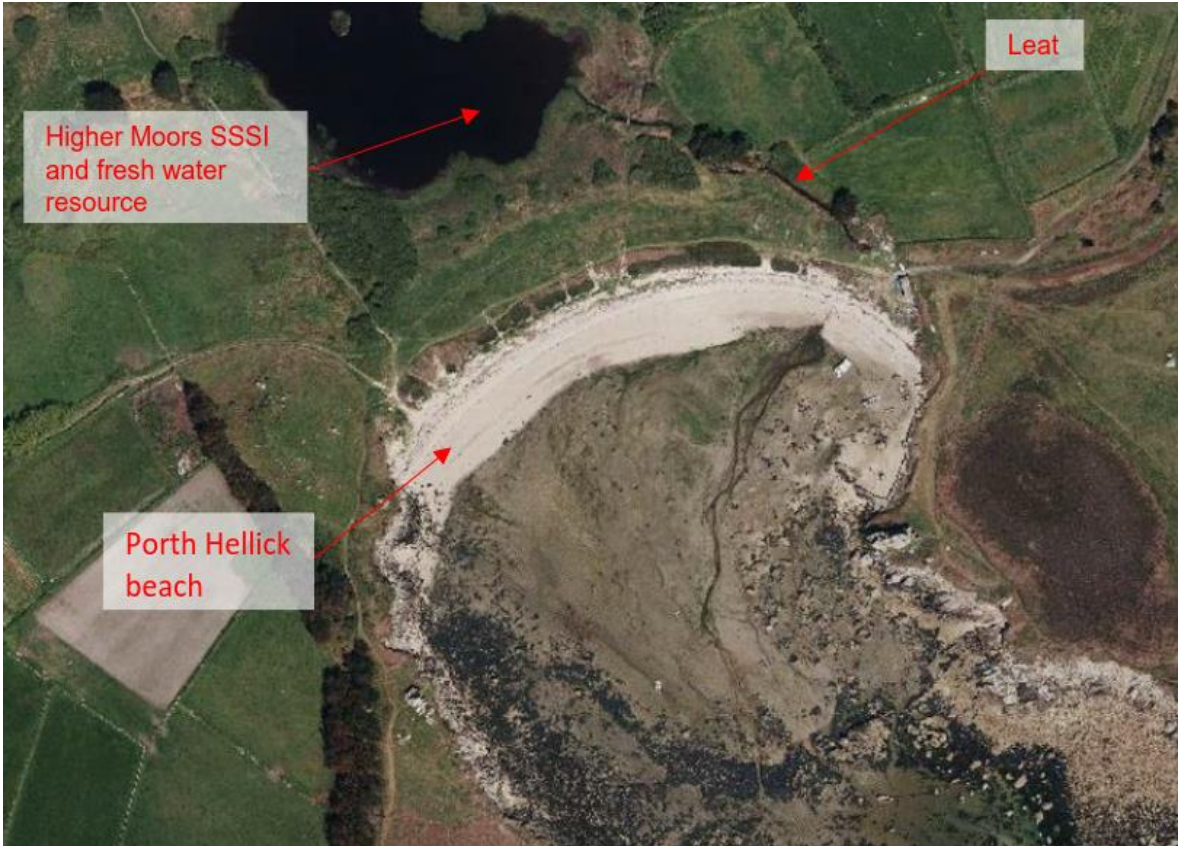
<p>Figure 1: Aerial photograph of Porth Hellick. Image orientated north (Channel Coastal Observatory, 2016)</p>

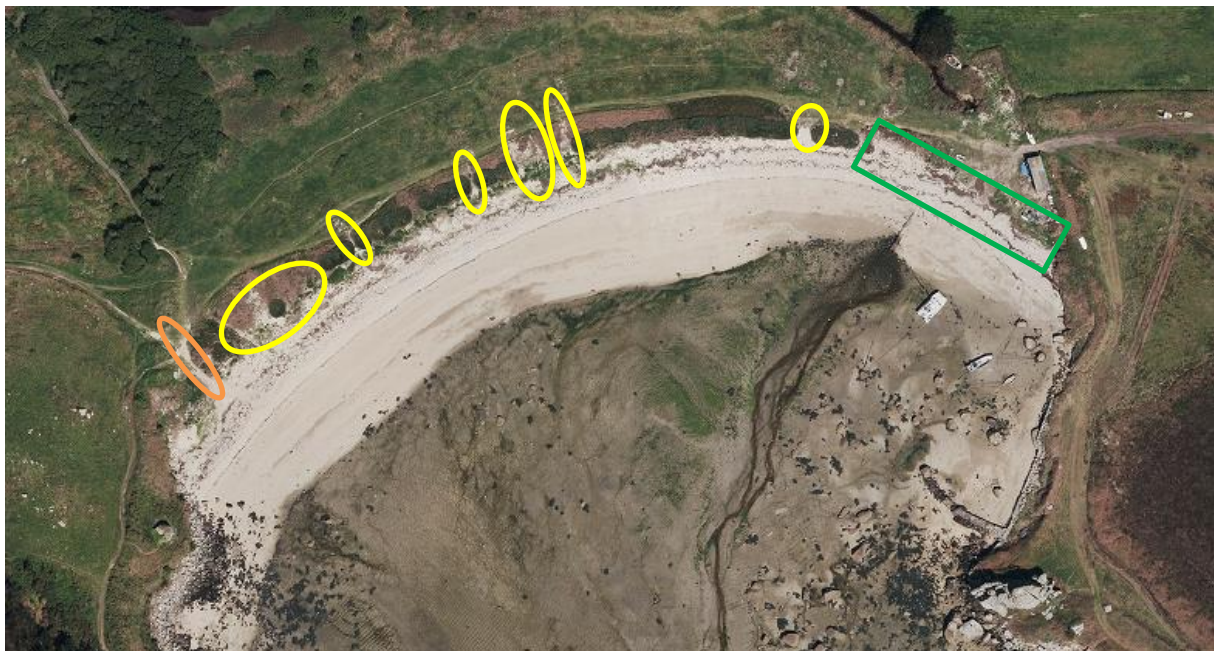
Figure 2. Key elements of the design

It can be observed in Figure 2 that the existing vegetation (*Fascicularia Bicolour*) on the crest of the dune has prevented beach material being moved to the rear of it. Therefore, it is proposed that non-vegetated

areas highlighted in yellow are revegetated with the same plant species found growing locally on the crest to provide a consistent and continuous line of defence against wave run-up and dune erosion.

The section highlighted in orange in Figure 2 at the western end of the site, is primarily used by members of the public to access the beach. This is causing the dune to erode, facilitating a path for sea water to reach the water resource during storm events. In this case, it is proposed to install a timber boardwalk which will be elevated above the underlying beach material (circa 100mm). This should stop further deterioration of the dune from the pedestrian induced erosion.

The existing dune is to be extended along the section highlighted in green with its crest set to +5.00 ODN. To do so, the existing ground will be cleared to provide a suitable founding surface. The dune will be profiled in two sections, leaving a gap in between for the construction of the ramp. The slopes of the dune will match the existing (1V:6H approximately) and will be stabilised with 100% biodegradable geotextile mats (Coconet 800 or similar approved). The imported material is to be crushed Cornish granite 4-10 mm grading. Following point no.1, the crest will be revegetated with bush found growing locally on the crest. A mix of sapling and mature plants is to be used. The required volume to be imported is ~276 m<sup>3</sup>.
